## Annual Inspection

Bugbrooke Parish Council

School Lane Play Area

Inspected: 30-June-2026 - 12:13 by Jamie Leeson (RPII Annual Inspector)

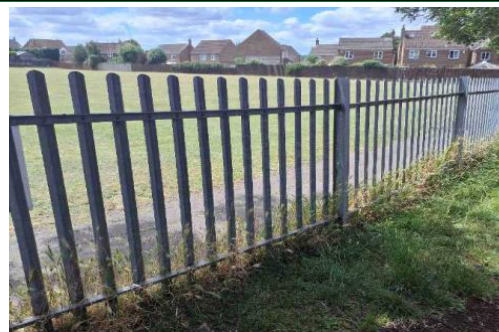
**Finding 1**

A number of fixings have worked loose around the fencing - Secure all loose fixings

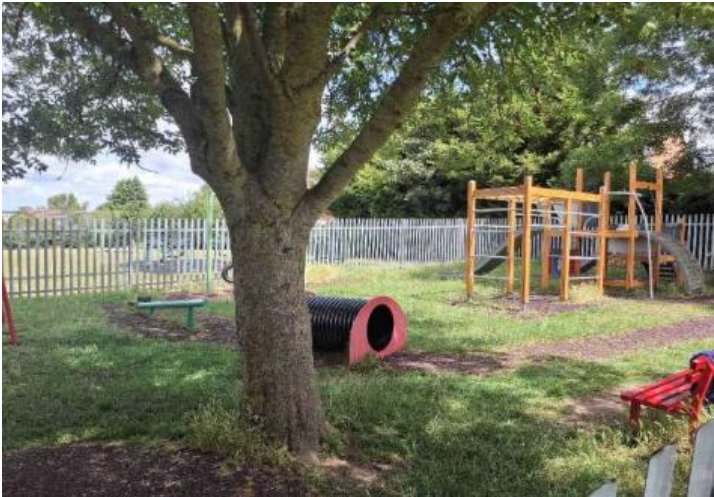
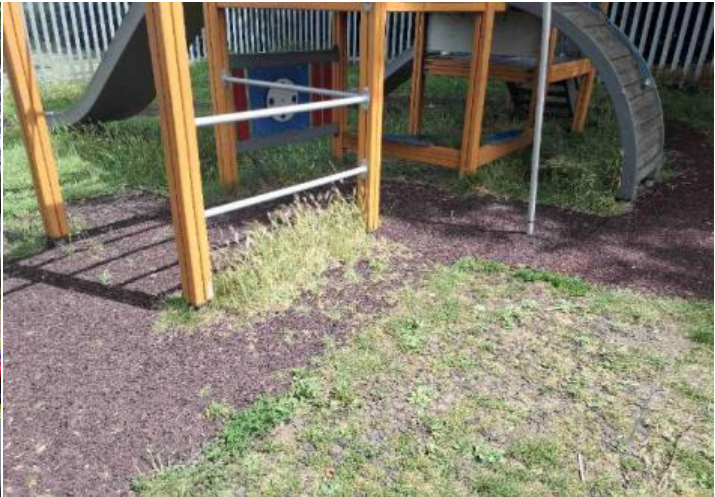
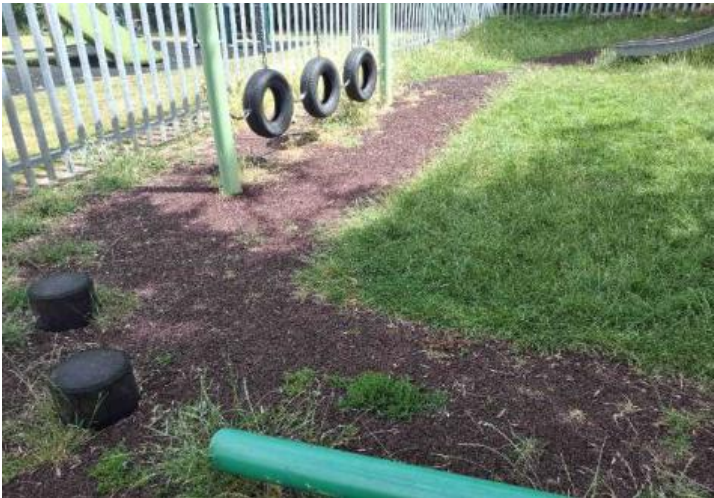
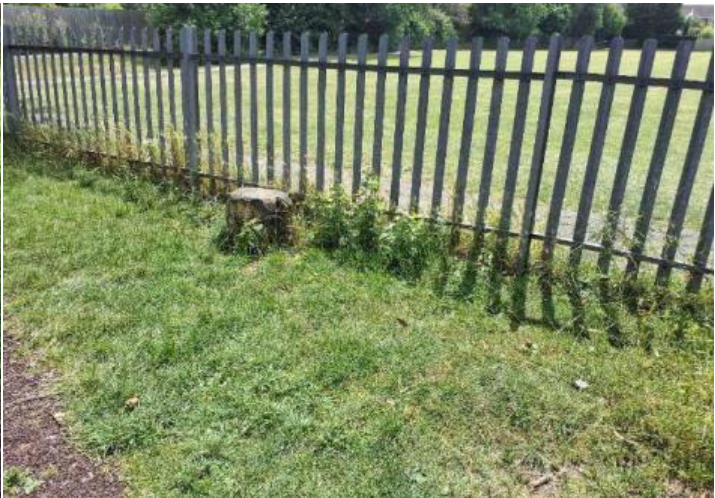
| <div> 6 - Low Risk (Finding 1) </div> | | | |
|---|--|---|--|
| <b>Finding:</b> There is weed / vegetation growth within the surface | | <b>Action:</b> Remove weed / vegetation growth | |

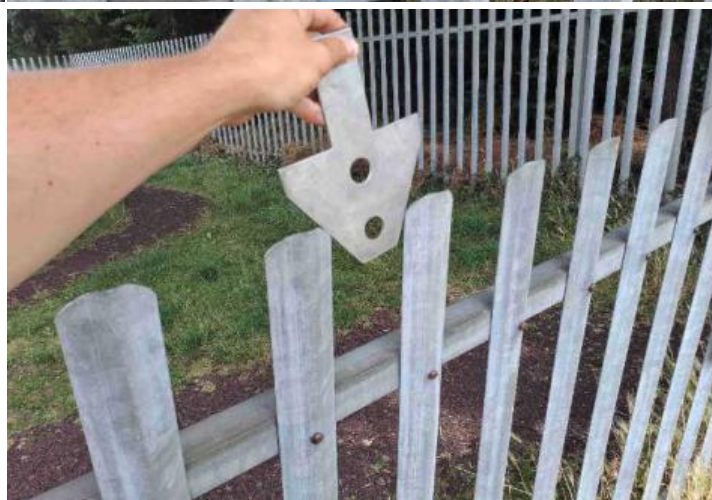
**Finding:** There is a risk of head and neck entrapment in the accessible castellations of the fence and gate  
**Action:** Monitor - no action given the risk assessment

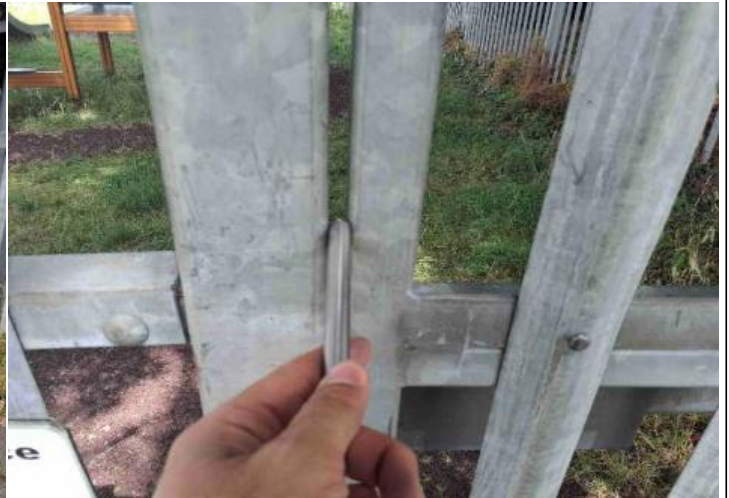
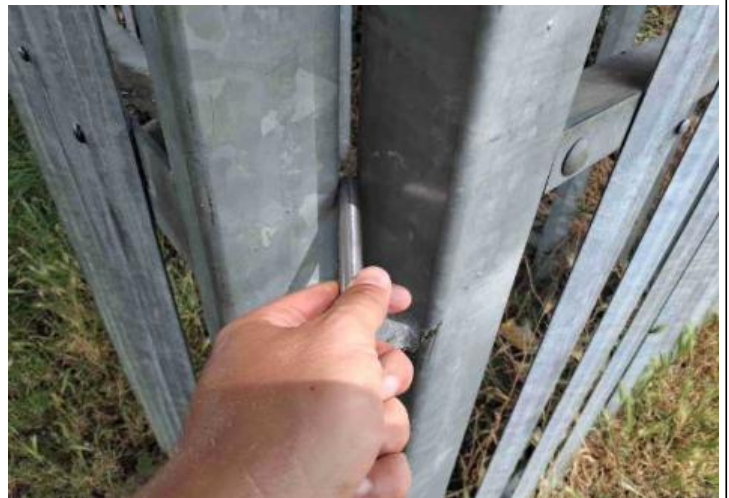
**i** 10 - Low Risk (Finding 1)

**Finding:** There are openings that are less than 12mm that could trap or crush fingers

**Action:** Provide a 12mm gap throughout full range of motion at both sides of gate

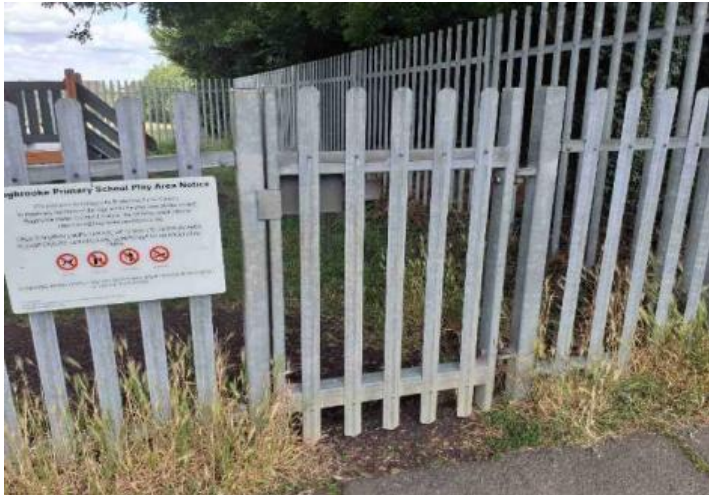
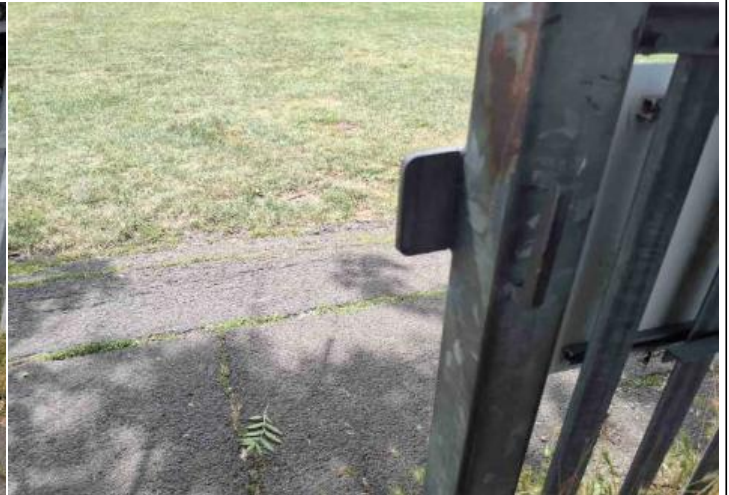
The rubber buffer is missing from the latch plate - Replace rubber buffer

**Finding:** The rubber buffer is missing from the latch plate

**Action:** Replace rubber buffer

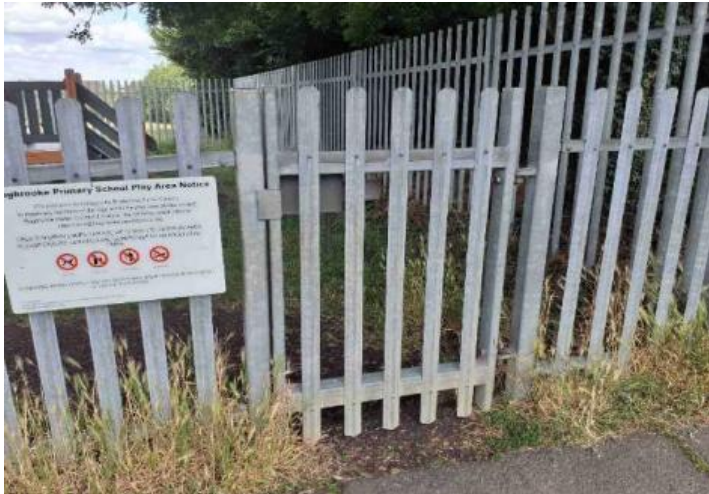
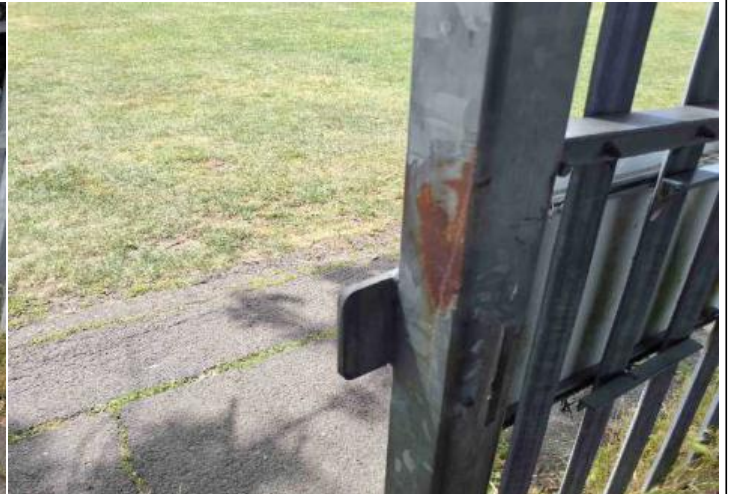
There is surface corrosion / rust present on the item - Consider treating the item

**Finding:** There is surface corrosion / rust present on the item

**Action:** Consider treating the item

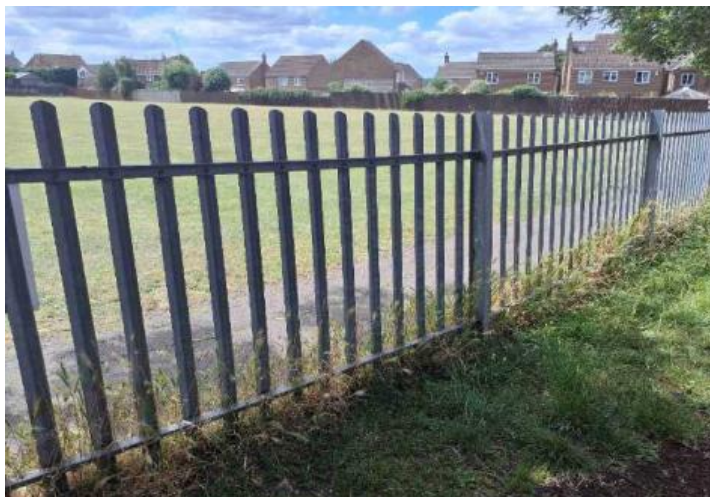
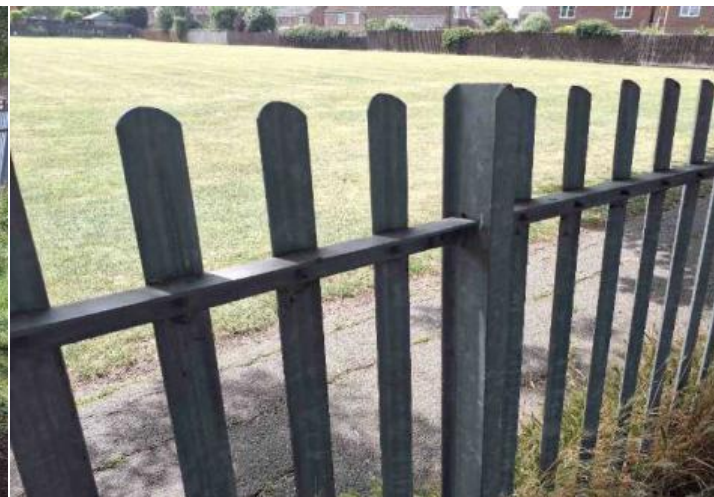
**Finding:** A number of fixings have worked loose around the fencing  
**Action:** Secure all loose fixings

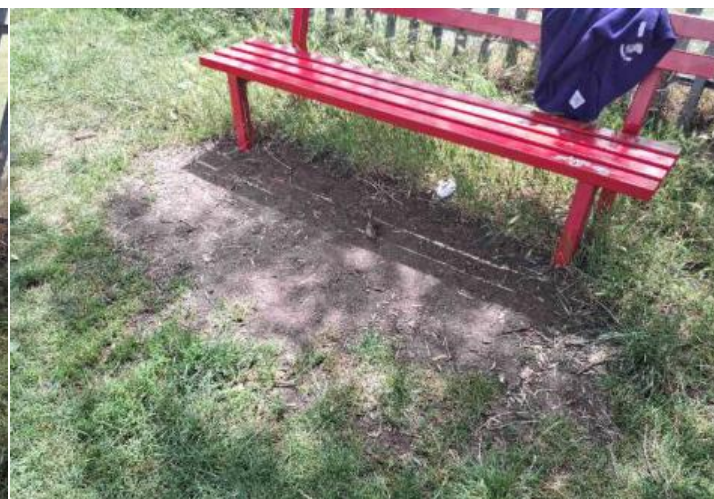
**i** 8 - Low Risk (Finding 1)

**Finding:** The area around the item has eroded and may become slippery  
**Action:** Reinstate eroded area

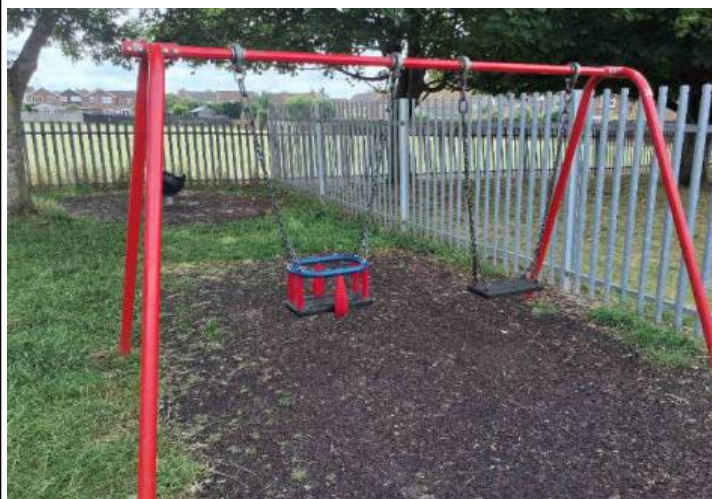
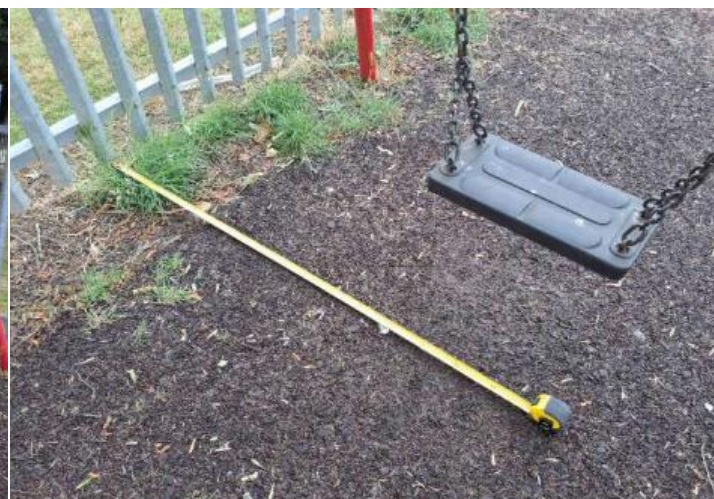
BS EN 1176 Part 2: Annex A makes a recommendation that fences or enclosures should be 1.50m from the edges of the swing seat to the sides, and subject to risk assessment, from the edge of the impact area. This is however, a low risk finding and no remedial action is recommended. - Monitor - No action given the risk assessment

**Finding:** BS EN 1176 Part 2: Annex A makes a recommendation that fences or enclosures should be 1.50m from the edges of the swing seat to the sides, and subject to risk assessment, from the edge of the impact area. This is however, a low risk finding and no remedial action is recommended.

**Action:** Monitor - No action given the risk assessment

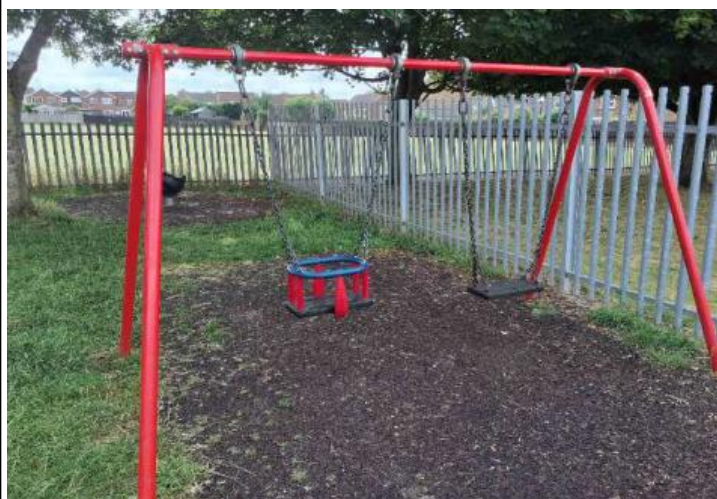
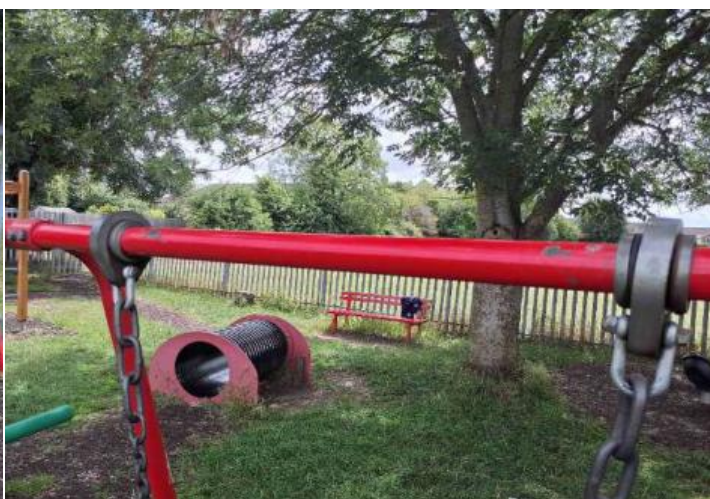
The paintwork on this item has been damaged or worn exposing the metal underneath which is rusting / corroding - Treat affected areas and repaint

**Finding:** The paintwork on this item has been damaged or worn exposing the metal underneath which is rusting / corroding

**Action:** Treat affected areas and repaint

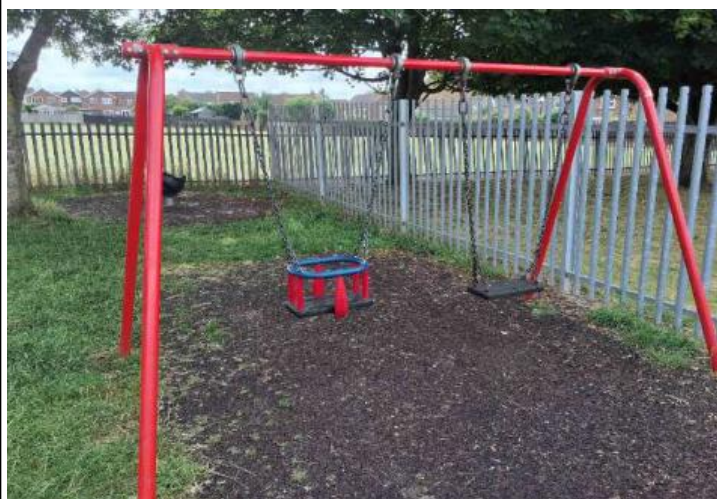
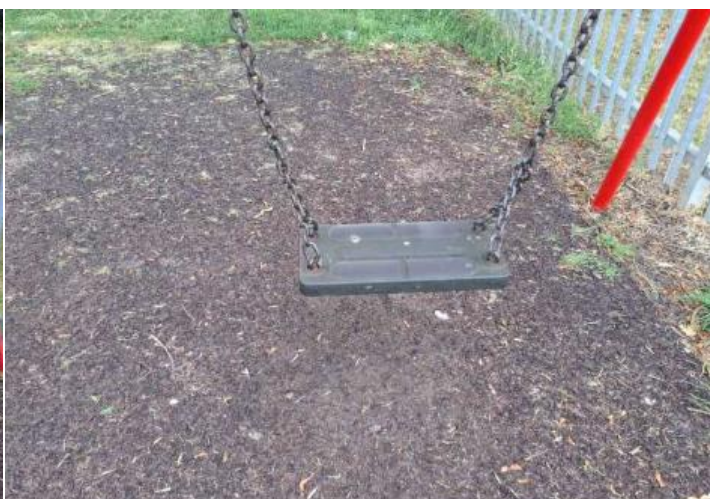
The swing seat connectors are loose - Tighten to secure

**Finding:** The swing seat connectors are loose

**Action:** Tighten to secure

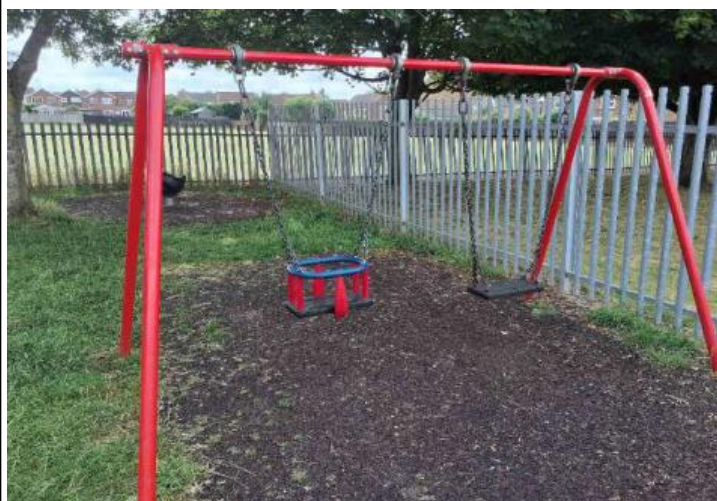
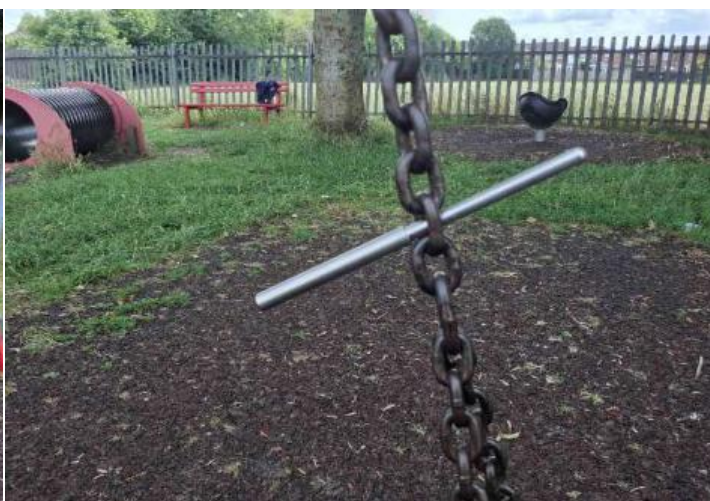
The chain openings are in excess of 8.6mm and do not meet the recommendations of BS EN 1176 Part 1 - Monitor - No action given the risk assessment

**Finding:** The chain openings are in excess of 8.6mm and do not meet the recommendations of BS EN 1176 Part 1

**Action:** Monitor - No action given the risk assessment

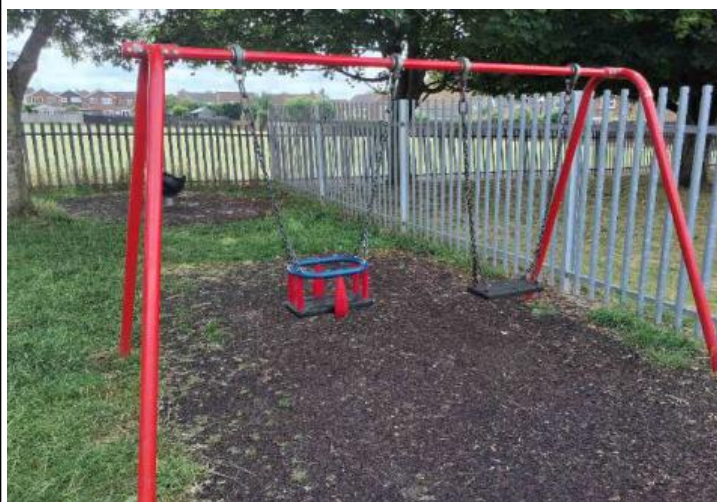
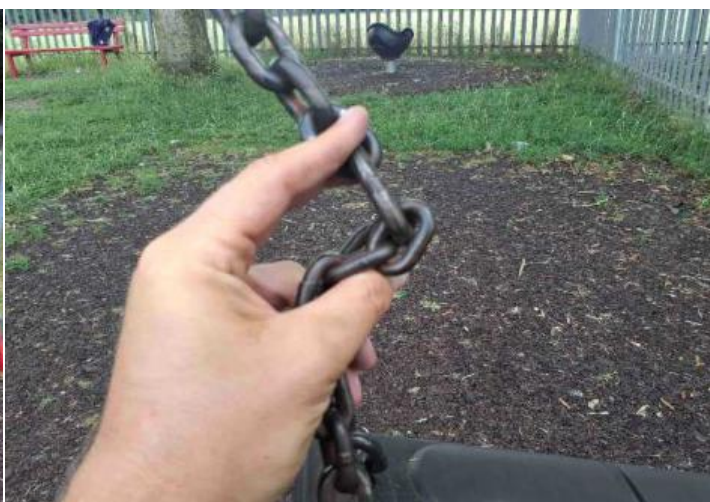
There is some notable evidence of chain wear - Monitor for any further deterioration and replace when 40% worn

**Finding:** There is some notable evidence of chain wear

**Action:** Monitor for any further deterioration and replace when 40% worn

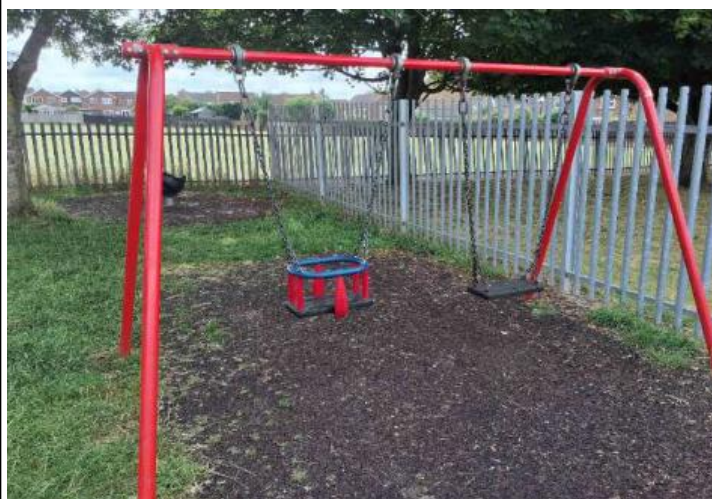
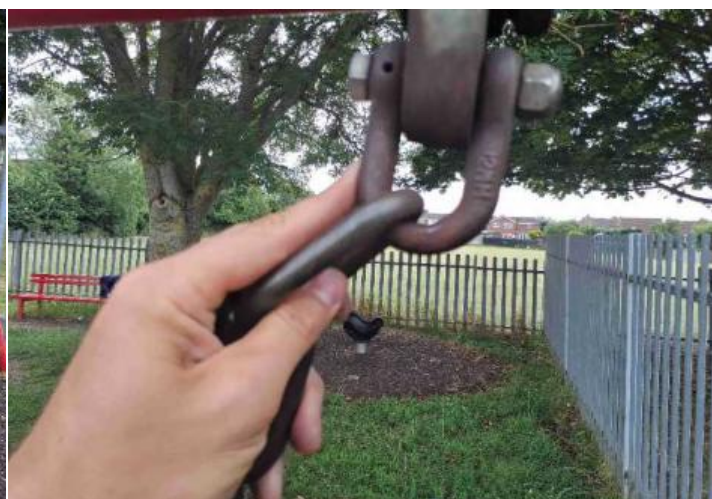
There is some wear to the shackles - Monitor for any further deterioration and replace when 40% worn

**Finding:** There is some wear to the shackles

**Action:** Monitor for any further deterioration and replace when 40% worn

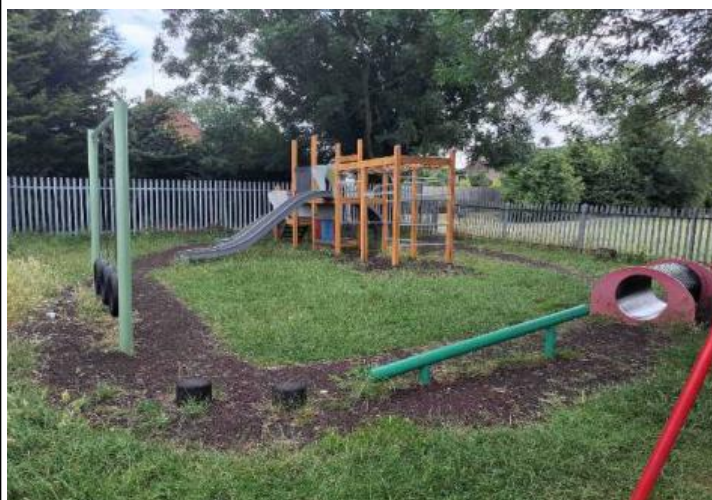
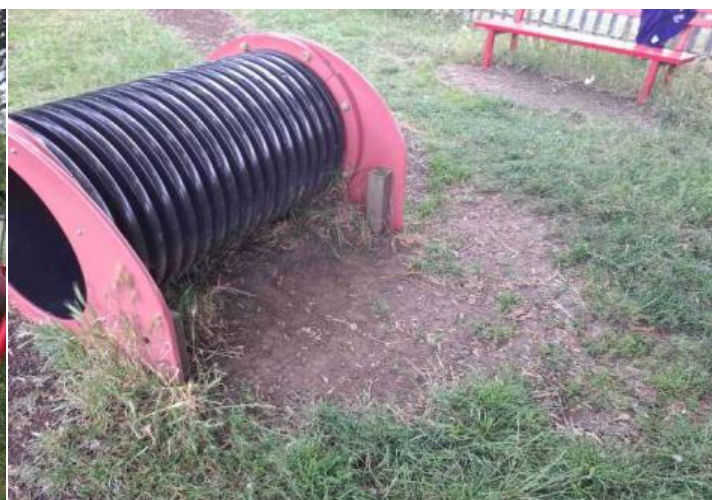
The surface has eroded in some areas and may be slippery in wet conditions - Reinstate the surface

**Finding:** The surface has eroded in some areas and may be slippery in wet conditions

**Action:** Reinststate the surface

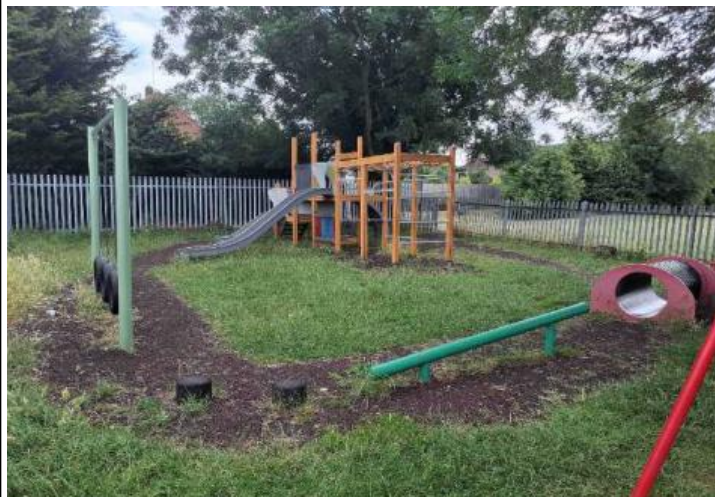
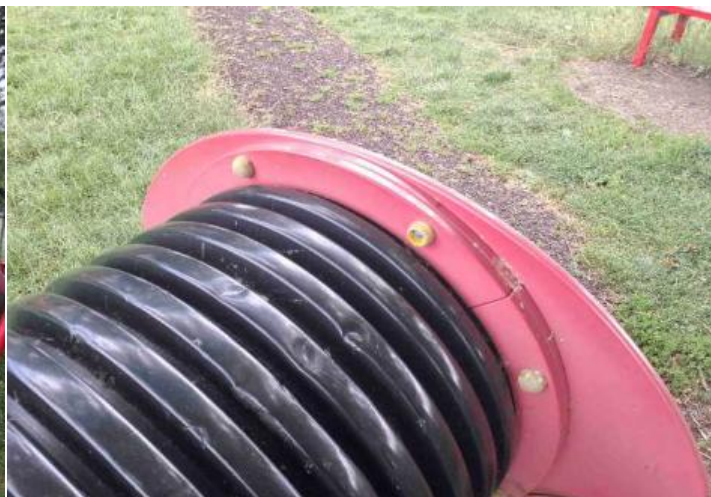
**Finding:** Bolt cap cover/s missing or damaged

**Action:** Replace

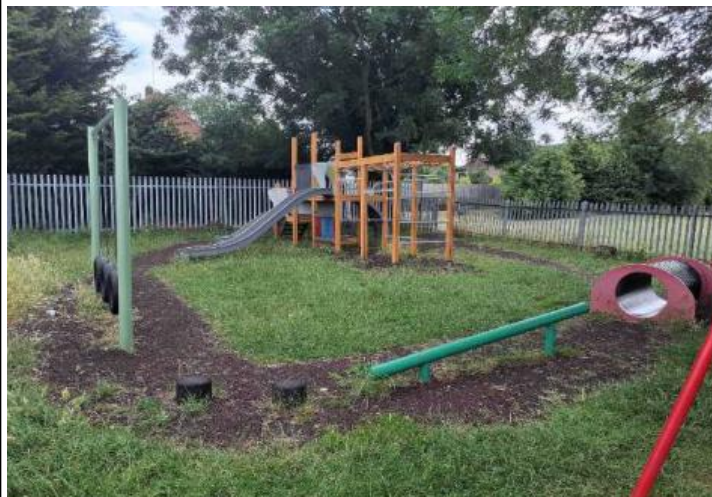
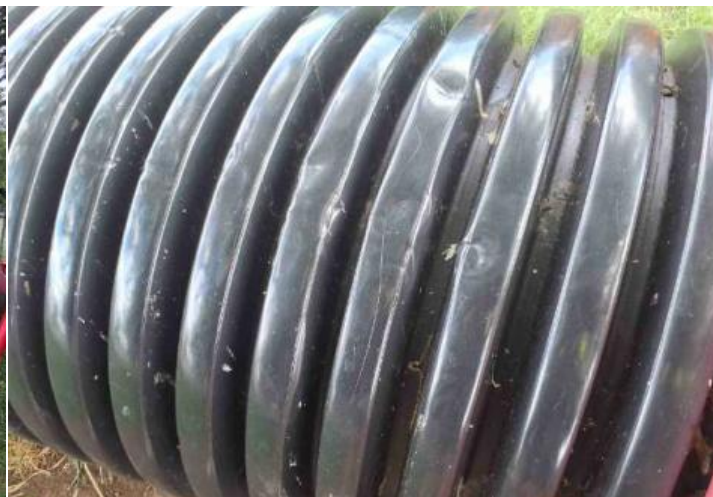
**i** 6 - Low Risk (Finding 4)

There is some evidence of fire damage to the item - Monitor for any further deterioration and repair as required

**Finding:** There is some evidence of fire damage to the item **Action:** Monitor for any further deterioration and repair as required

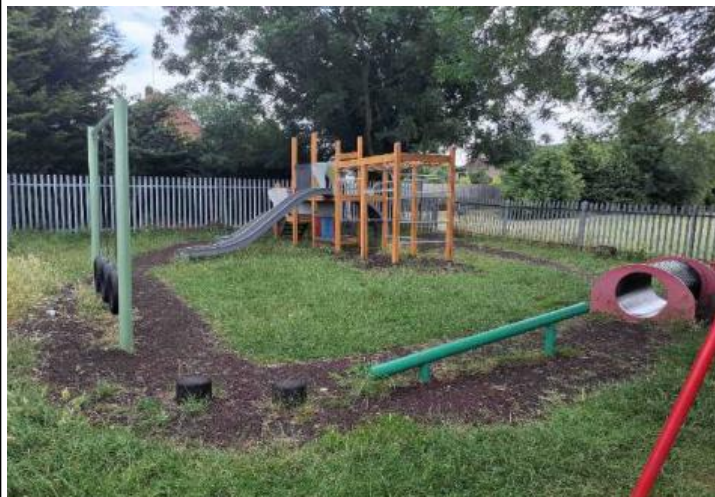
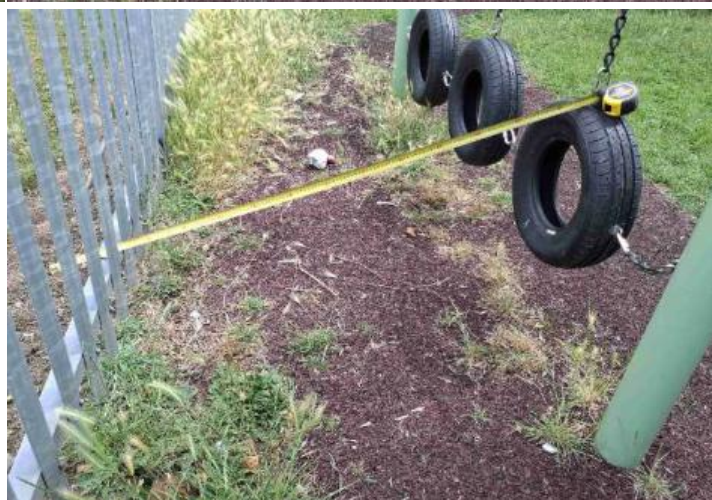
**Finding:** The fence forms a hard object within the falling space of the equipment and there is also insufficient surfacing provided in contravention of BS EN 1176 Part 1

**Action:** Monitor - No action given the risk assessment

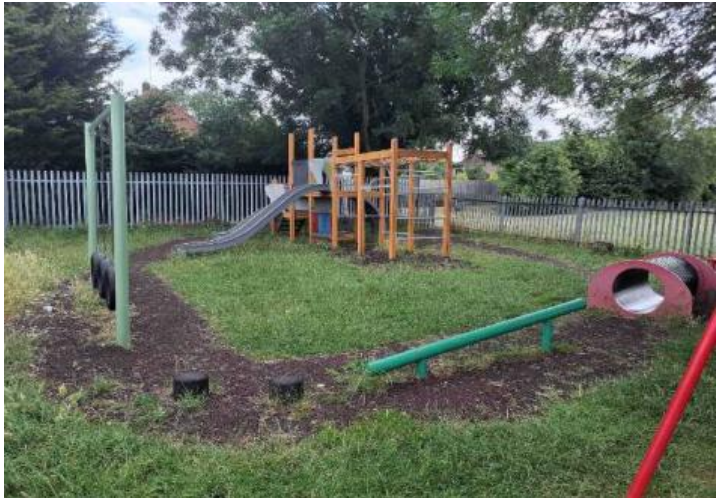
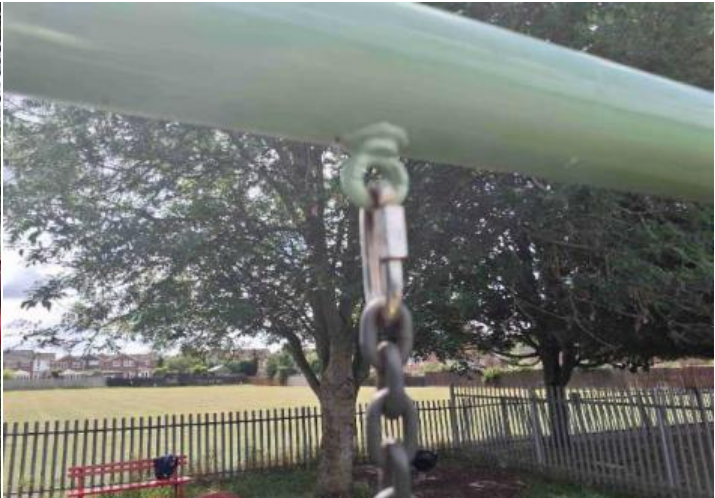
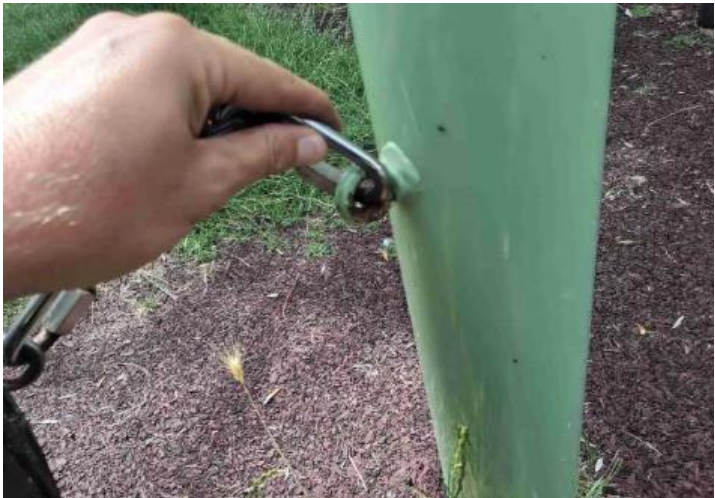
The connecting lugs are showing signs of wear - Monitor for any further deterioration and repair as required

| <div> 6 - Low Risk (Finding 7) </div> | | | |
|---|--|---|--|
| <div> <b>Finding:</b> The connecting lugs are showing signs of wear </div> | | <div> <b>Action:</b> Monitor for any further deterioration and repair as required </div> | |

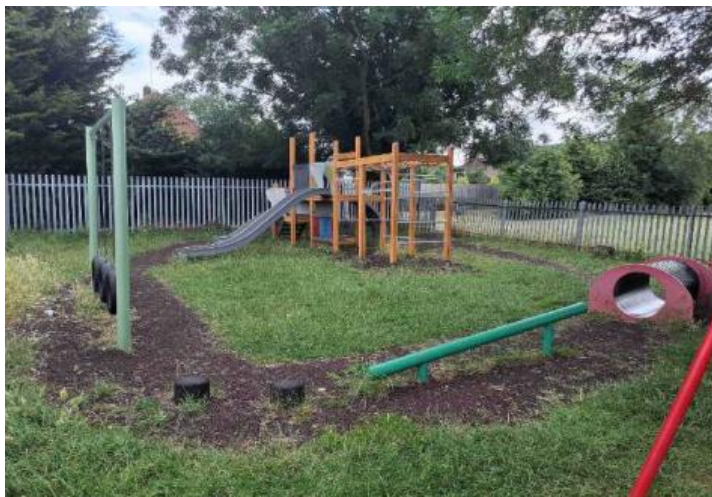
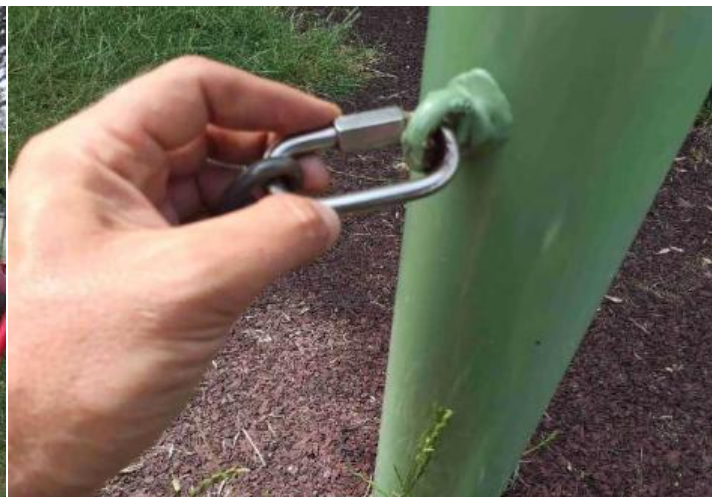
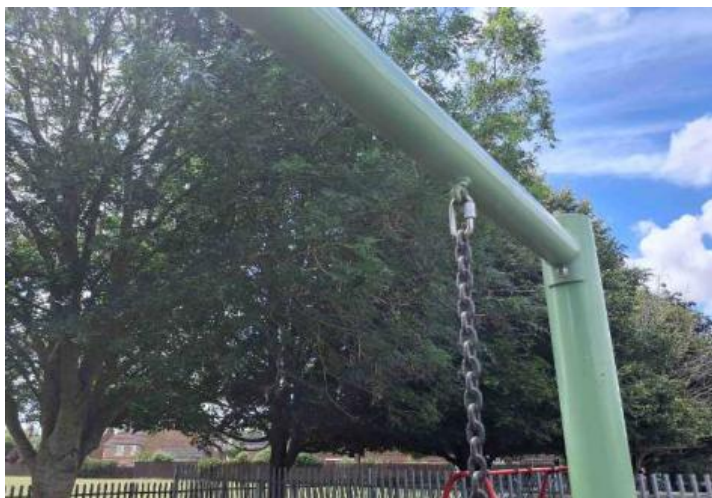
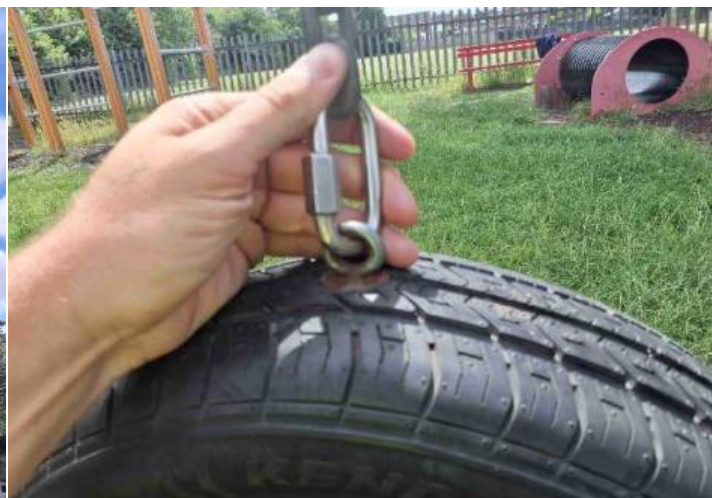
**i** 6 - Low Risk (Finding 8)

There is some wear to the shackles - Monitor for any further deterioration and replace when 40% worn

**Finding:** There is some wear to the shackles

**Action:** Monitor for any further deterioration and replace when 40% worn

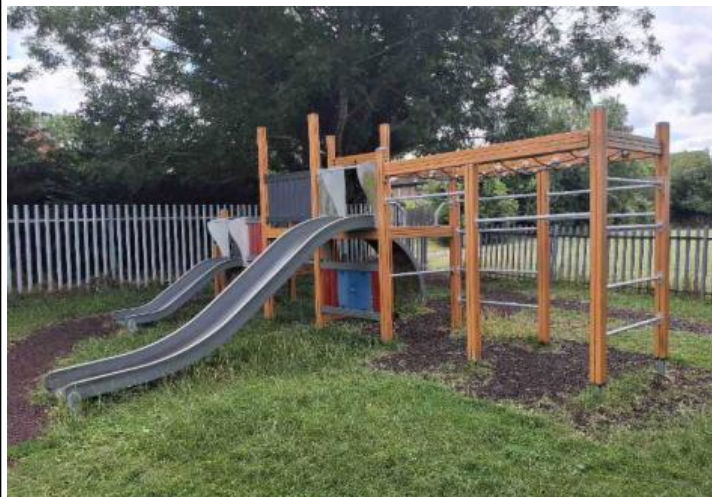
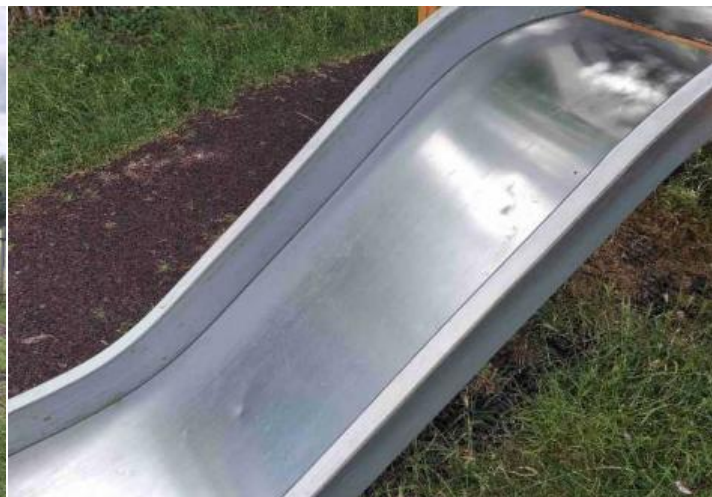
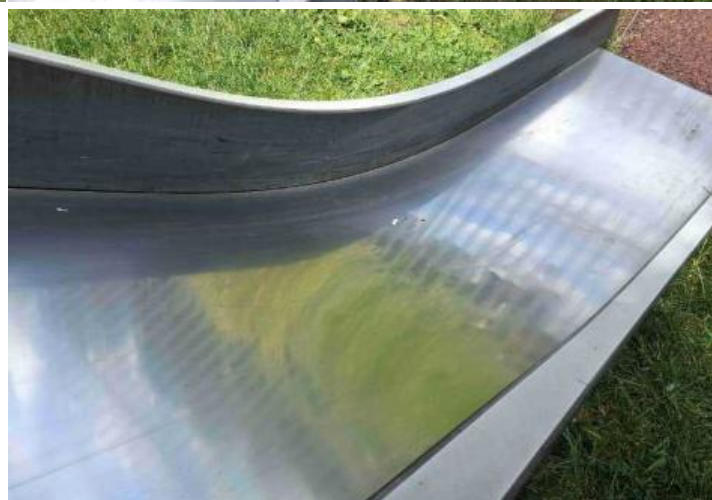
There are a number of dents in the slide surface - Monitor for any further deterioration and repair as required

**Finding:** There are a number of dents in the slide surface

**Action:** Monitor for any further deterioration and repair as required

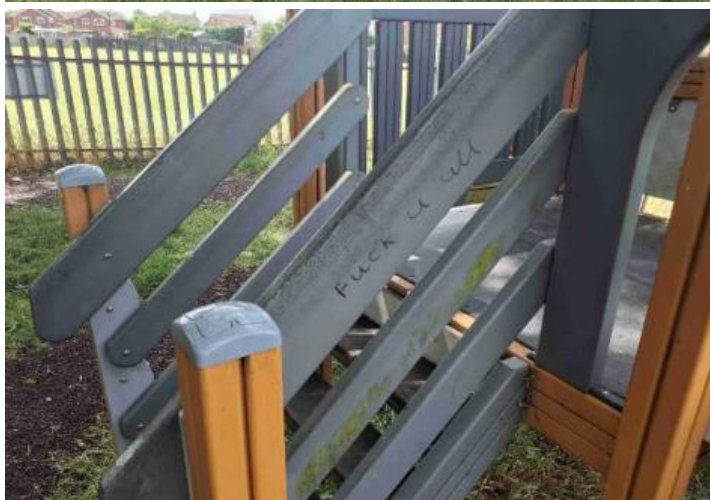
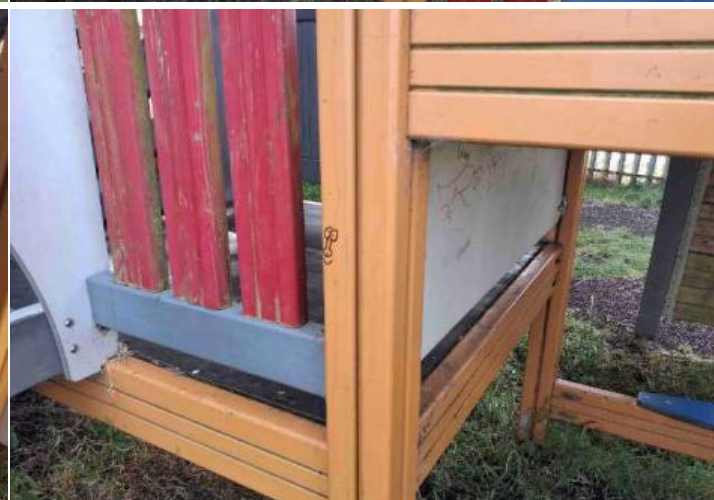
**Finding:** There is offensive graffiti present

**Action:** Remove as soon as practicable

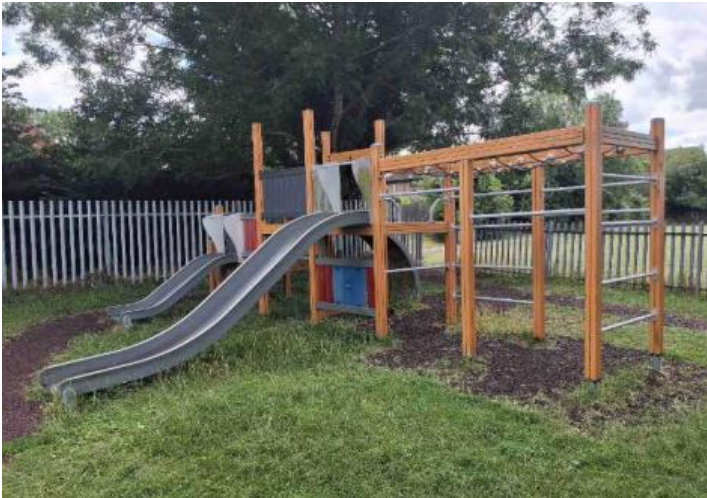
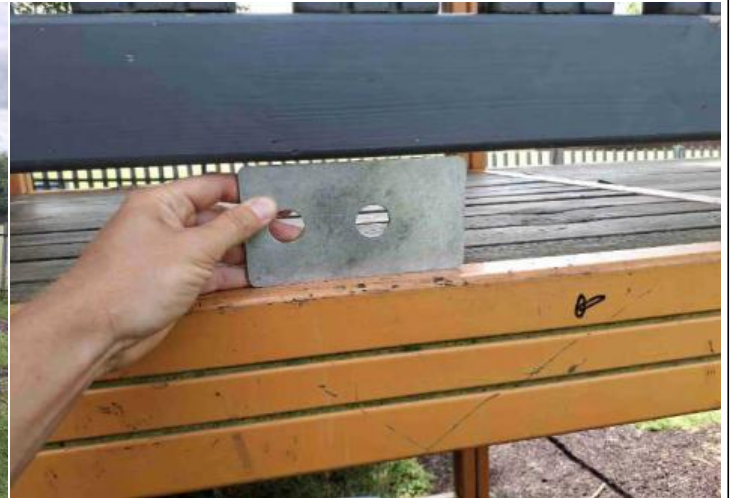
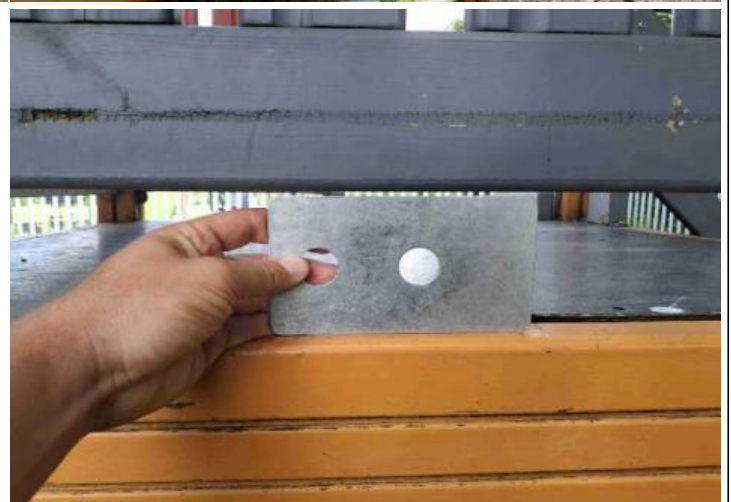
The item fails to meet the requirements of BS EN 1176 Part 1 4.2.7.2 head and neck entrapment in the barriers and/or steps - Monitor - No action given the risk assessment

**Finding:** The item fails to meet the requirements of BS EN 1176 Part 1 4.2.7.2 head and neck entrapment in the barriers and/or steps

**Action:** Monitor - No action given the risk assessment

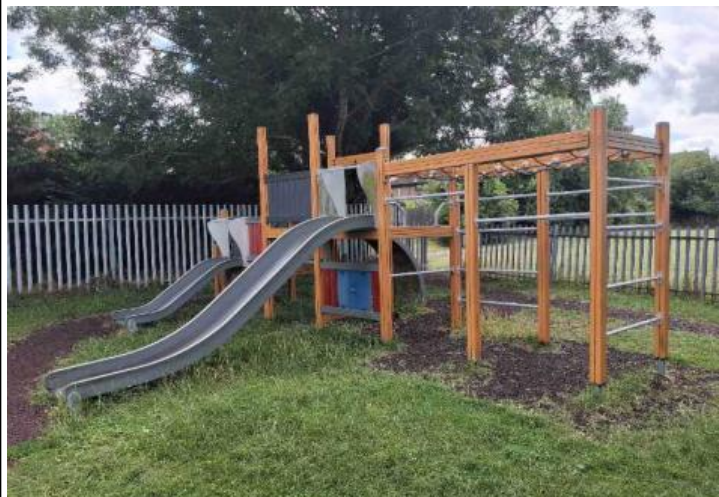
**Finding:** There is algae or moss on the surface of the equipment

**Action:** Clean and treat appropriately

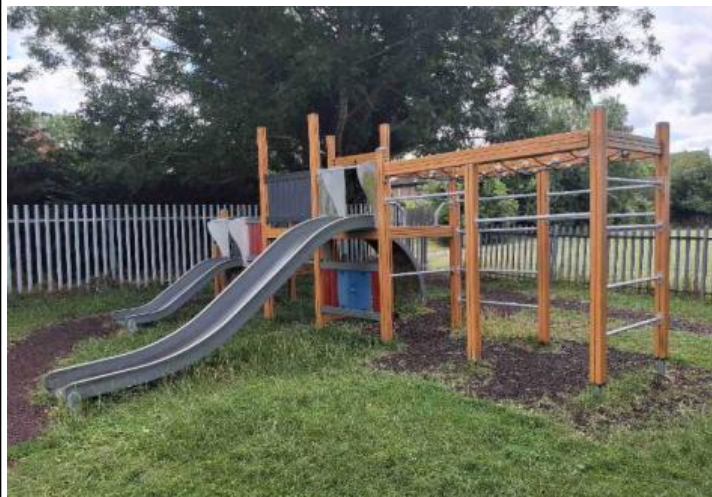
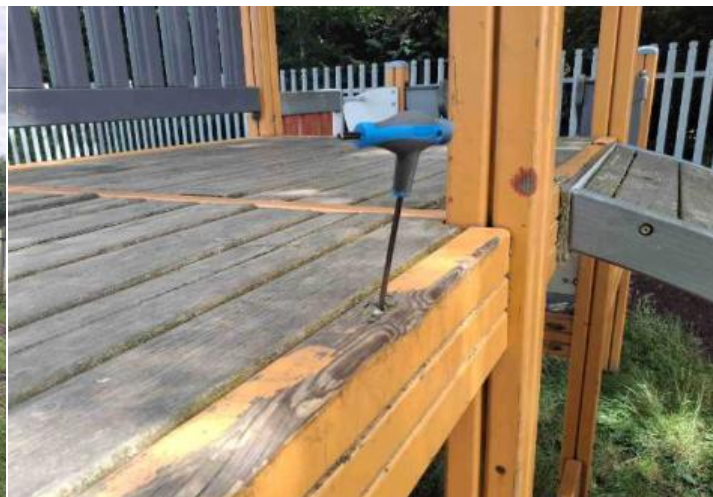
There is some evidence of rot in the timber - Monitor for any further deterioration and replace as required

**Finding:** There is some evidence of rot in the timber

**Action:** Monitor for any further deterioration and replace as required

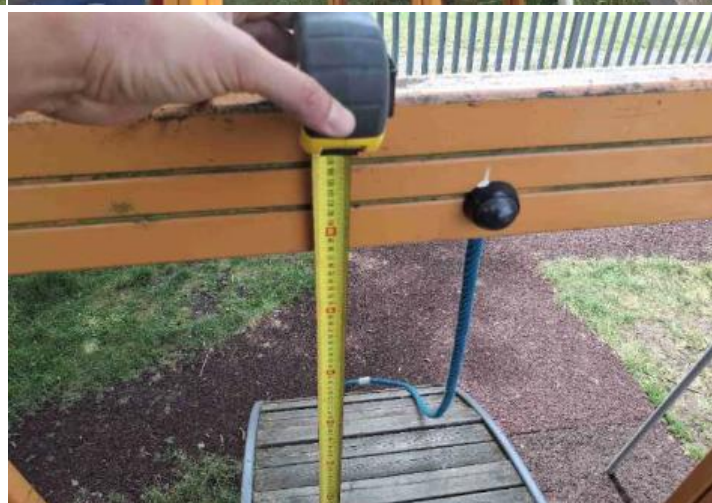
**Finding:** The unit is easily accessible and has an opening in the barrier to steep play elements in excess of 500mm in contravention of BS EN 1176 Part 1  
**Action:** Monitor - No action given the risk assessment

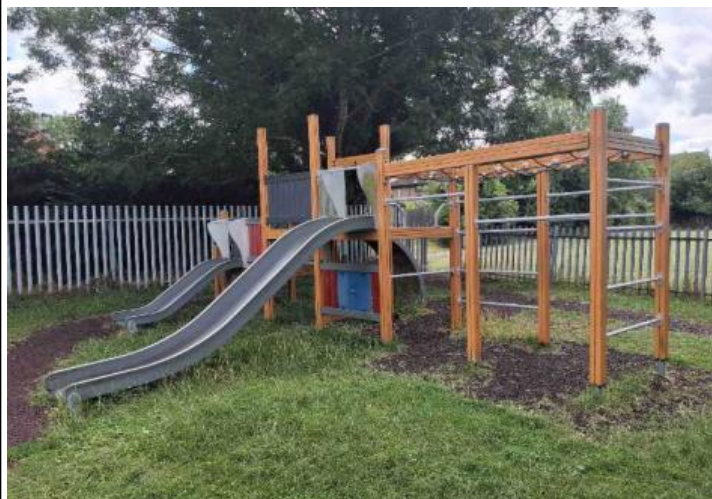
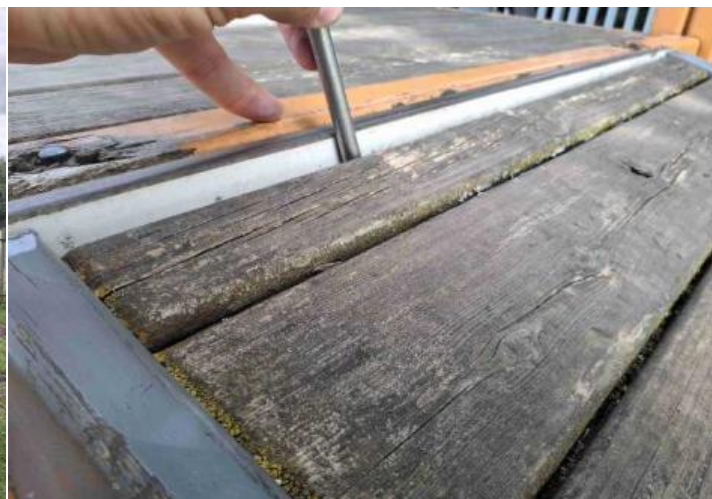
There is/are finger entrapment/s in the access element and the item fails to meet the requirements of BS EN 1176 Part 1 4.2.7.6 Entrapment of fingers - Monitor - No action given the risk assessment

**Finding:** There is/are finger entrapment/s in the access element and the item fails to meet the requirements of BS EN 1176 Part 1 4.2.7.6 Entrapment of fingers

**Action:** Monitor - No action given the risk assessment

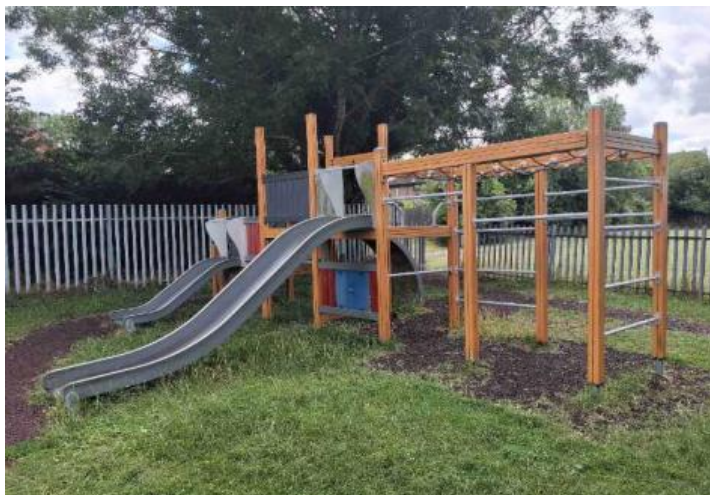
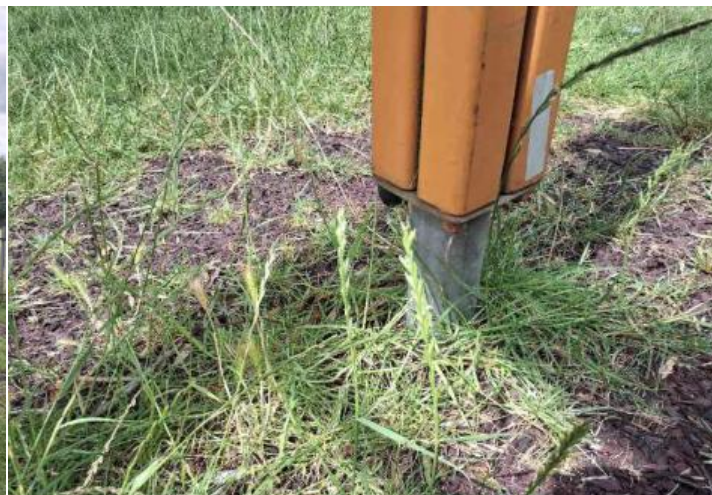
**Finding:** Bolt cap cover/s missing or damaged

**Action:** Replace

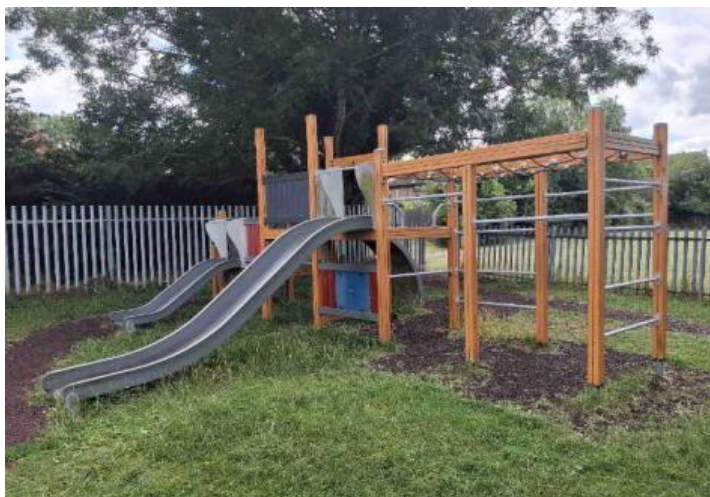
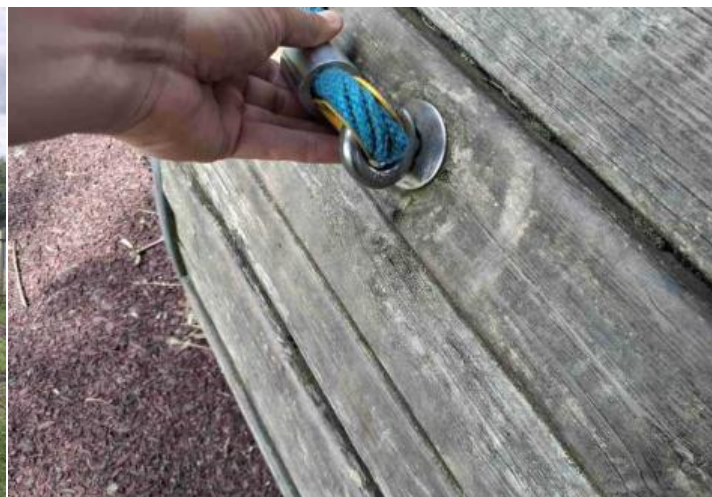
The ropes/nets are worn/damaged in places - Monitor for any further deterioration and repair or replace as required

**Finding:** The ropes/nets are worn/damaged in places

**Action:** Monitor for any further deterioration and repair or replace as required
