## Annual Inspection

Bugbrooke Parish Council

School Lane Play Area

Inspected: 30-June-2026 - 12:13 by Jamie Leeson (RPII Annual Inspector)

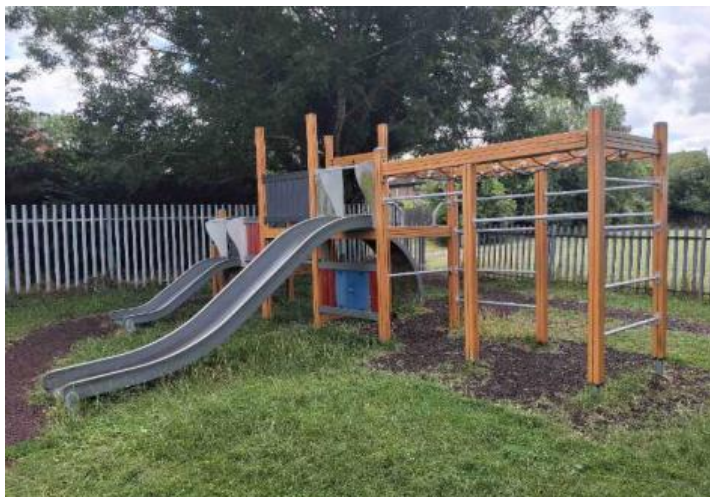
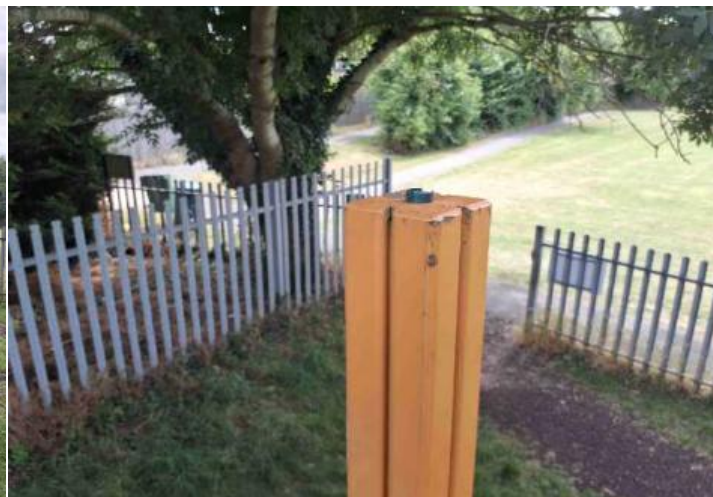
There is / are post or end caps missing / damaged on the item - Replace missing / damaged post or end caps

**Finding:** There is / are post or end caps missing / damaged on the item  
**Action:** Replace missing / damaged post or end caps

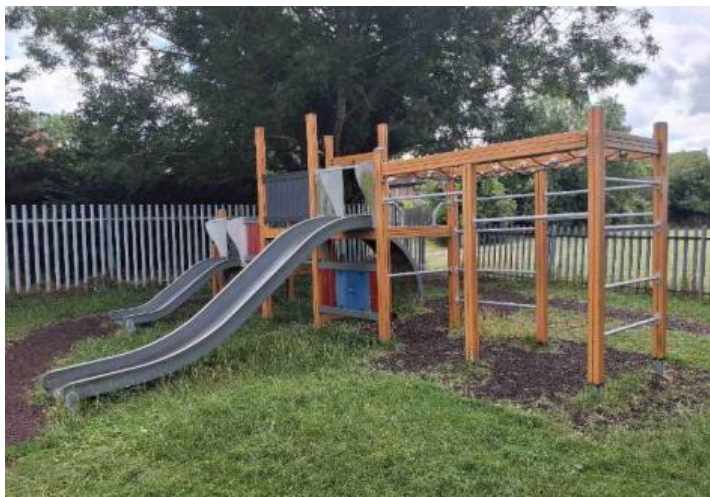
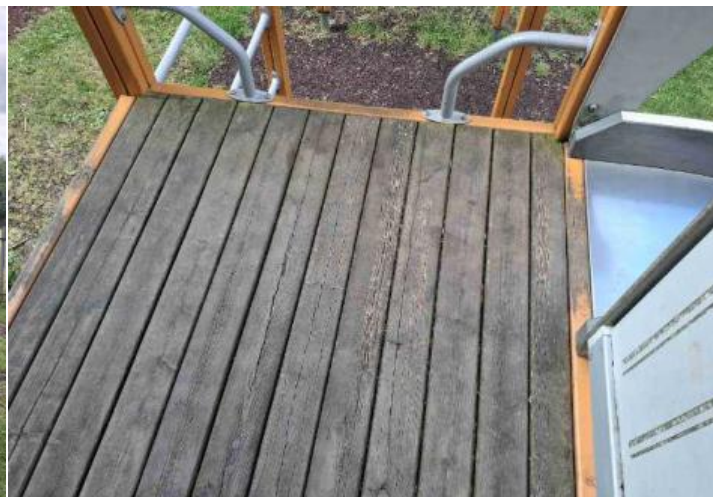
The timber stain is in poor condition - Prepare all affected parts and re-stain with an appropriate preservative

**Finding:** The timber stain is in poor condition  
**Action:** Prepare all affected parts and re-stain with an appropriate preservative
