the **play inspection** company

## Annual Inspection

Bugbrooke Parish Council

Bugbrooke Community Centre

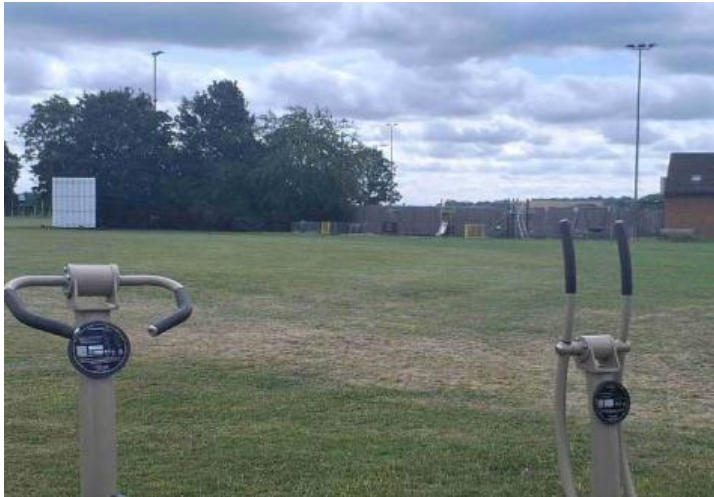
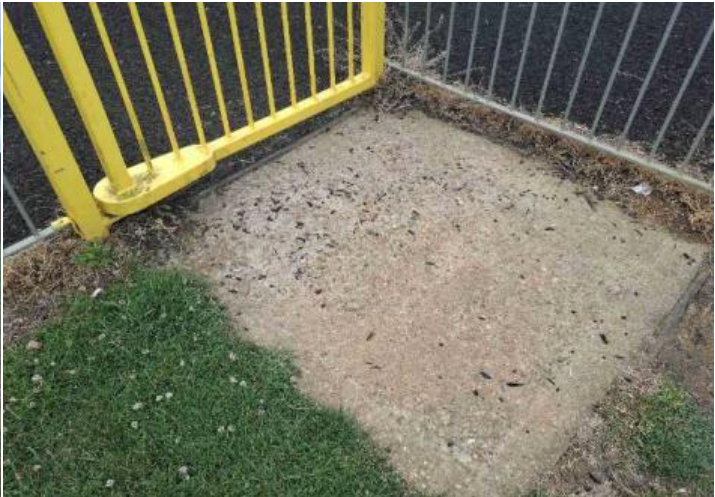
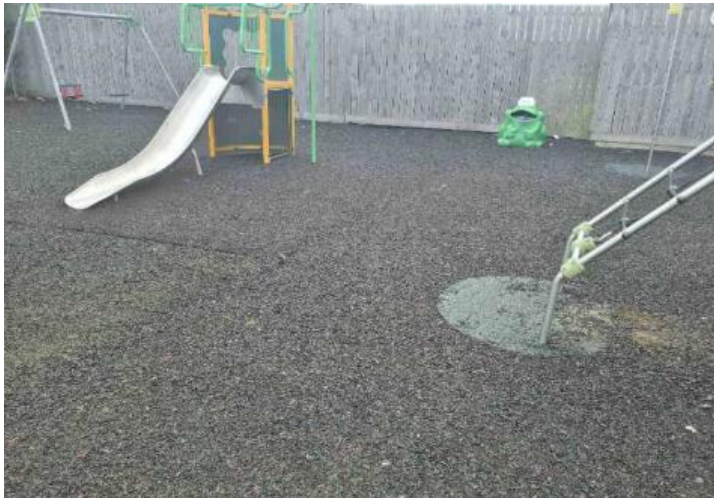
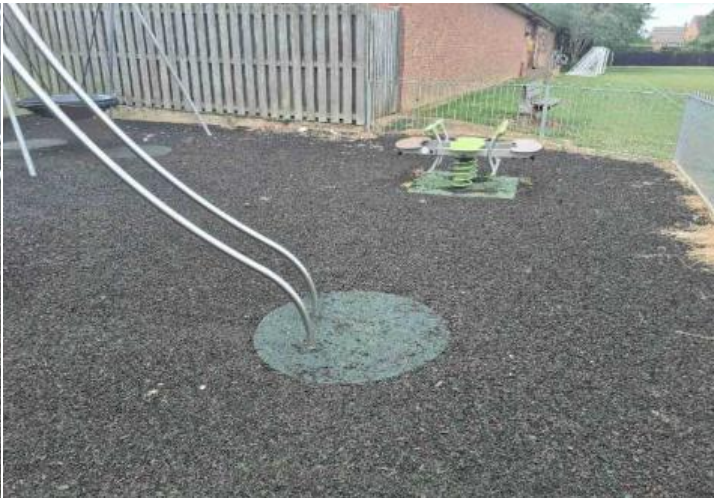
| <b>Finding:</b> The wetpour is crumbling in areas | | <b>Action:</b> Monitor for any further deterioration and repair as required | |

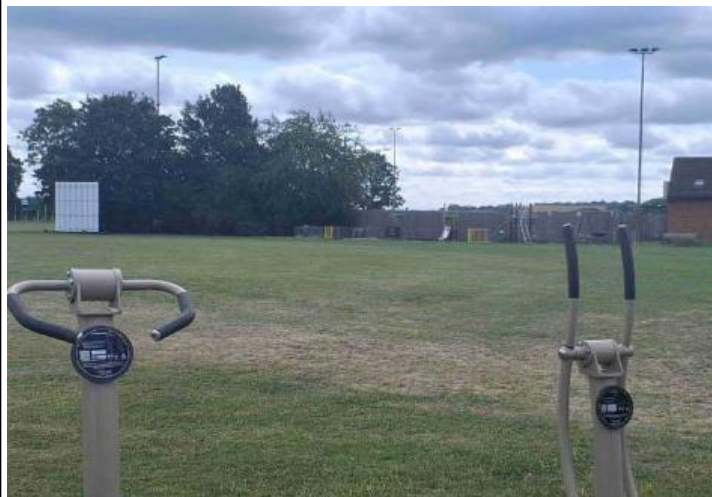
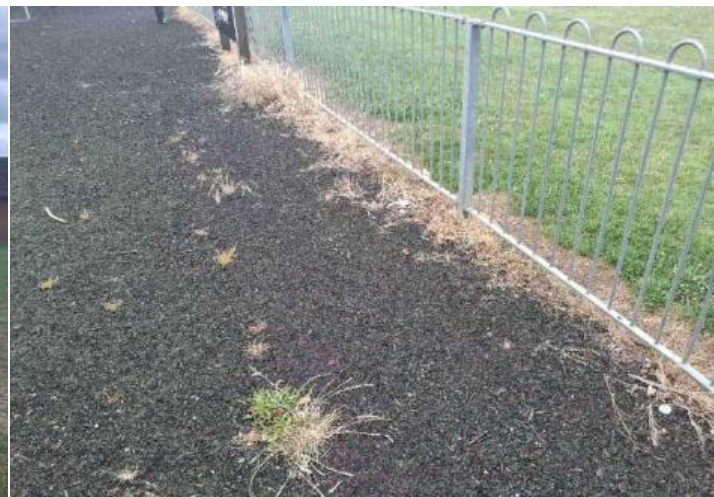
**Finding:** The surface has subsided in some areas

**Action:** Monitor for any further deterioration and repair as required

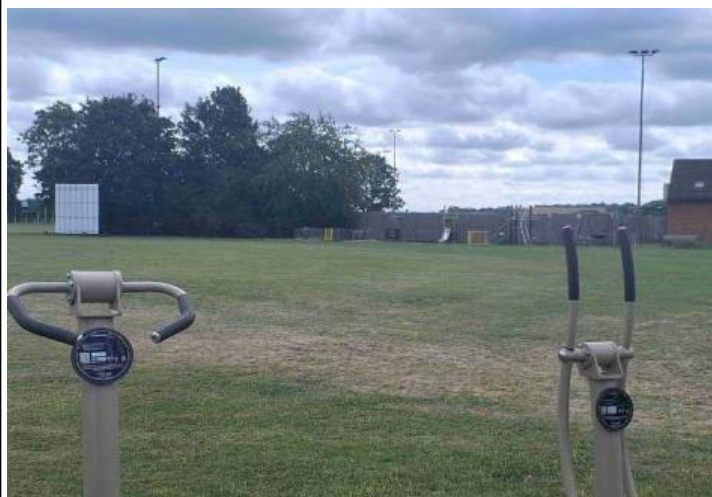
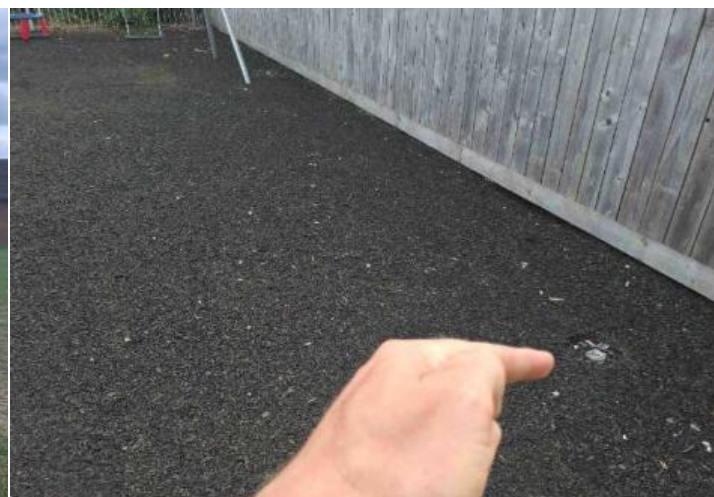
**Finding:** There are trip hazards present

**Action:** Remove trip hazard

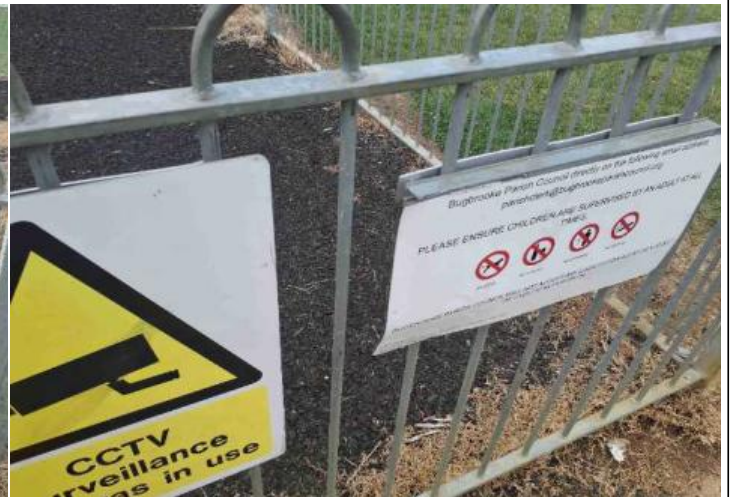
**Finding:** The item has been damaged

**Action:** Monitor for any further deterioration and replace as required

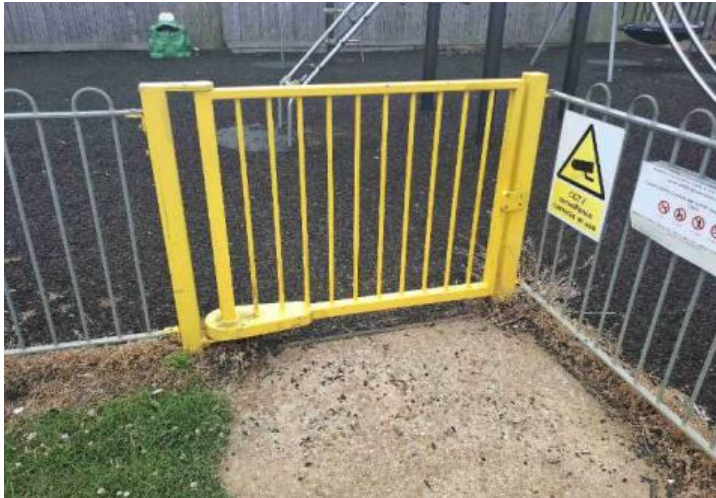
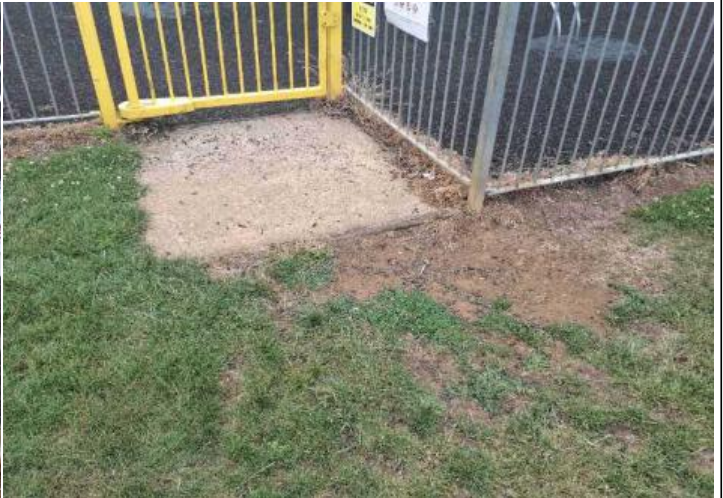
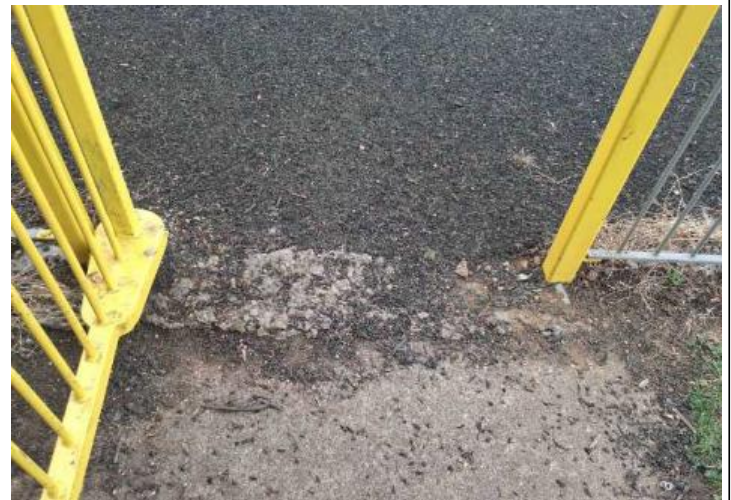
**Finding:** The area under the gate has eroded leaving uneven areas, or the concrete foundations exposed, resulting in trip hazards at the entrance/exit to the playground

**Action:** Reinststate to level with surrounding surfaces

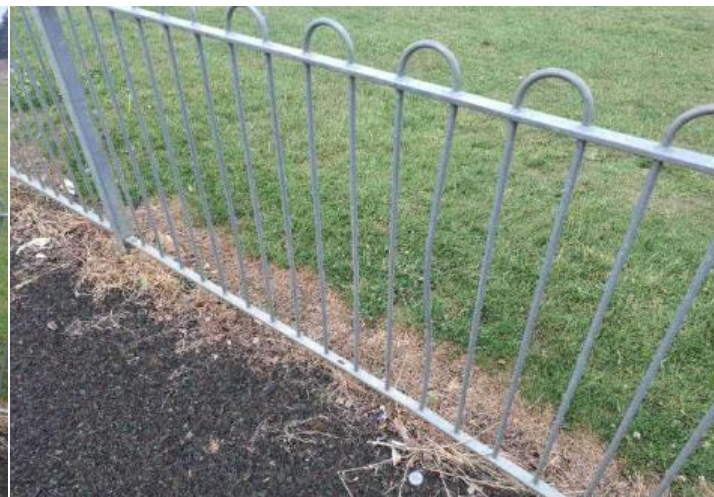
**Finding:** There is some damage to the fence sections

**Action:** Monitor for any further deterioration and repair as required

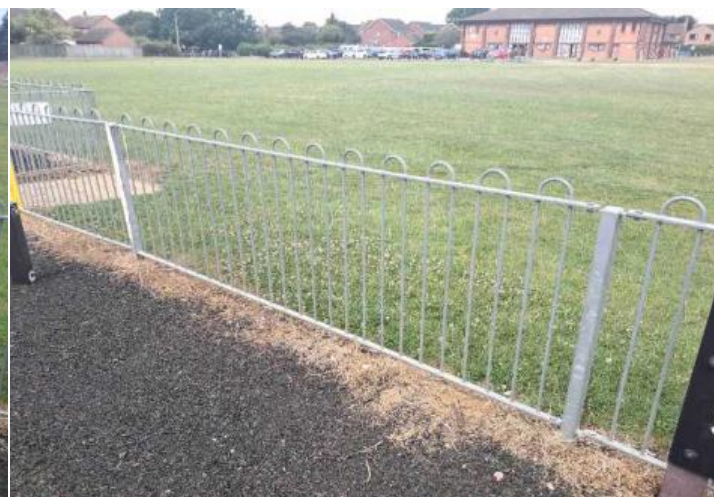
**Finding:** There are a number of loose posts around the fence

**Action:** Monitor for any further deterioration and reset as required

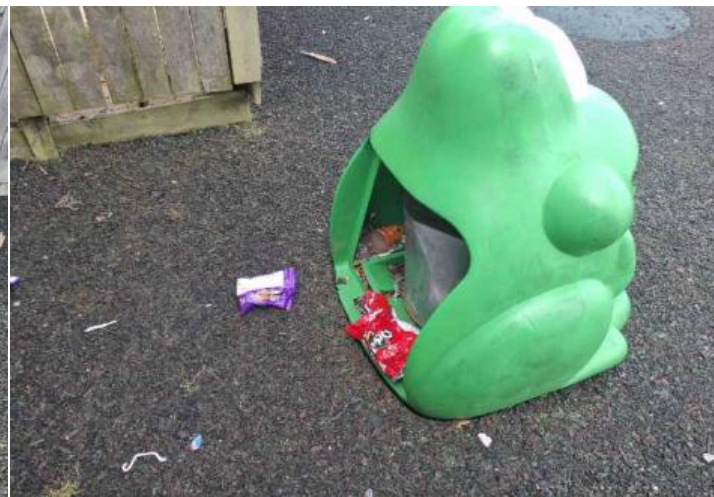
**Finding:** The lid or door of the litter bin is missing

**Action:** Replace and ensure the lid or door is kept locked

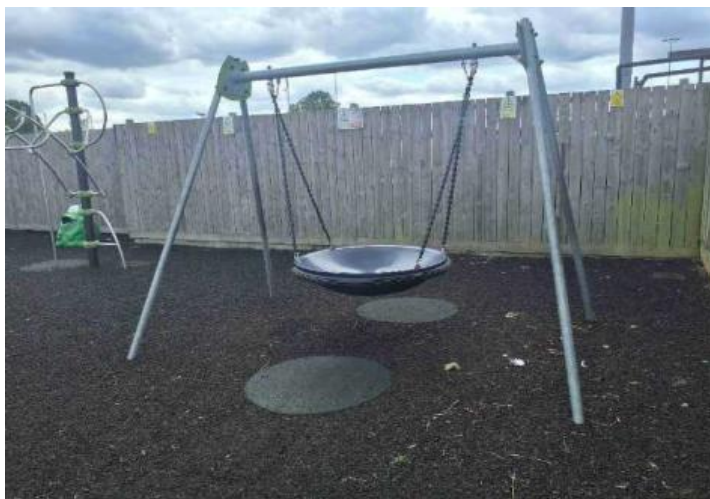
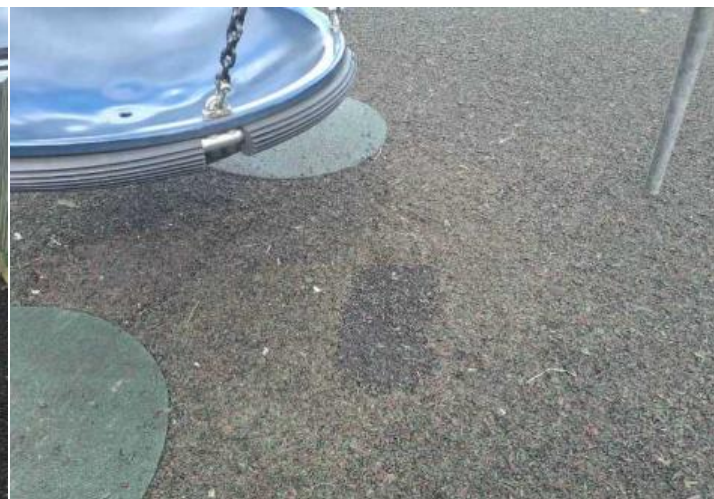
**Finding:** There is moderate damage to the surface

**Action:** Repair the damaged areas of surfacing

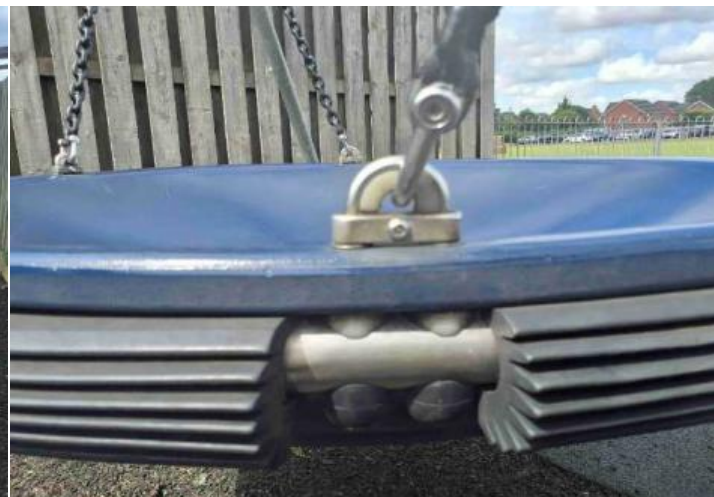
**Finding:** The bushes are showing signs of wear

**Action:** Monitor for any further deterioration and replace as required

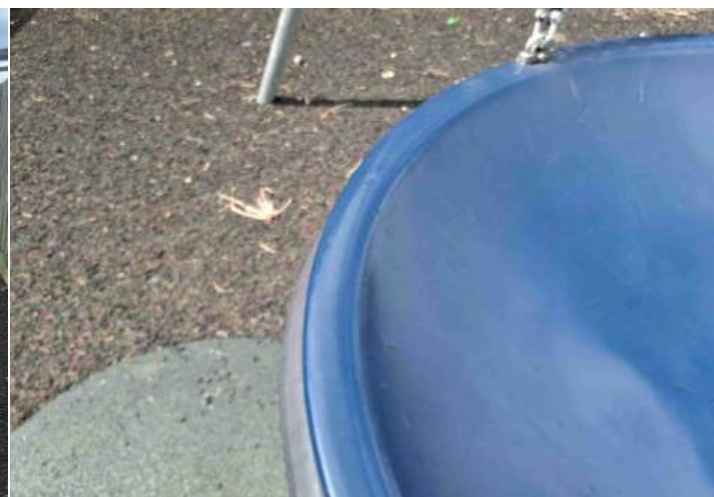
**Finding:** The seat has minor damage or wear

**Action:** Monitor for any further deterioration and replace as required

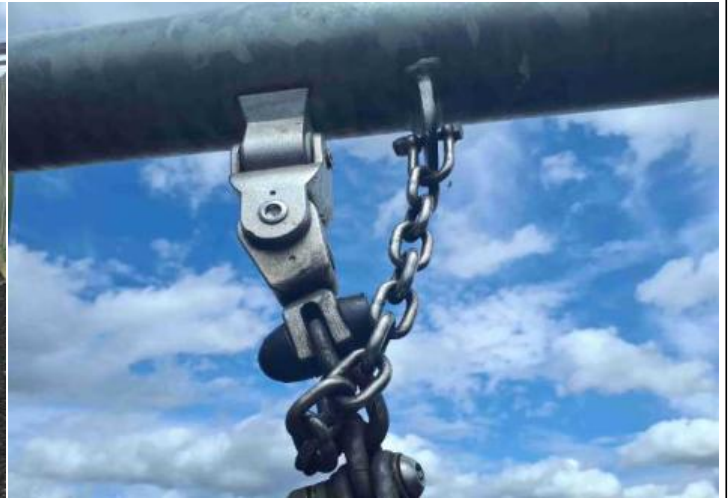
**Finding:** There is some wear to the shackles

**Action:** Monitor for any further deterioration and replace when 40% worn

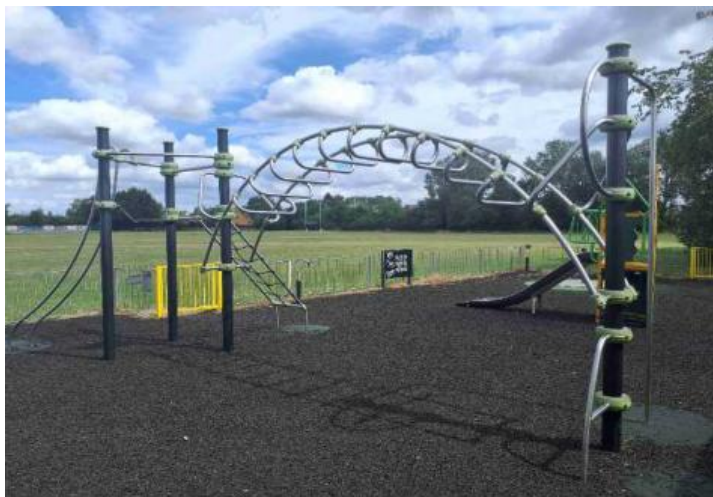
**Finding:** There is / are post or end caps missing / damaged on the item  
**Action:** Replace missing / damaged post or end caps

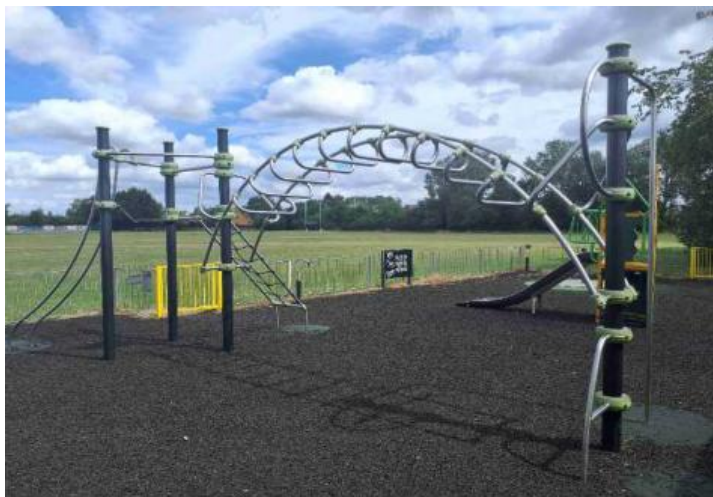
**Finding:** There is some notable evidence of chain wear  
**Action:** Monitor for any further deterioration and replace when 40% worn

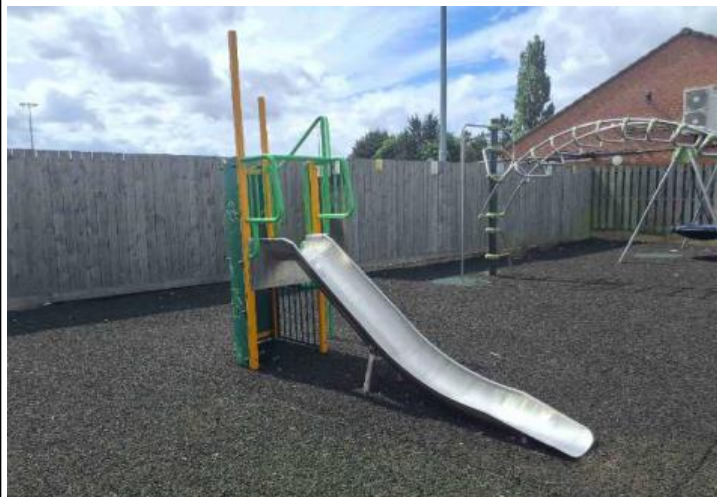
**Finding:** There are gaps opening between the surfacing and the edging surround or between the joints in the surfacing  
**Action:** Monitor for any further deterioration and repair as required

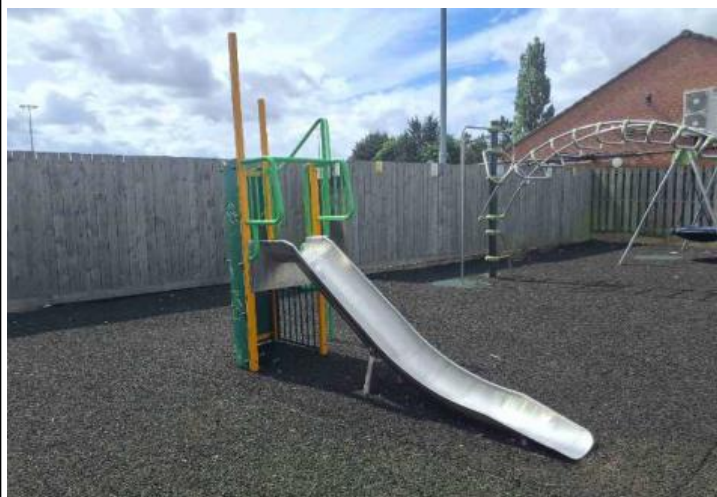
**Finding:** There are a number of dents in the slide surface  
**Action:** Monitor for any further deterioration and repair as required

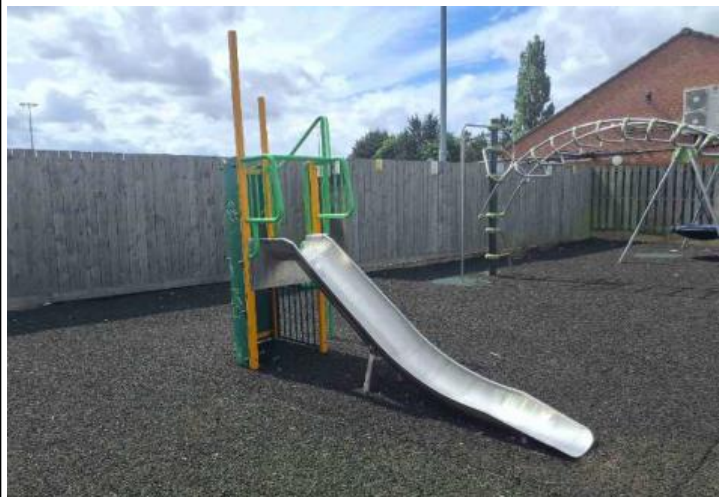
**Finding:** There is / are toggle entrapment/s present in contravention of the recommendations set out in BS EN 1176 Part 1

**Action:** Monitor - No action given the risk assessment

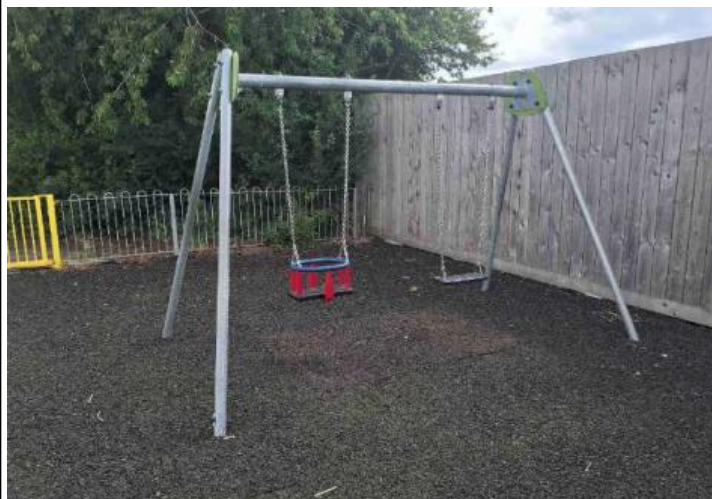
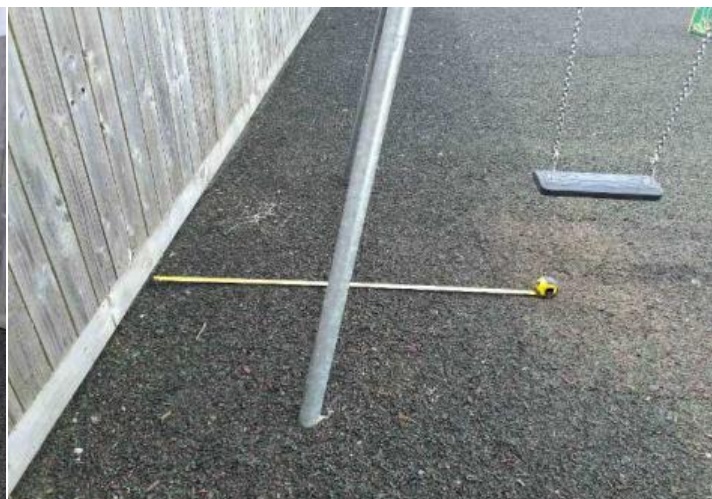
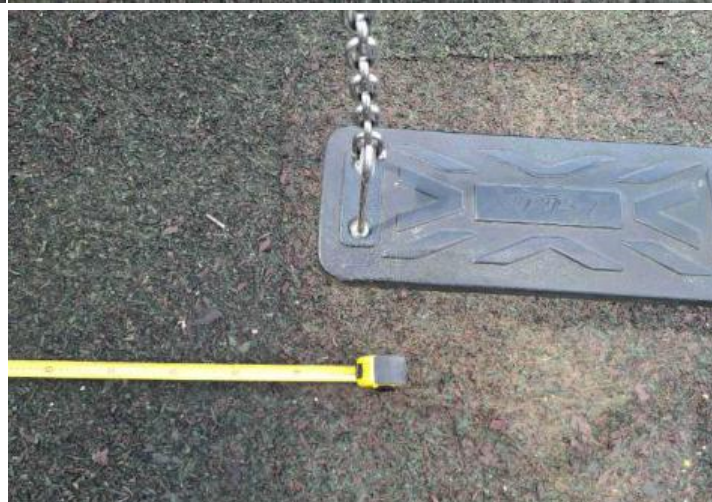
**Finding:** BS EN 1176 Part 2: Annex A makes a recommendation that fences or enclosures should be 1.50m from the edges of the swing seat to the sides, and subject to risk assessment, from the edge of the impact area. This is however, a low risk finding and no remedial action is recommended.

**Action:** Monitor - No action given the risk assessment

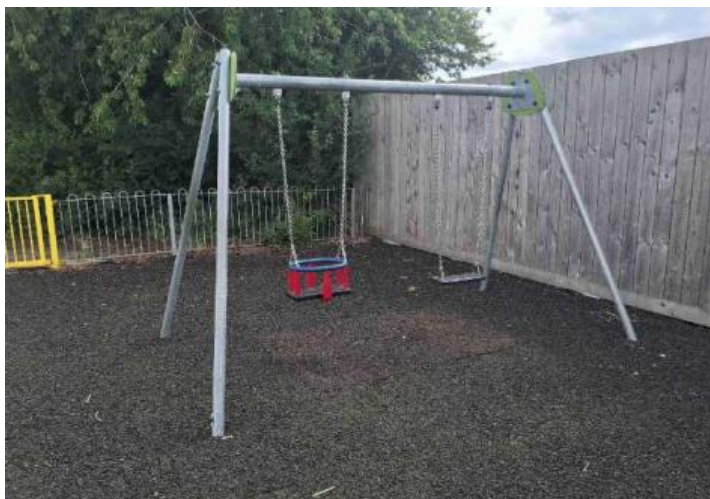
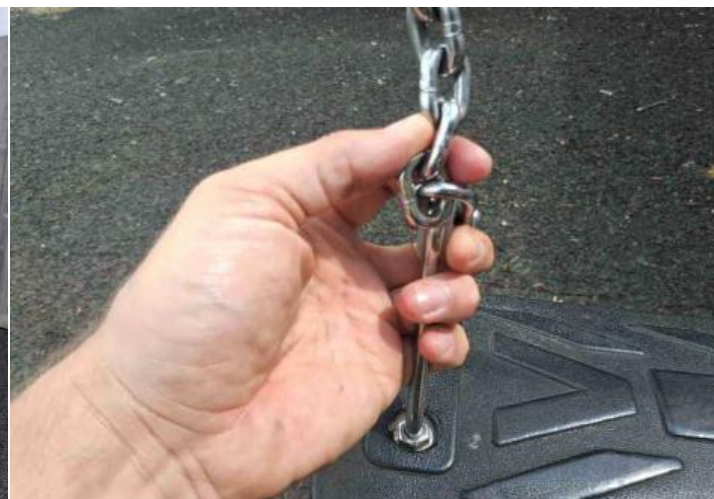
**Finding:** There is some notable evidence of chain wear

**Action:** Monitor for any further deterioration and replace when 40% worn

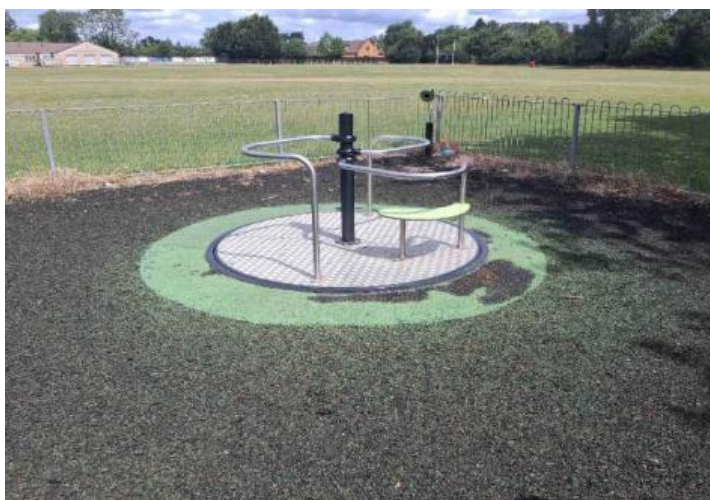
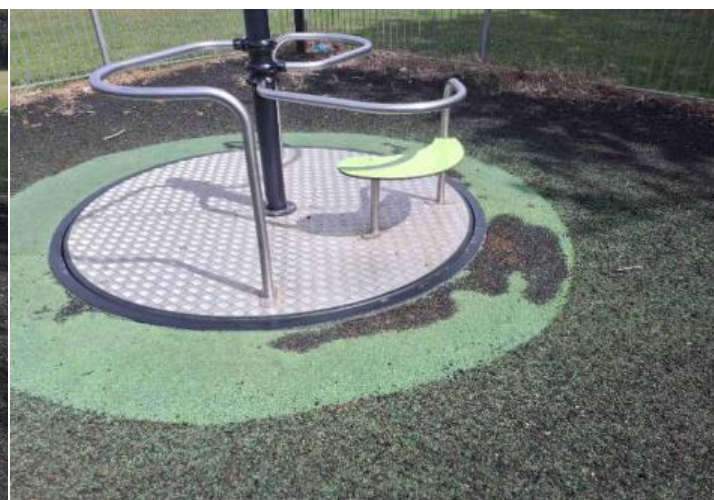
**Finding:** There is moderate damage to the surface

**Action:** Repair the damaged areas of surfacing

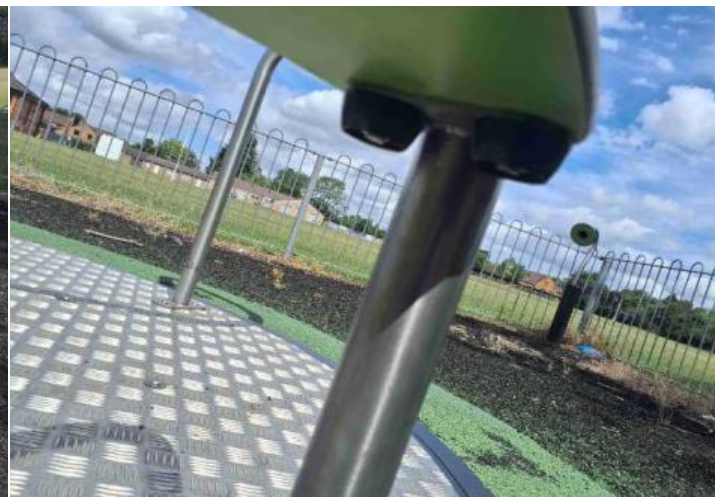
**Finding:** Bolt cap cover/s missing or damaged

**Action:** Replace

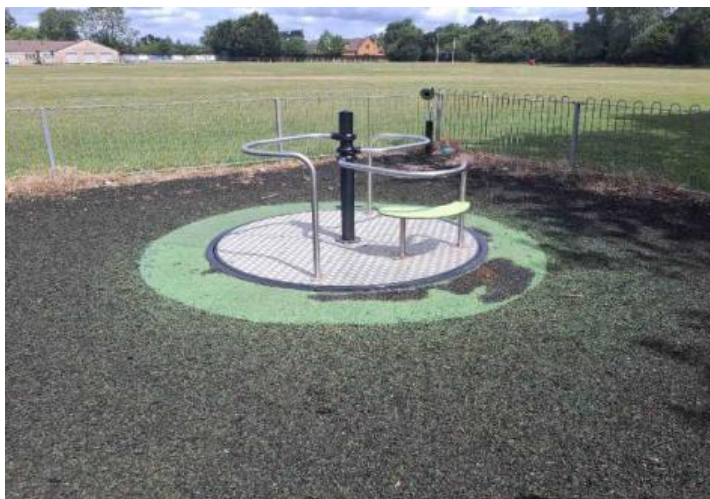
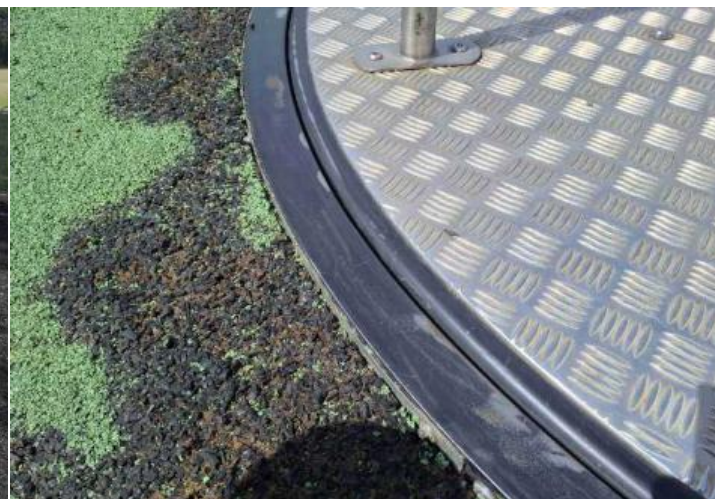
**Finding:** The paintwork on this item has been damaged or worn exposing the metal underneath which is rusting / corroding

**Action:** Treat affected areas and repaint

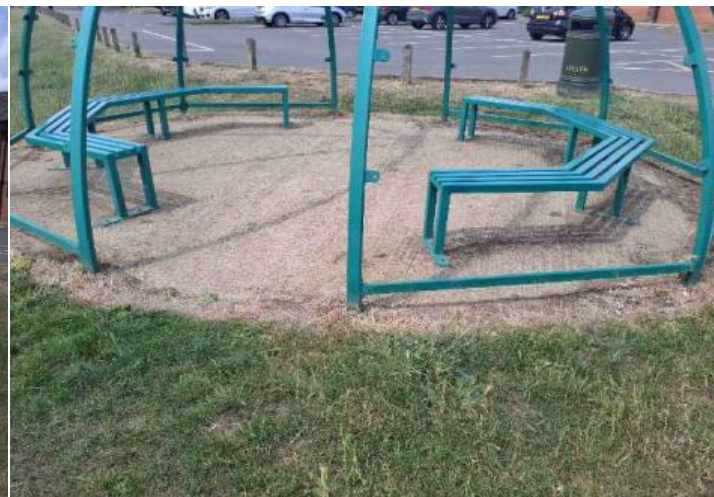
**Finding:** There is algae, silt or moss growth on the surface resulting in slippery conditions

**Action:** Clean and treat appropriately

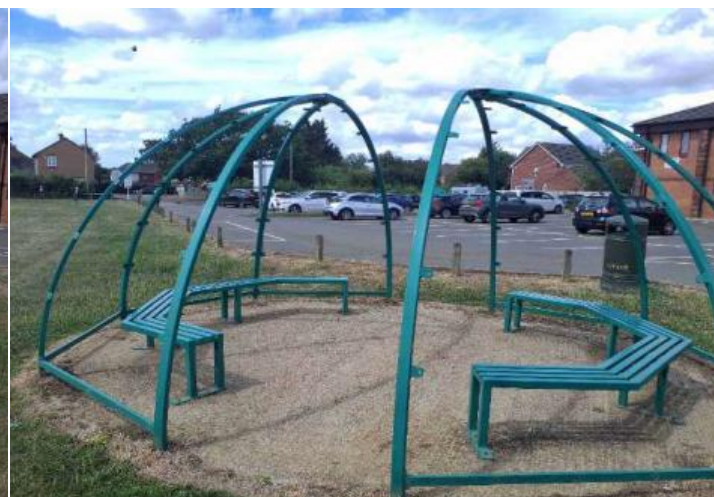
**Finding:** The item has missing panels exposing projecting brackets

**Action:** Replace missing components

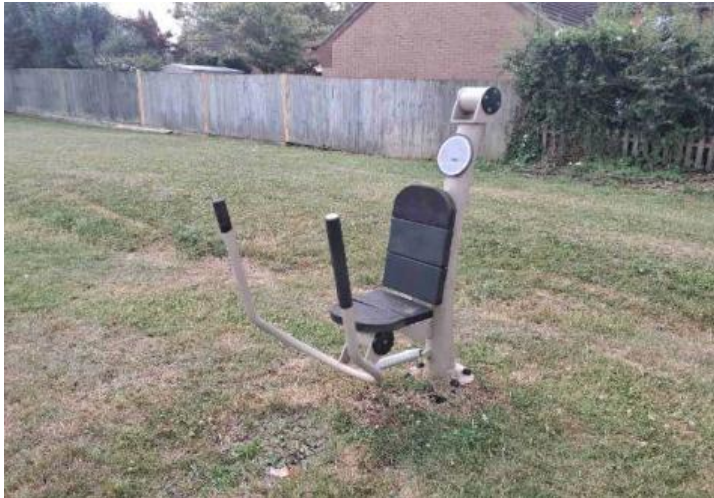
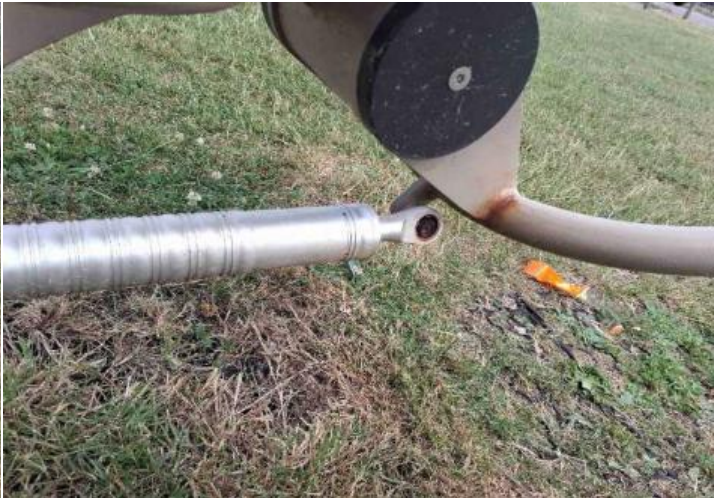
| <div> 6 - Low Risk (Finding 2) </div> | | | |
|---|--|---|--|
| <b>Finding:</b> The paintwork on this item has been damaged or worn exposing the metal underneath which is rusting / corroding | | <b>Action:</b> Treat affected areas and repaint | |

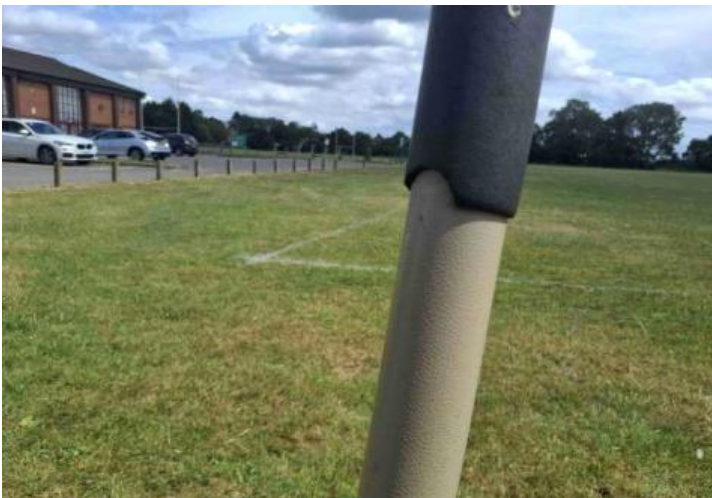
| <div> <div></div> <div>6 - Low Risk (Finding 3)</div> </div> | | | |
|---|---|---|---|
| <b>Finding:</b> The item has been damaged | | <b>Action:</b> Monitor for any further deterioration and replace as required | |

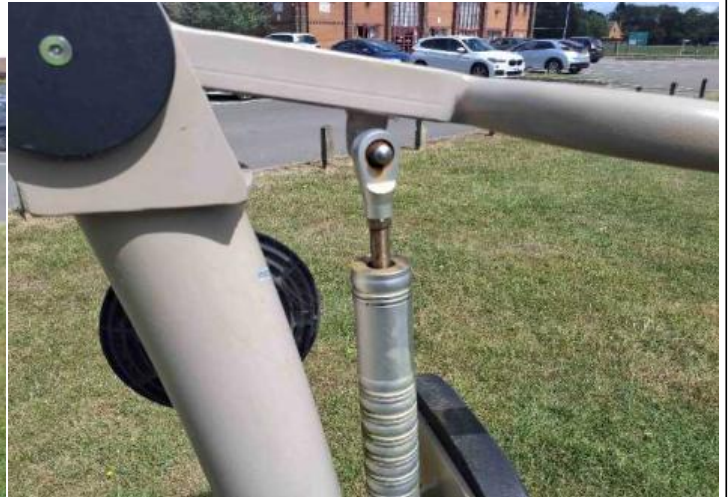
**Finding:** There is surface corrosion / rust present on the item

**Action:** Consider treating the item

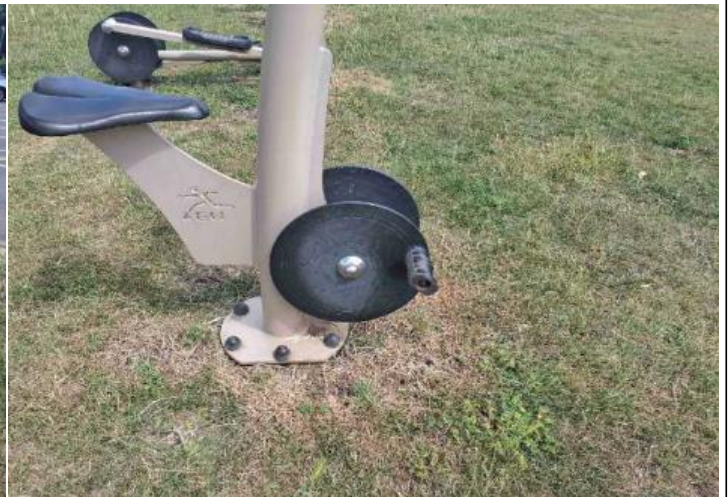
**Finding:** There is / are post or end caps missing / damaged on the item

**Action:** Replace missing / damaged post or end caps

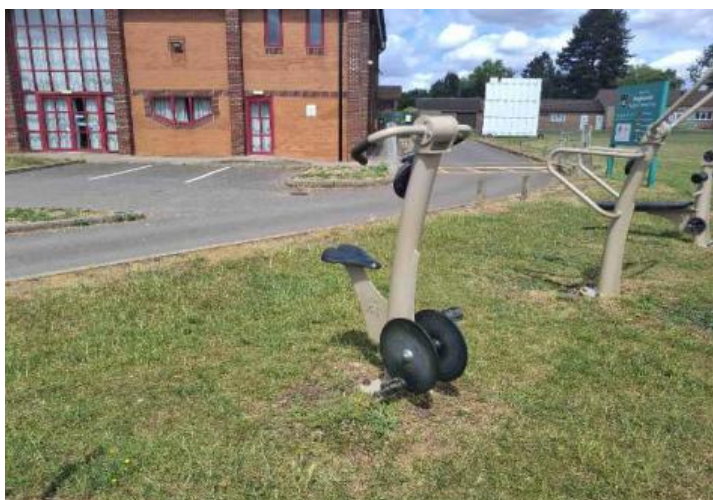
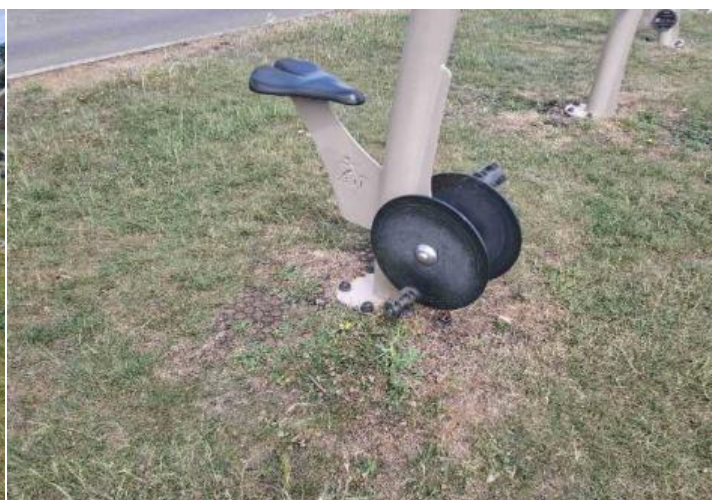
**Finding:** There is / are post or end caps missing / damaged on the item

**Action:** Replace missing / damaged post or end caps

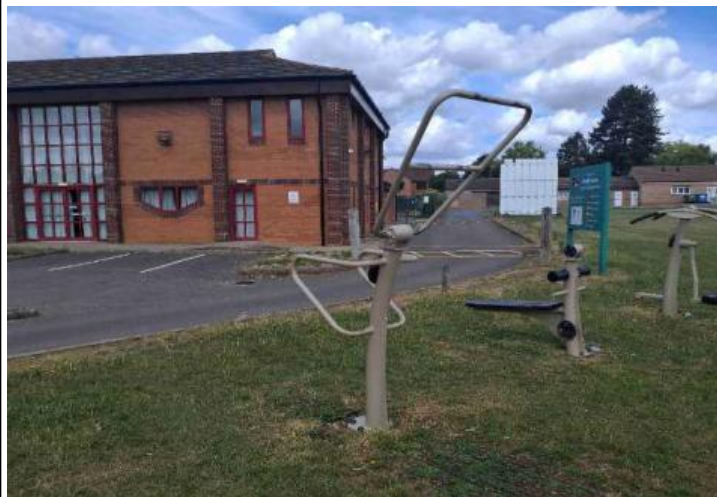
**Finding:** The item is slightly loose in its foundations

**Action:** Monitor for any further deterioration and repair as required

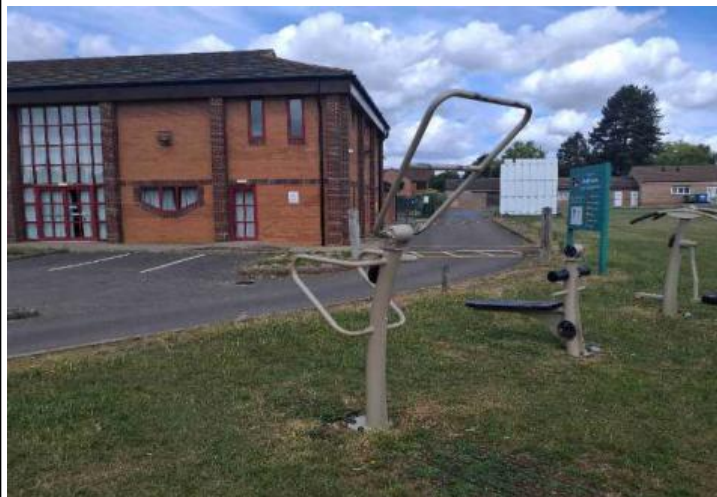
**Finding:** There is surface corrosion / rust present on the item

**Action:** Consider treating the item

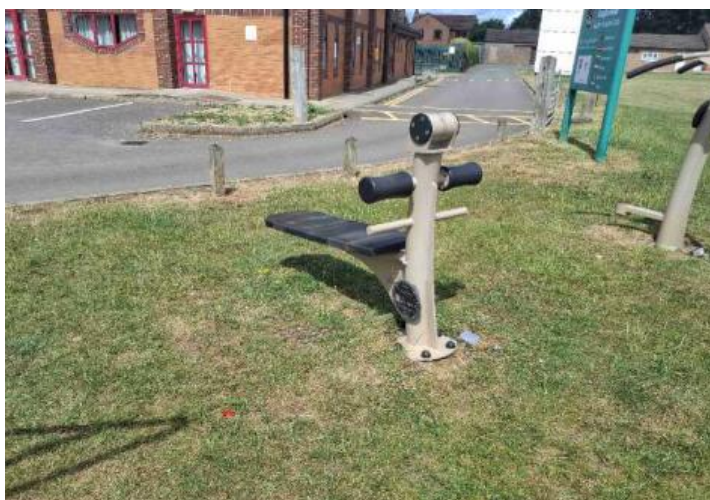
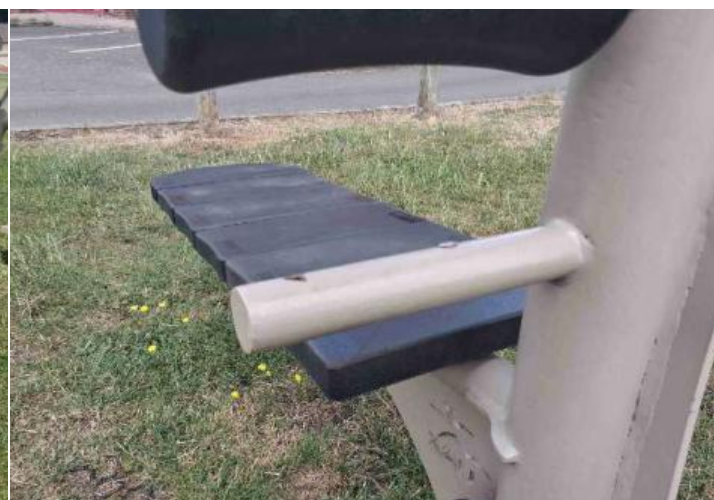
**Finding:** There is or are fixings missing on the item

**Action:** Replace all missing fixings

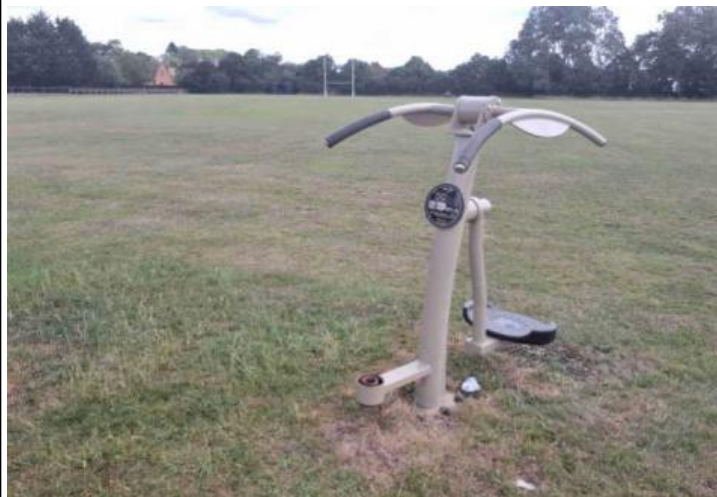
**Finding:** The item has missing component(s)

**Action:** Replace missing components

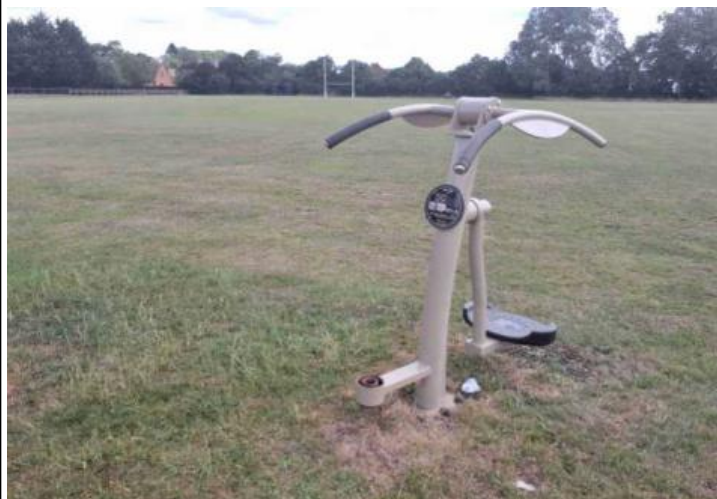
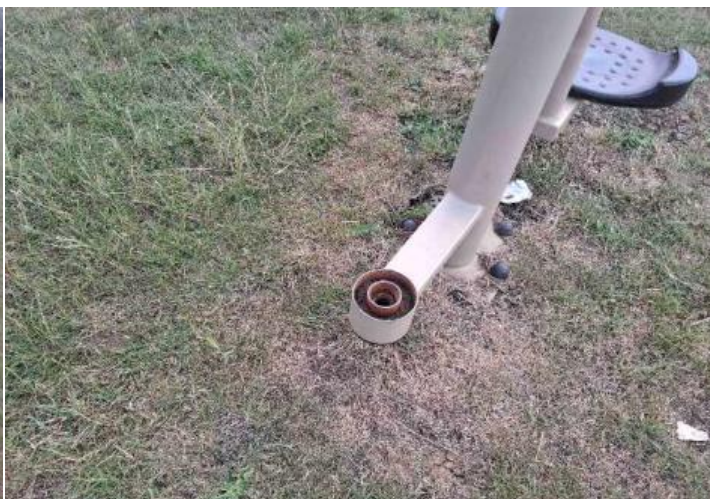
**Finding:** The paintwork on this item has been damaged or worn exposing the metal underneath which is rusting / corroding

**Action:** Treat affected areas and repaint

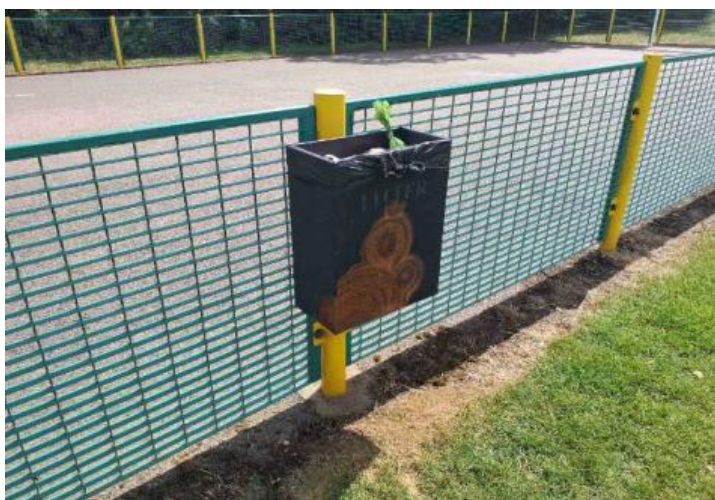
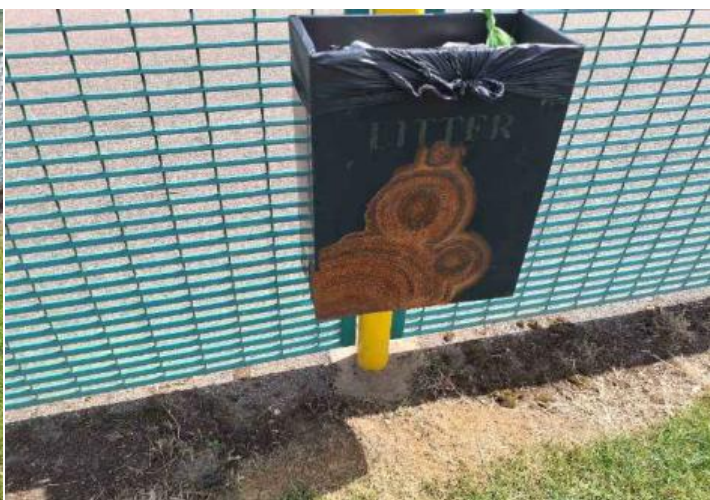
**Finding:** There is some evidence of fire damage to the item

**Action:** Monitor for any further deterioration and repair as required

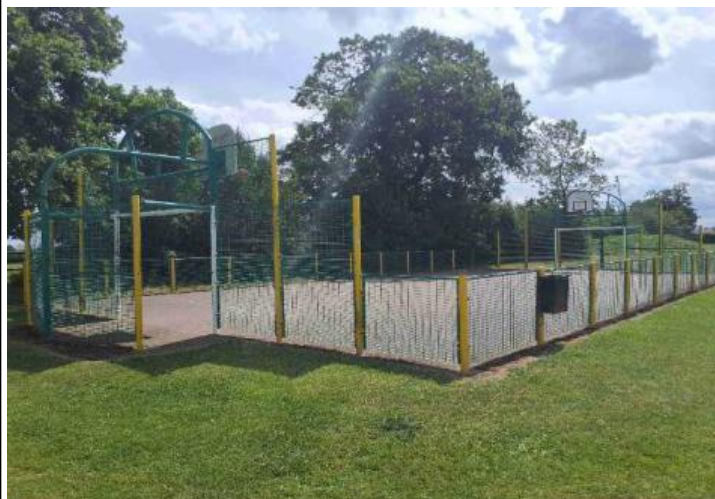
**Finding:** A clearly visible facility sign should be provided in a prominent position with the wording as detailed BS EN 15312 - the equipment is not intended for children less than 3 years old - the warning - Do not climb on the framework or nets - the warning - Do not hang on the ring (if provided) - the warning - Do not wear rings or other jewellery - name and telephone number of the administrator - number to call in case of accident

**Action:** Provide signage to BS EN 15312

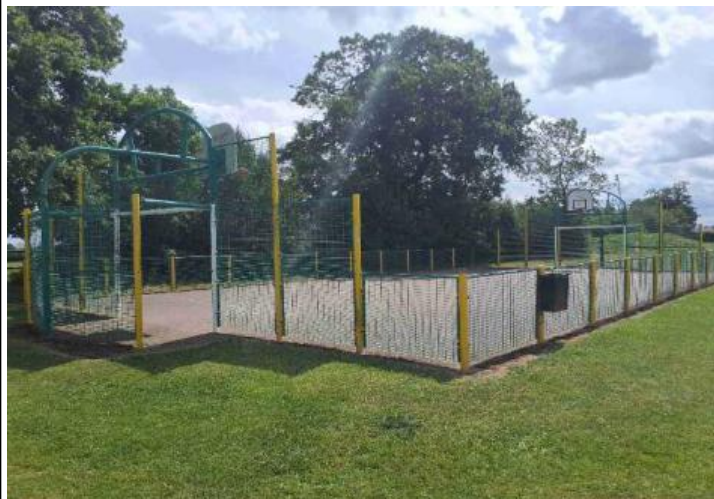
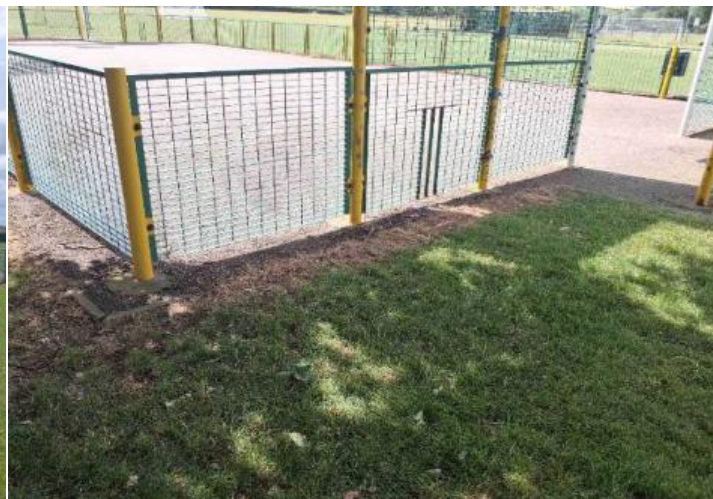
**Finding:** There are trip hazards at the edges of the surface

**Action:** Remove trip hazard

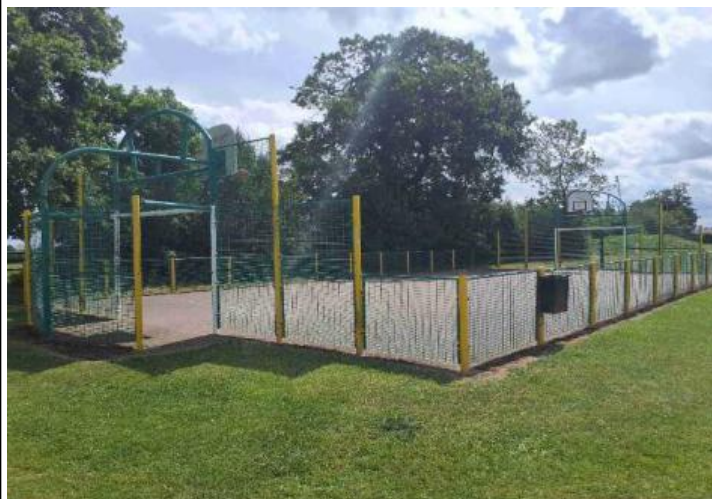
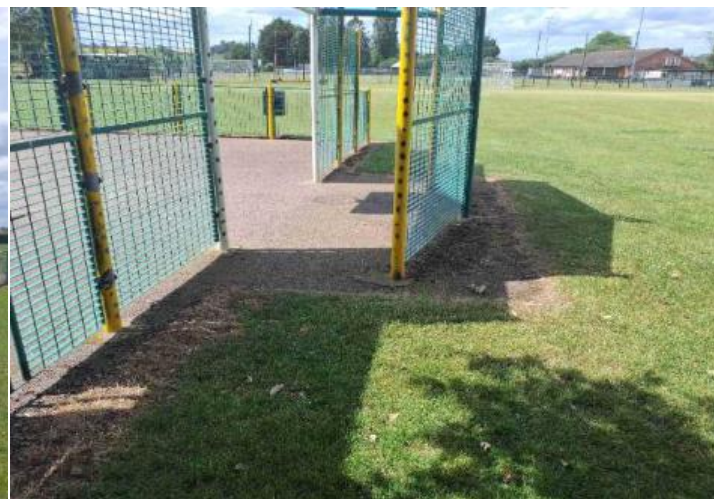
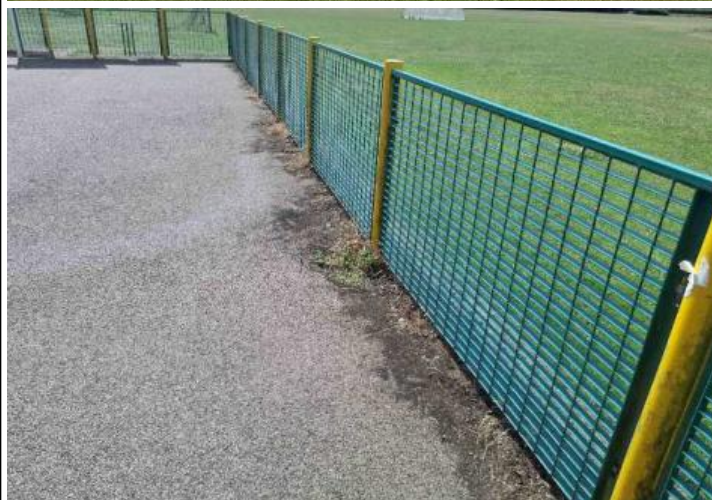
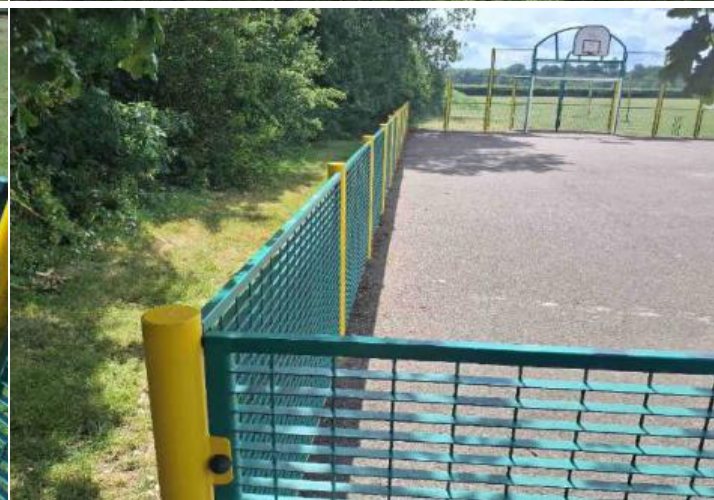
**Finding:** There is algae, silt or moss growth on the surface resulting in slippery conditions

**Action:** Clean and treat appropriately
