the **play inspection** company

## Annual Inspection

Bugbrooke Parish Council

Bugbrooke Community Centre

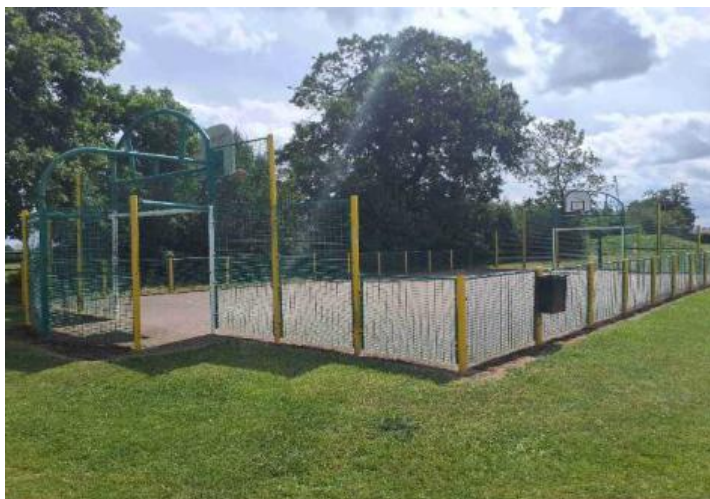
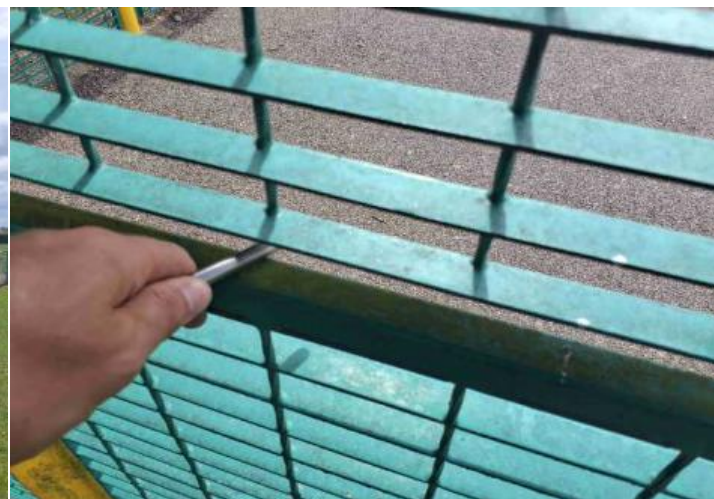
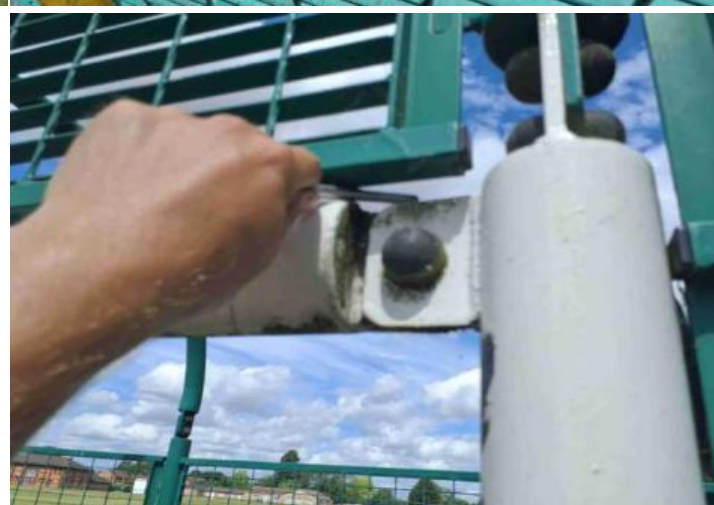
**Finding:** There is/are finger entrapments in the fencing and the item fails to meet the requirements of BS EN 15312 Clause 4.4.2.2 Entrapment of fingers

**Action:** Monitor - No action given the risk assessment

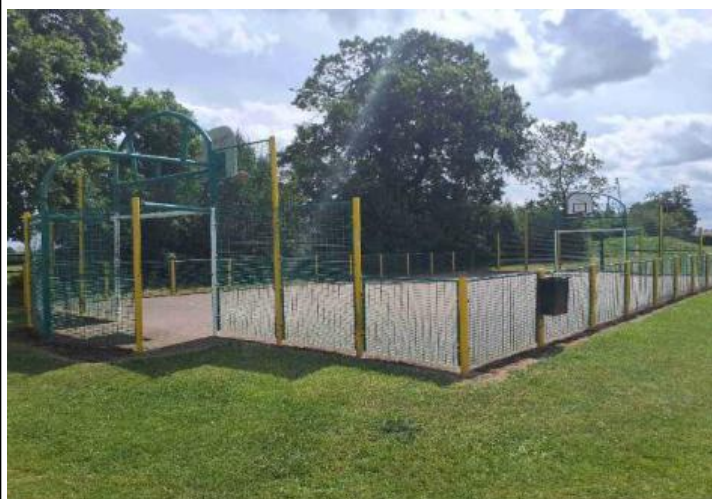
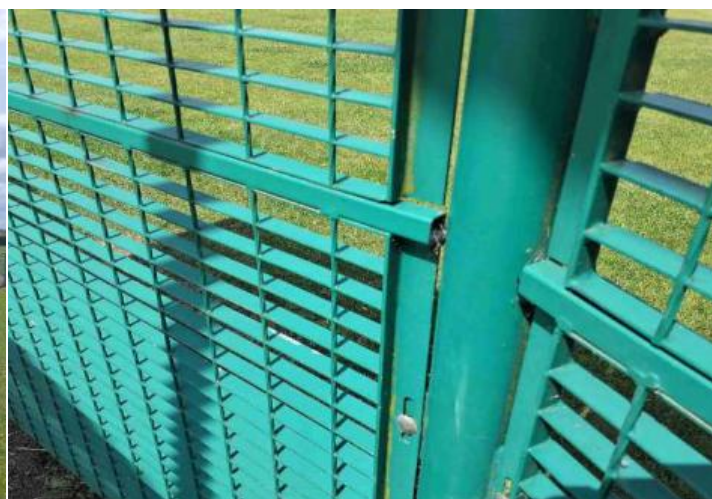
**Finding:** There is / are post or end caps missing / damaged on the item  
**Action:** Replace missing / damaged post or end caps

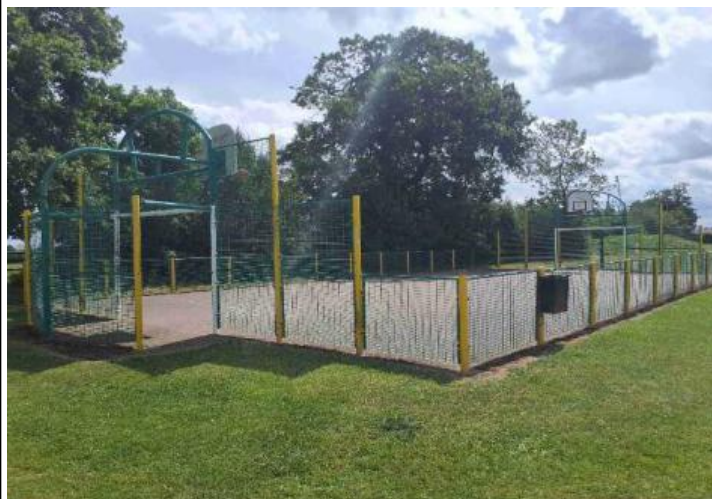
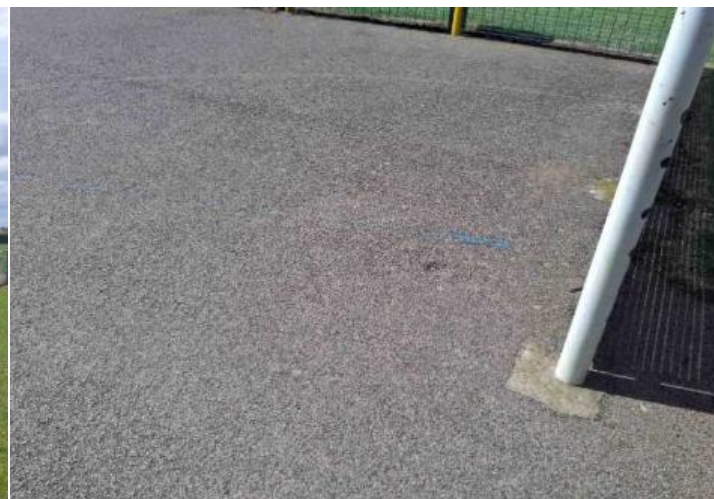
**Finding:** The bitumen surface is worn or damaged

**Action:** Repair the bitumen to provide a uniform surface

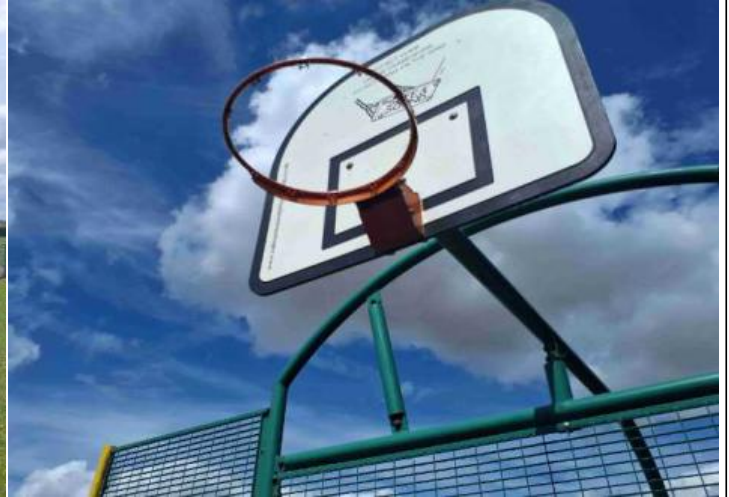
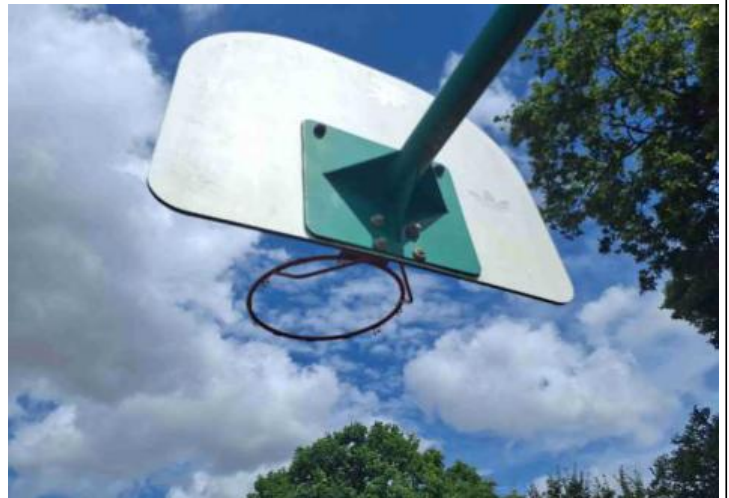
**Finding:** Bolt cap cover/s missing or damaged

**Action:** Replace
