## Annual Inspection

Bugbrooke Parish Council

School Lane Play Area

Inspected: 30-June-2026 - 12:13 by Jamie Leeson (RPII Annual Inspector)

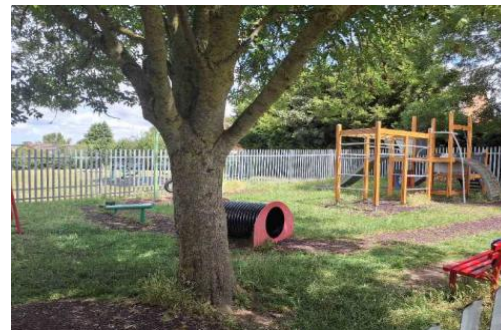
**Item:** Site General  
**Manufacturer:** Owner/Operator  
**Surface Type:** N/A  
**Item Quantity:** 1  
**Equipment Compliance:** N/A  
**Surface Area Compliance:** N/A

There is weed / vegetation growth within the surface -  
 Remove weed / vegetation growth

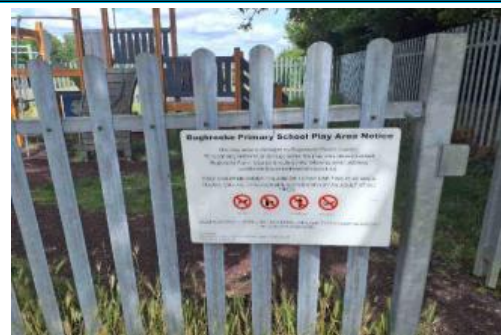
**Item:** Sign  
**Manufacturer:** Not Identified  
**Surface Type:** N/A  
**Item Quantity:** 1  
**Equipment Compliance:** N/A  
**Surface Area Compliance:** N/A

This item is satisfactory - no work required -

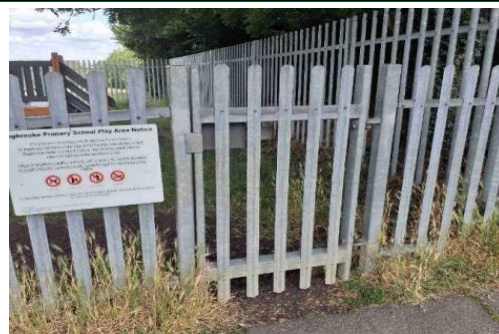
**Item:** Gate  
**Manufacturer:** Not Identified  
**Surface Type:** Bark Mulch  
**Item Quantity:** 1  
**Equipment Compliance:** N/A  
**Surface Area Compliance:** N/A

There are openings that are less than 12mm that could trap or crush fingers - Provide a 12mm gap throughout full range of motion at both sides of gate

There is surface corrosion / rust present on the item - Consider treating the item

The rubber buffer is missing from the latch plate - Replace rubber buffer

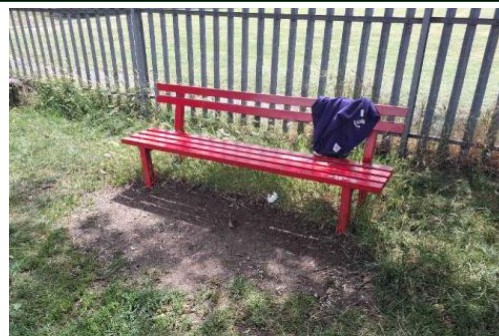
**Item:** Bench  
**Manufacturer:** Not Identified  
**Surface Type:** Grass  
**Item Quantity:** 1  
**Equipment Compliance:** N/A  
**Surface Area Compliance:** N/A

The area around the item has eroded and may become slippery - Reinstate eroded area

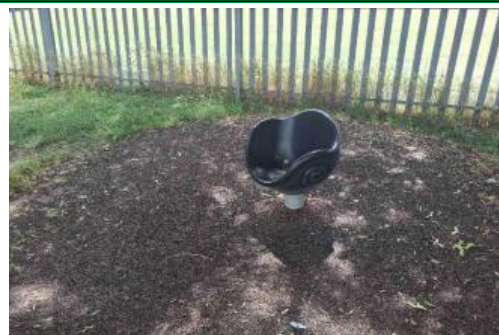
**Item:** Chair Spinner  
**Manufacturer:** Proludic  
**Surface Type:** Bonded Rubber Mulch  
**Item Quantity:** 1  
**Equipment Compliance:** Yes  
**Surface Area Compliance:** Yes

This item is satisfactory - no work required -

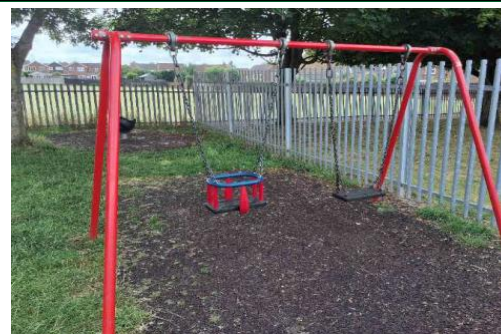
**Item:** 1 Bay Mixed Seat, 1 Cradle, 1 Flat  
**Manufacturer:** Safe & Sound  
**Surface Type:** Bonded Rubber Mulch  
**Item Quantity:** 1  
**Equipment Compliance:** No  
**Surface Area Compliance:** Yes

BS EN 1176 Part 2: Annex A makes a recommendation that fences or enclosures should be 1.50m from the edges of the swing seat to the sides, and subject to risk assessment, from the edge of the impact area. This is however, a low risk finding and no remedial action is recommended. - Monitor - No action given the risk assessment

The paintwork on this item has been damaged or worn exposing the metal underneath which is rusting / corroding - Treat affected areas and repaint

The swing seat connectors are loose - Tighten to secure

The chain openings are in excess of 8.6mm and do not meet the recommendations of BS EN 1176 Part 1 - Monitor - No action given the risk assessment

There is some notable evidence of chain wear - Monitor for any further deterioration and replace when 40% worn

There is some wear to the shackles - Monitor for any further deterioration and replace when 40% worn

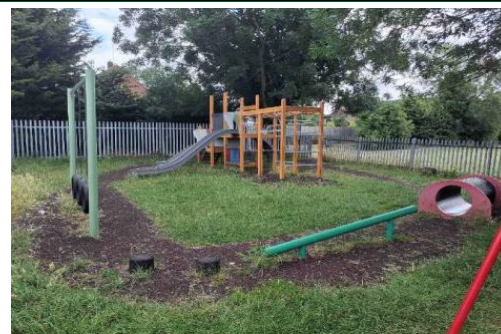
**Item:** Activity Trail  
**Manufacturer:** Not Identified  
**Surface Type:** Bonded Rubber Mulch  
**Item Quantity:** 1  
**Equipment Compliance:** No  
**Surface Area Compliance:** No

The surface has eroded in some areas and may be slippery in wet conditions - Reinstate the surface

There are areas or parts of the timber posts that have rotted - Replace all affected timbers

The connecting lugs are showing signs of wear - Monitor for any further deterioration and repair as required

Bolt cap cover/s missing or damaged - Replace

There is some evidence of fire damage to the item - Monitor for any further deterioration and repair as required

There is some wear to the shackles - Monitor for any further deterioration and replace when 40% worn

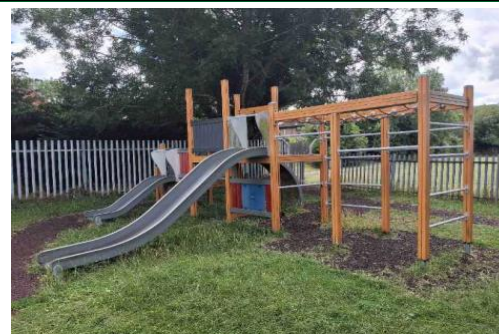
**Item:** Multi Play (Junior)  
**Manufacturer:** Lappset UK Ltd  
**Surface Type:** Mixed Surface  
**Item Quantity:** 1  
**Equipment Compliance:** No  
**Surface Area Compliance:** No

The surfacing dimensions are short and do not meet with the requirements of the current applicable standard - Monitor - No action given the risk assessment

There is/are finger entrapment/s in the access element and the item fails to meet the requirements of BS EN 1176 Part 1 4.2.7.6 Entrapment of fingers - Monitor - No action given the risk assessment

The ropes/nets are worn/damaged in places - Monitor for any further deterioration and repair or replace as required

The timber stain is in poor condition - Prepare all affected parts and re-stain with an appropriate preservative

There are a number of dents in the slide surface - Monitor for any further deterioration and repair as required

The item fails to meet the requirements of BS EN 1176 Part 1 4.2.7.2 head and neck entrapment in the barriers and/or steps - Monitor - No action given the risk assessment

There is some evidence of rot in the timber - Monitor for any further deterioration and replace as required

Bolt cap cover/s missing or damaged - Replace

There is / are post or end caps missing / damaged on the item - Replace missing / damaged post or end caps

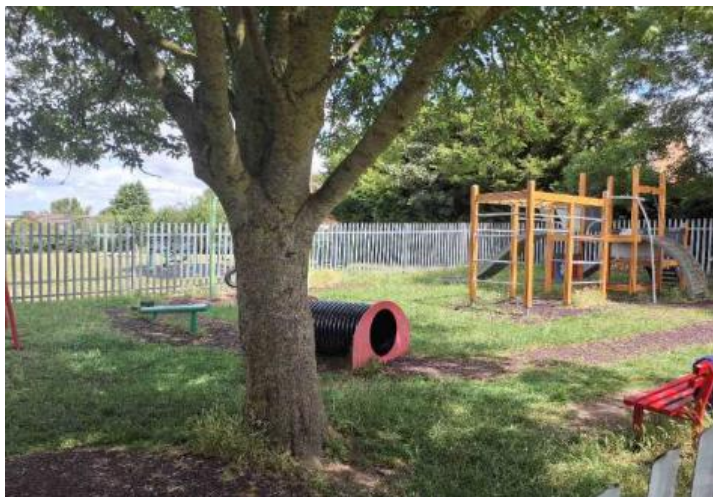
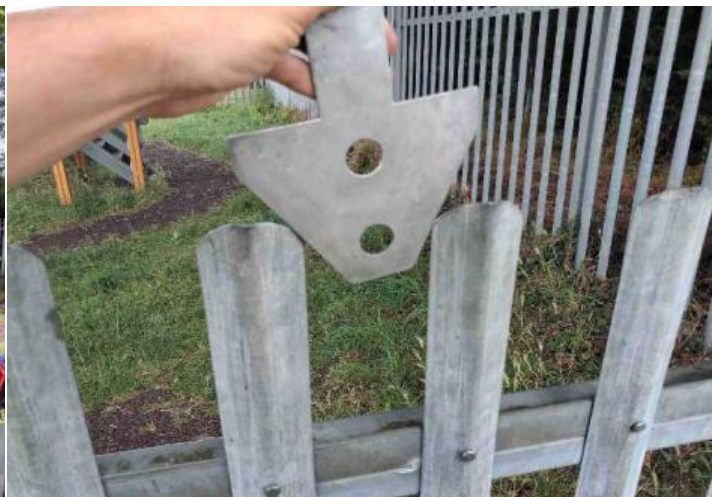
**Item:** Ancillary Items - Site General  
**Manufacturer:** Owner/Operator

**Risk Level:** V - Very Low Risk  
**Surface:** N/A

**Finding:** There is a risk of head and neck entrapment in the accessible castellations of the fence and gate  
**Action:** Monitor - no action given the risk assessment

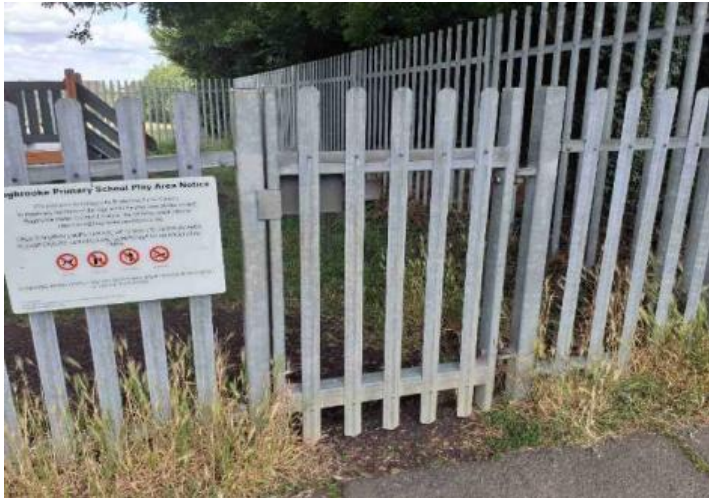
**Item:** Gates - Gate  
**Manufacturer:** Not Identified

**Risk Level:** L - Low Risk  
**Surface:** Bark Mulch

**Finding:** There are openings that are less than 12mm that could trap or crush fingers

**Action:** Provide a 12mm gap throughout full range of motion at both sides of gate

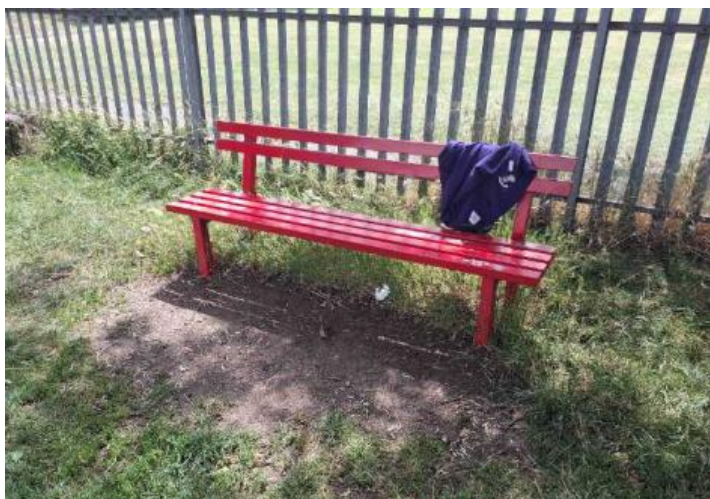
**Item:** Ancillary Items - Bench  
**Manufacturer:** Not Identified

**Risk Level:** L - Low Risk  
**Surface:** Grass

**Finding:** The area around the item has eroded and may become slippery  
**Action:** Reinstate eroded area

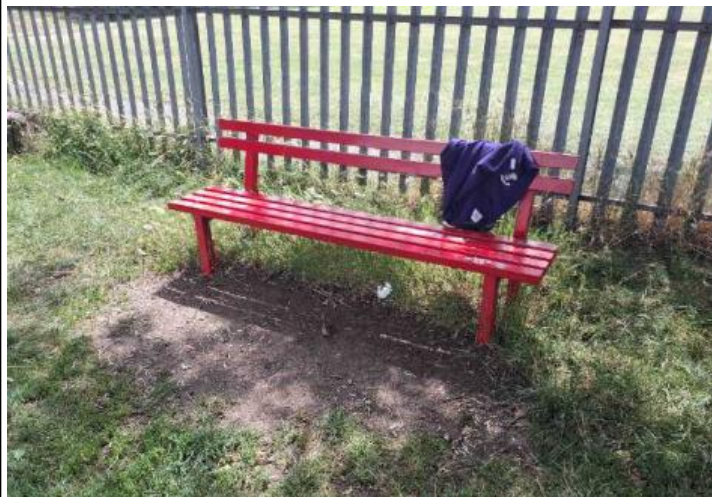
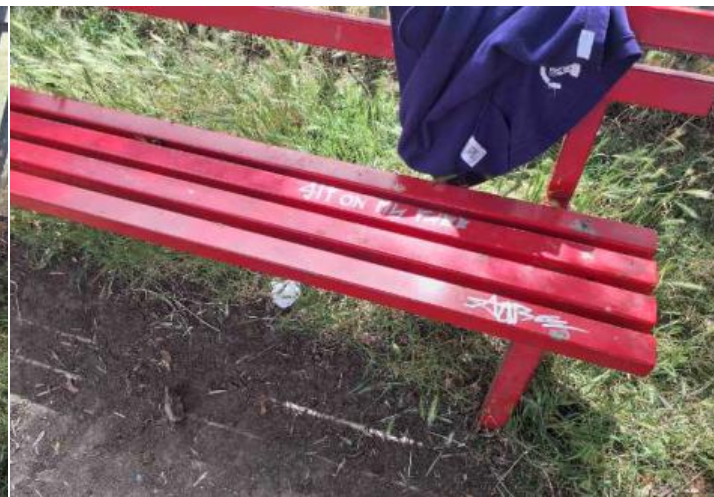
**Item:** Ancillary Items - Bench  
**Manufacturer:** Not Identified

**Finding:** There is some graffiti present

**Action:** Remove the graffiti

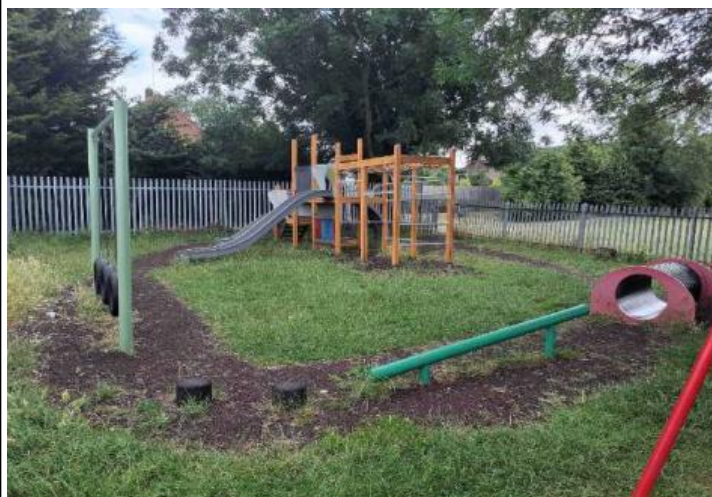
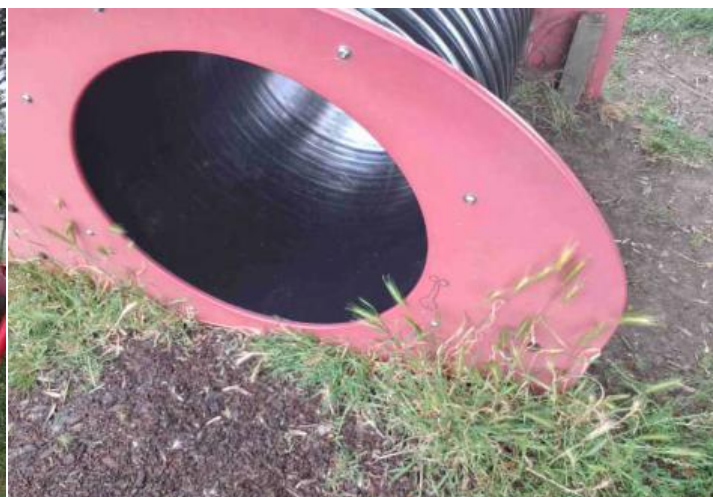
**Item:** Activity Equipment - Activity Trail  
**Manufacturer:** Not Identified

**Finding:** There is offensive graffiti present **Action:** Remove as soon as practicable

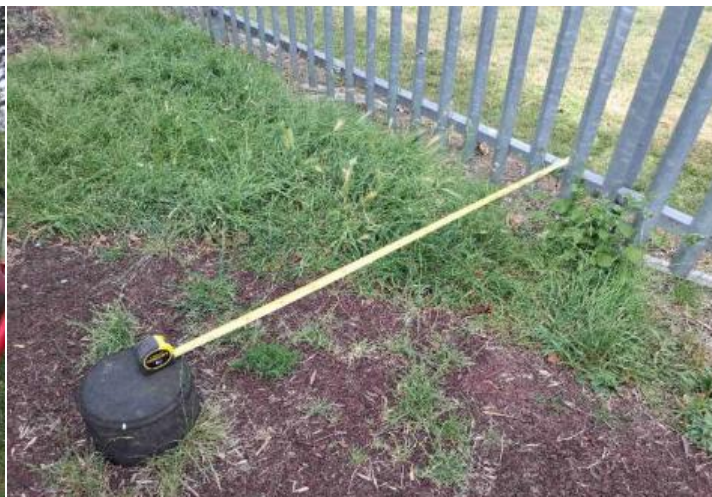
**Item:** Activity Equipment - Activity Trail  
**Manufacturer:** Not Identified

**Risk Level:** L - Low Risk  
**Surface:** Bonded Rubber Mulch

**Finding:** The fence forms a hard object within the falling space of the equipment and there is also insufficient surfacing provided in contravention of BS EN 1176 Part 1

**Action:** Monitor - No action given the risk assessment

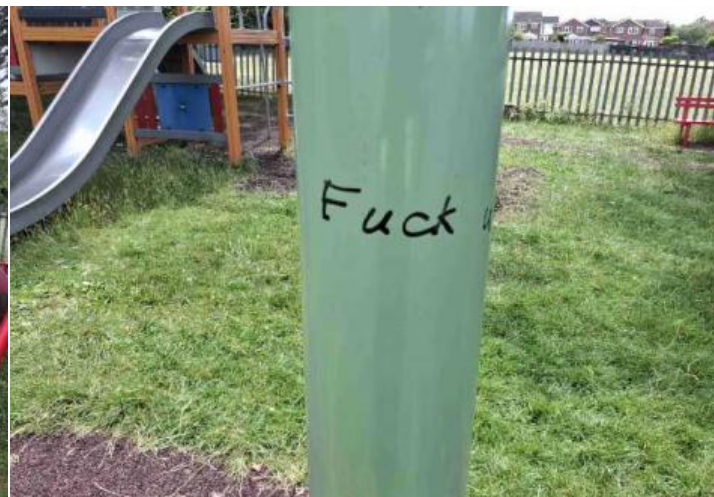
**Item:** Activity Equipment - Activity Trail  
**Manufacturer:** Not Identified

**Finding:** There is offensive graffiti present

**Action:** Remove as soon as practicable

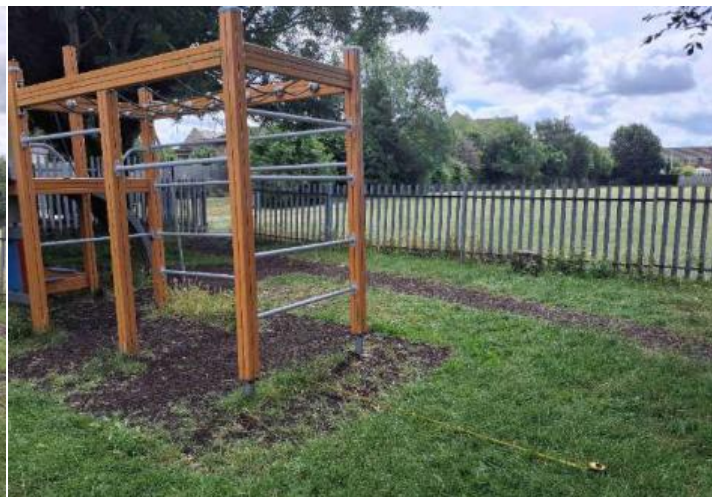
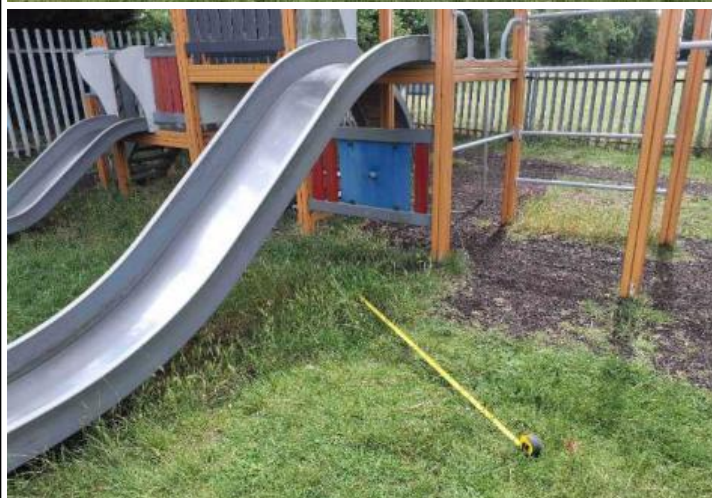
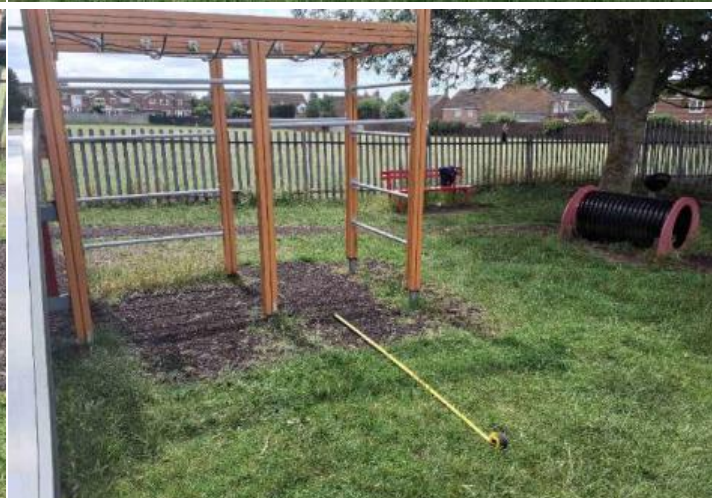
**Item:** Activity Equipment - Multi Play (Junior)  
**Manufacturer:** Lappset UK Ltd

**Risk Level:** V - Very Low Risk  
**Surface:** Mixed Surface

**Finding:** The surfacing dimensions are short and do not meet with the requirements of the current applicable standard

**Action:** Monitor - No action given the risk assessment

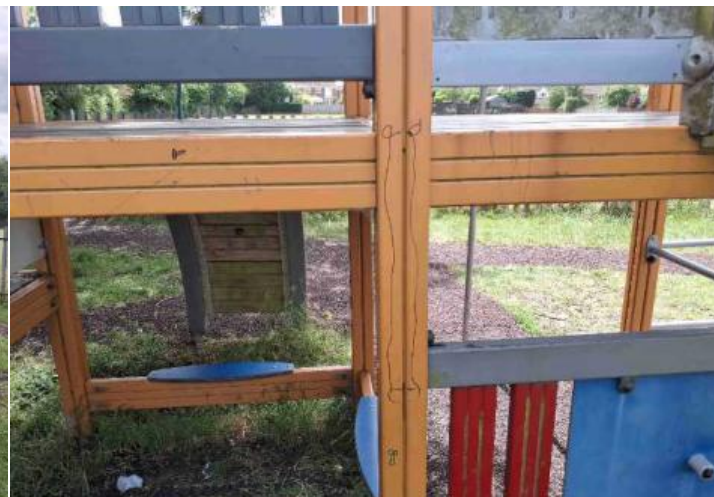
**Item:** Activity Equipment - Multi Play (Junior)  
**Manufacturer:** Lappset UK Ltd

**Finding:** There is offensive graffiti present

**Action:** Remove as soon as practicable

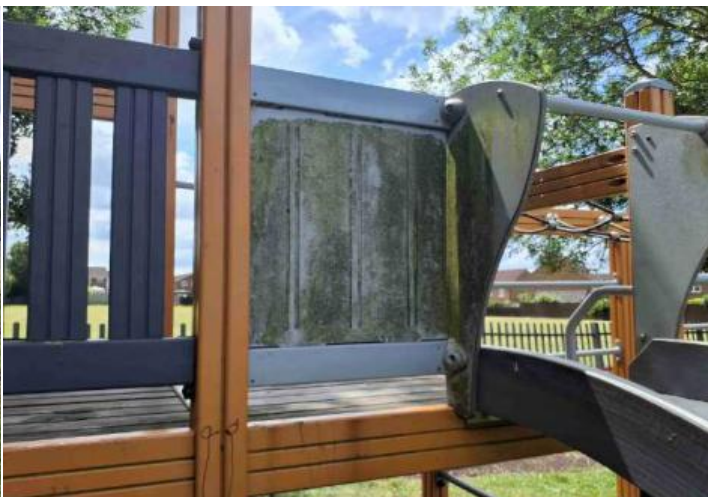
**Item:** Activity Equipment - Multi Play (Junior)  
**Manufacturer:** Lappset UK Ltd

**Risk Level:** L - Low Risk  
**Surface:** Mixed Surface

**Finding:** There is algae or moss on the surface of the equipment

**Action:** Clean and treat appropriately

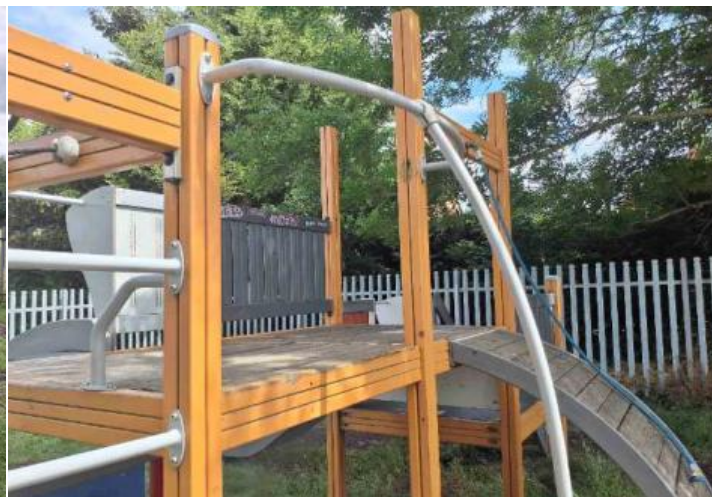
**Item:** Activity Equipment - Multi Play (Junior)  
**Manufacturer:** Lappset UK Ltd

**Risk Level:** L - Low Risk  
**Surface:** Mixed Surface

**Finding:** The unit is easily accessible and has an opening in the barrier to steep play elements in excess of 500mm in contravention of BS EN 1176 Part 1  
**Action:** Monitor - No action given the risk assessment

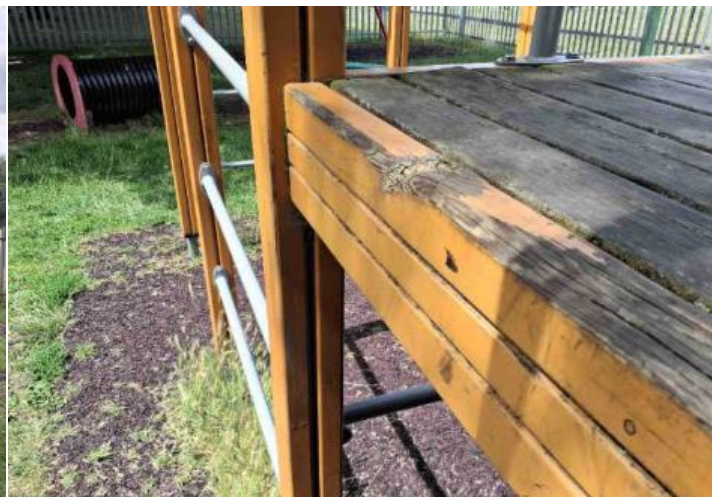
**Item:** Activity Equipment - Multi Play (Junior)  
**Manufacturer:** Lappset UK Ltd

**Risk Level:** L - Low Risk  
**Surface:** Mixed Surface

**Finding:** Parts of the timber are rough or splintered

**Action:** Remove all rough or sharp edges

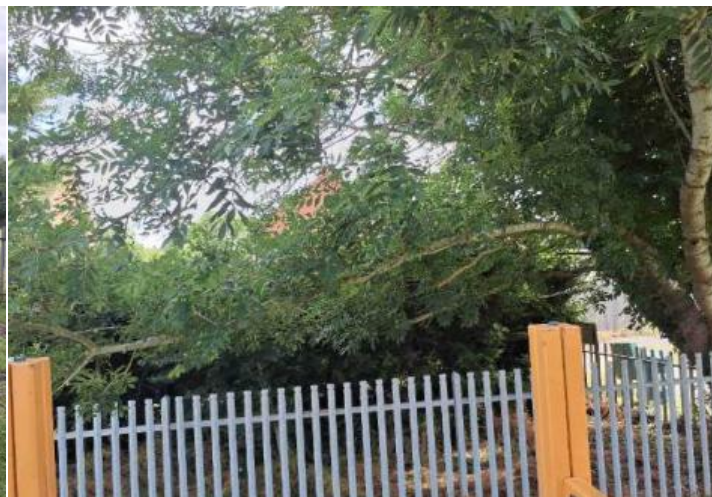
**Item:** Activity Equipment - Multi Play (Junior)  
**Manufacturer:** Lappset UK Ltd

**Risk Level:** L - Low Risk  
**Surface:** Mixed Surface

**Finding:** The tree canopy overhangs the equipment and is less than 2.0m away

**Action:** Lift tree canopy to ensure a minimum clearance of 2.0m from the equipment

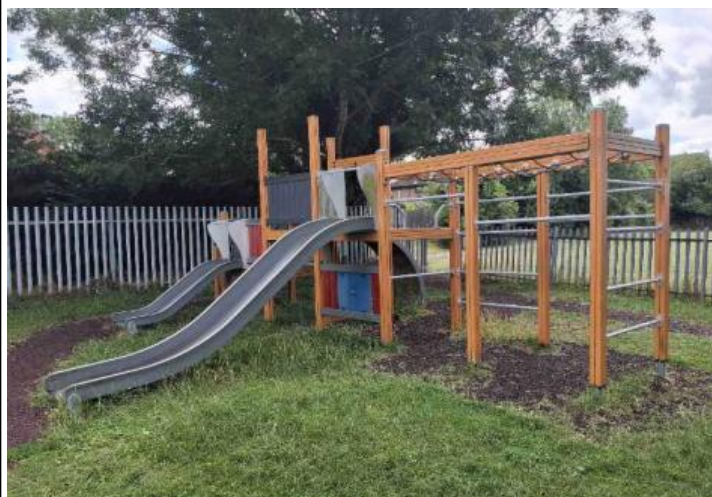
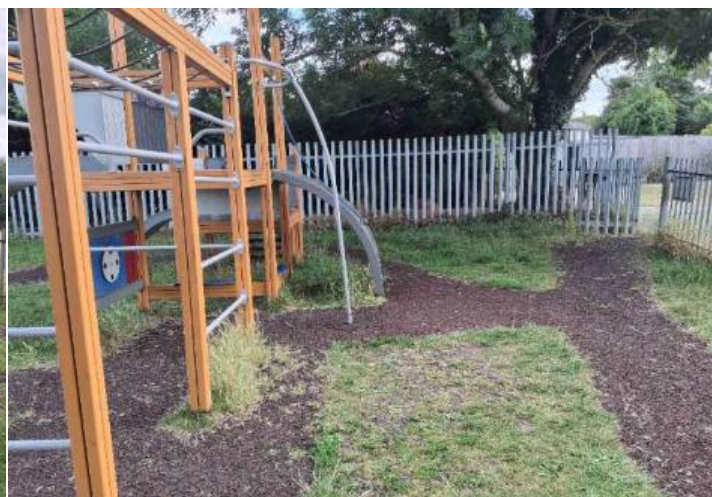
**Item:** Activity Equipment - Multi Play (Junior)  
**Manufacturer:** Lappset UK Ltd

**Risk Level:** L - Low Risk  
**Surface:** Mixed Surface

**Finding:** The grass mats are silted up and the soil is compacted; this may have an effect on the impact absorbing properties of the surface. Consideration should be given to HIC testing the surface to verify impact attenuating properties ( <https://playinspections.co.uk/inspection-services/safety-surface-testing/> )

**Action:** Contact our office for a quotation for this service
