the **play inspection** company

## Annual Inspection

Bugbrooke Parish Council

Bugbrooke Community Centre

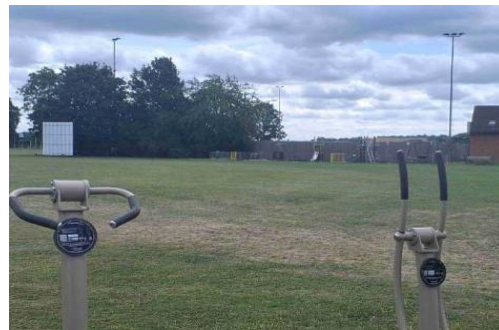
**Item:** Site General  
**Manufacturer:** Owner/Operator  
**Surface Type:** N/A  
**Item Quantity:** 1  
**Equipment Compliance:** N/A  
**Surface Area Compliance:** N/A

The wetpour is crumbling in areas - Monitor for any further deterioration and repair as required

The surface has subsided in some areas - Monitor for any further deterioration and repair as required

There are trip hazards present - Remove trip hazard

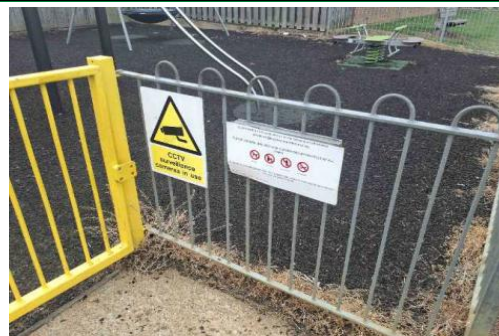
**Item:** Sign  
**Manufacturer:** Not Identified  
**Surface Type:** N/A  
**Item Quantity:** 1  
**Equipment Compliance:** N/A  
**Surface Area Compliance:** N/A

The item has been damaged - Monitor for any further deterioration and replace as required

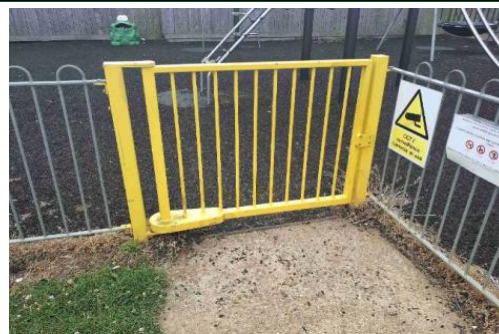
**Item:** Gate - Self Closing  
**Manufacturer:** I.A.E. Fencing  
**Surface Type:** Bonded Rubber Mulch  
**Item Quantity:** 2  
**Equipment Compliance:** N/A  
**Surface Area Compliance:** N/A

The area under the gate has eroded leaving uneven areas, or the concrete foundations exposed, resulting in trip hazards at the entrance/exit to the playground - Reinstate to level with surrounding surfaces

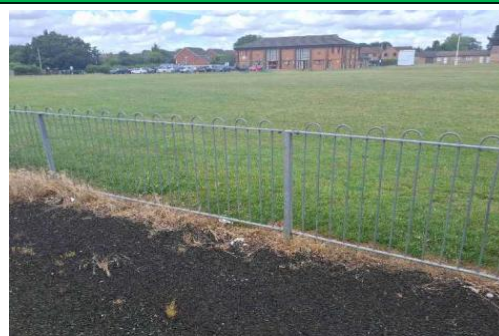
**Item:** Fence - Bow Top  
**Manufacturer:** Not Identified  
**Surface Type:** Bonded Rubber Mulch  
**Item Quantity:** 1  
**Equipment Compliance:** N/A  
**Surface Area Compliance:** N/A

There is some damage to the fence sections - Monitor for any further deterioration and repair as required

There are a number of loose posts around the fence - Monitor for any further deterioration and reset as required

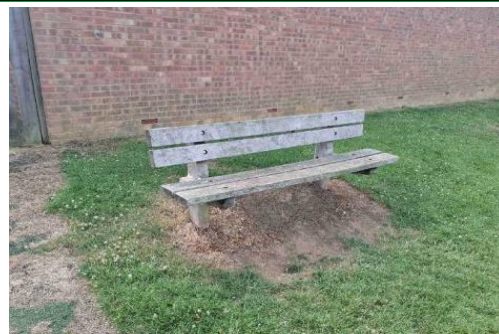
**Item:** Bench  
**Manufacturer:** Not Identified  
**Surface Type:** Grass  
**Item Quantity:** 1  
**Equipment Compliance:** N/A  
**Surface Area Compliance:** N/A

The area around the item has eroded and may become slippery - Reinstate eroded area

There is some strimmer / machinery damage apparent on the posts, this can penetrate the preservative applied to the timber and accelerate the rotting process - Monitor for any deterioration (rot) and replace as required

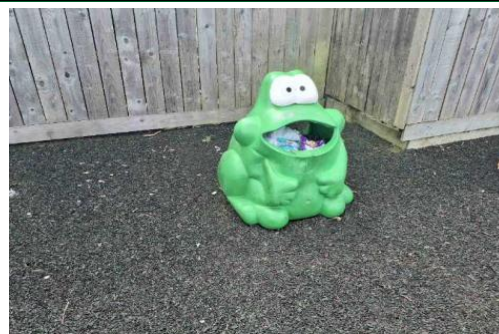
**Item:** Litter Bin  
**Manufacturer:** Not Identified  
**Surface Type:** Bonded Rubber Mulch  
**Item Quantity:** 1  
**Equipment Compliance:** N/A  
**Surface Area Compliance:** N/A

The lid or door of the litter bin is missing - Replace and ensure the lid or door is kept locked

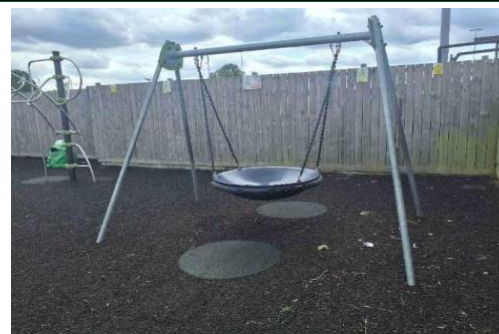
**Item:** Basket Swing - Type 1  
**Manufacturer:** Proludic  
**Surface Type:** Bonded Rubber Mulch  
**Surface Nominal Depth:** 75mm  
**Item Quantity:** 1  
**Equipment Compliance:** No  
**Surface Area Compliance:** Yes  
**Total Findings:** 8

There is moderate damage to the surface - Repair the damaged areas of surfacing

There are caps missing from the underside of the seats - Replace missing caps under the seats

The seat has minor damage or wear - Monitor for any further deterioration and replace as required

There is some notable evidence of chain wear - Monitor for any further deterioration and replace when 40% worn

The safety surface around the area is beginning to wear - Monitor for any further deterioration and repair as required

The bushes are showing signs of wear - Monitor for any further deterioration and replace as required

Bolt cap cover/s missing or damaged - Replace

There is some wear to the shackles - Monitor for any further deterioration and replace when 40% worn

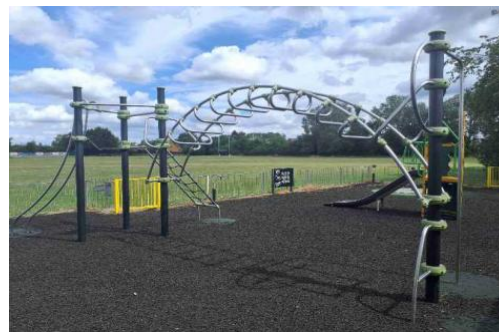
**Item:** Climbing Frame  
**Manufacturer:** Proludic  
**Surface Type:** Bonded Rubber Mulch  
**Surface Nominal Depth:** 100mm  
**Item Quantity:** 1  
**Equipment Compliance:** Yes  
**Surface Area Compliance:** Yes  
**Total Findings:** 5

Cable ties are present and there are sharp projecting ends - Remove

Insert/s missing or damaged - Replace

A number of fixing(s) have worked loose - Secure all loose fixings

There is / are post or end caps missing / damaged on the item - Replace missing / damaged post or end caps

There is some notable evidence of chain wear - Monitor for any further deterioration and replace when 40% worn

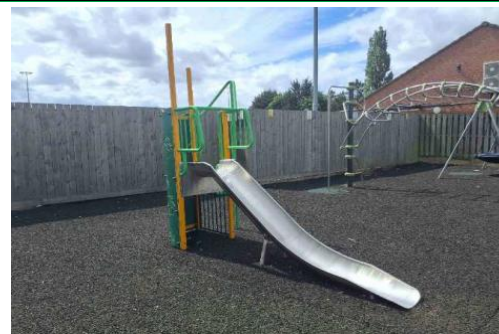
**Item:** Multi Play (Junior)  
**Manufacturer:** Wicksteed Playgrounds  
**Surface Type:** Bonded Rubber Mulch  
**Item Quantity:** 1  
**Equipment Compliance:** No  
**Surface Area Compliance:** Yes

There are gaps opening between the surfacing and the edging surround or between the joints in the surfacing - Monitor for any further deterioration and repair as required

There is / are toggle entrapment/s present in contravention of the recommendations set out in BS EN 1176 Part 1 - Monitor - No action given the risk assessment

The item has been damaged - Monitor for any further deterioration and replace as required

There are a number of dents in the slide surface - Monitor for any further deterioration and repair as required

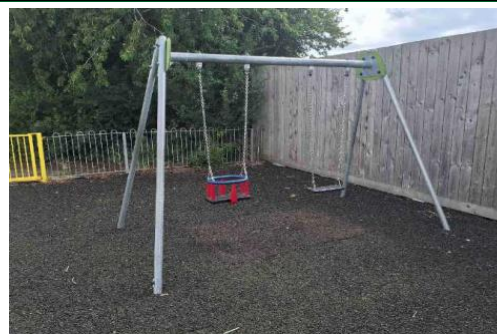
**Item:** 1 Bay Mixed Seat, 1 Cradle, 1 Flat  
**Manufacturer:** Proludic  
**Surface Type:** Bonded Rubber Mulch  
**Surface Nominal Depth:** 70mm  
**Item Quantity:** 1  
**Equipment Compliance:** Yes  
**Surface Area Compliance:** Yes  
**Total Findings:** 3

The safety surface around the area is beginning to wear - Monitor for any further deterioration and repair as required

There is some notable evidence of chain wear - Monitor for any further deterioration and replace when 40% worn

BS EN 1176 Part 2: Annex A makes a recommendation that fences or enclosures should be 1.50m from the edges of the swing seat to the sides, and subject to risk assessment, from the edge of the impact area. This is however, a low risk finding and no remedial action is recommended. - Monitor - No action given the risk assessment

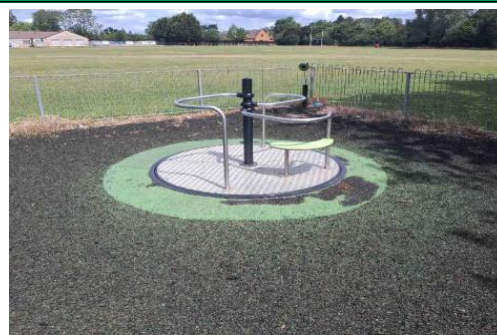
**Item:** Inclusive Roundabout  
**Manufacturer:** Proludic  
**Surface Type:** Wet Pour  
**Item Quantity:** 1  
**Equipment Compliance:** Yes  
**Surface Area Compliance:** Yes

There is moderate damage to the surface - Repair the damaged areas of surfacing

The paintwork on this item has been damaged or worn exposing the metal underneath which is rusting / corroding - Treat affected areas and repaint

Bolt cap cover/s missing or damaged - Replace

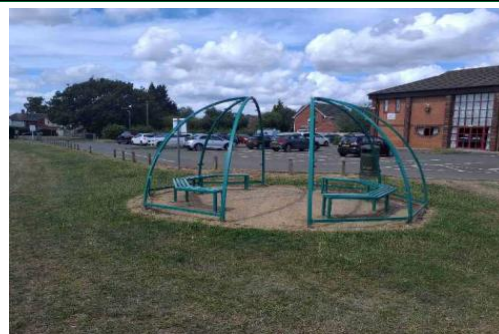
**Item:** Shelter  
**Manufacturer:** Not Identified  
**Surface Type:** Concrete  
**Item Quantity:** 1  
**Equipment Compliance:** N/A  
**Surface Area Compliance:** N/A

There is algae, silt or moss growth on the surface resulting in slippery conditions - Clean and treat appropriately

The item has missing panels exposing projecting brackets - Replace missing components

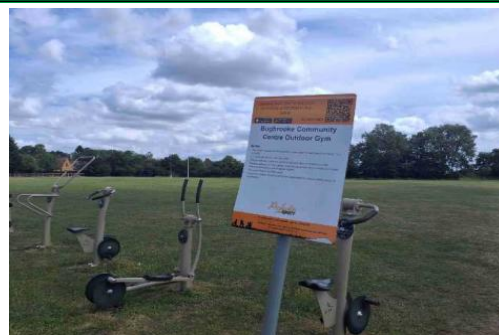
**Item:** Sign  
**Manufacturer:** Proludic  
**Surface Type:** Grass  
**Item Quantity:** 1  
**Equipment Compliance:** N/A  
**Surface Area Compliance:** N/A

The item is slightly loose in its foundations - Monitor for any further deterioration and repair as required

The item has been damaged - Monitor for any further deterioration and replace as required

Cable ties are present and there are sharp projecting ends - Replace with a more appropriate fixing method

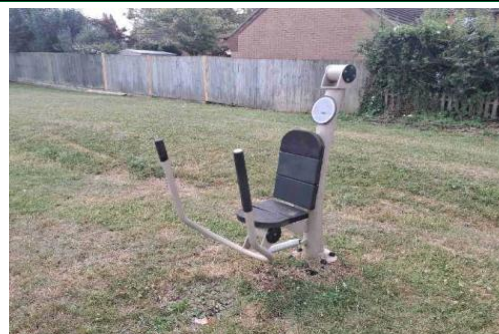
**Item:** Chest Press  
**Manufacturer:** Proludic  
**Surface Type:** Grass Matrix Tiles  
**Item Quantity:** 1  
**Equipment Compliance:** Yes  
**Surface Area Compliance:** Yes

There is / are post or end caps missing / damaged on the item - Replace missing / damaged post or end caps

The item has been damaged - Monitor for any further deterioration and replace as required

The paintwork on this item has been damaged or worn exposing the metal underneath which is rusting / corroding - Treat affected areas and repaint

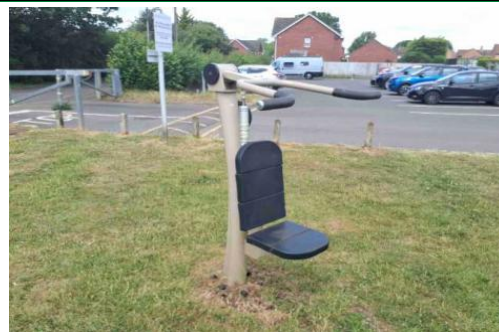
**Item:** Lateral Pull Down  
**Manufacturer:** Proludic  
**Surface Type:** Grass Matrix Tiles  
**Item Quantity:** 1  
**Equipment Compliance:** Yes  
**Surface Area Compliance:** Yes

There is surface corrosion / rust present on the item - Consider treating the item

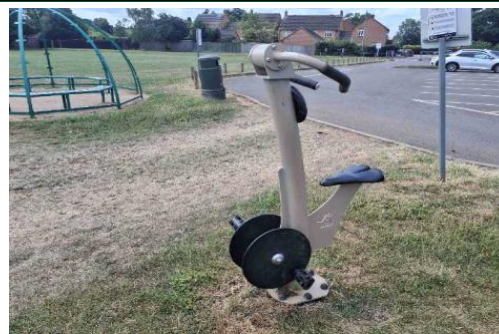
**Item:** Cycle  
**Manufacturer:** Proludic  
**Surface Type:** Grass Matrix Tiles  
**Item Quantity:** 1  
**Equipment Compliance:** Yes  
**Surface Area Compliance:** Yes

There is / are post or end caps missing / damaged on the item - Replace missing / damaged post or end caps

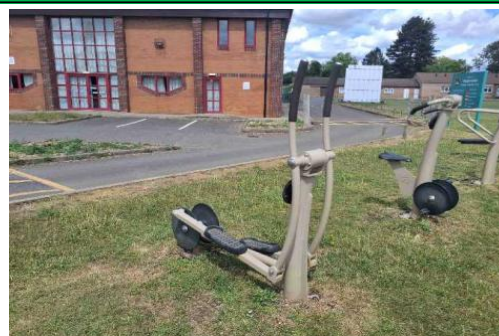
**Item:** Cross Trainer  
**Manufacturer:** Proludic  
**Surface Type:** Grass Matrix Tiles  
**Item Quantity:** 1  
**Equipment Compliance:** No  
**Surface Area Compliance:** Yes

The distance between the underside of the item and the ground is less than the 110mm required by BS EN 16630 - Monitor - No action given the risk assessment

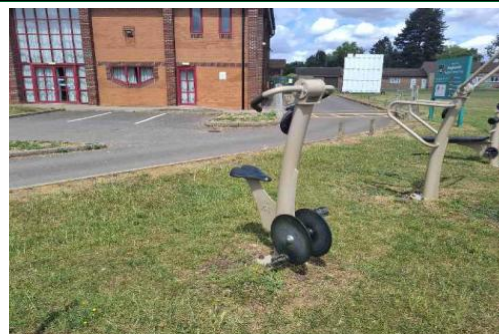
**Item:** Cycle  
**Manufacturer:** Proludic  
**Surface Type:** Grass Matrix Tiles  
**Item Quantity:** 1  
**Equipment Compliance:** Yes  
**Surface Area Compliance:** Yes

There is / are post or end caps missing / damaged on the item - Replace missing / damaged post or end caps

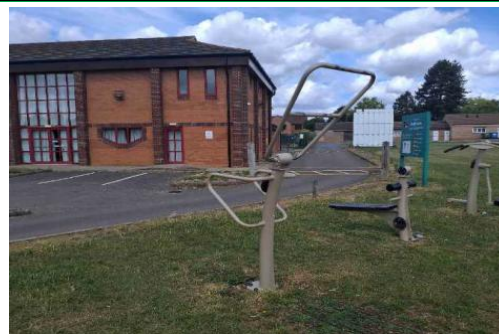
**Item:** Dip Station  
**Manufacturer:** Proludic  
**Surface Type:** Grass Matrix Tiles  
**Item Quantity:** 1  
**Equipment Compliance:** Yes  
**Surface Area Compliance:** Yes

The item is slightly loose in its foundations - Monitor for any further deterioration and repair as required

There is surface corrosion / rust present on the item - Consider treating the item

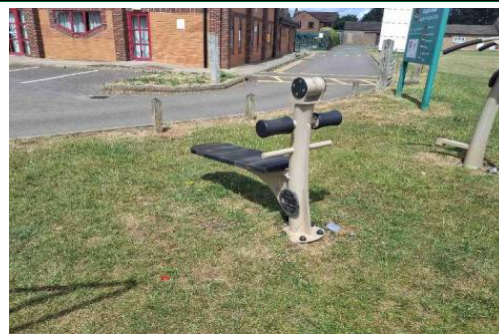
**Item:** Ab Station  
**Manufacturer:** Proludic  
**Surface Type:** Grass Matrix Tiles  
**Item Quantity:** 1  
**Equipment Compliance:** No  
**Surface Area Compliance:** Yes

There is a head and neck entrapment in the framework in contravention of the requirements of BS EN 16630:2015 clause 4.3.6.1 - Monitor - No action given the risk assessment

There is or are fixings missing on the item - Replace all missing fixings

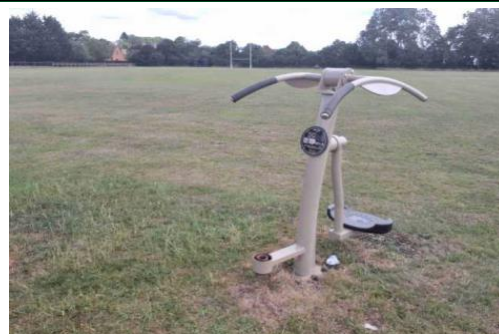
**Item:** Hip Twister  
**Manufacturer:** Proludic  
**Surface Type:** Grass Matrix Tiles  
**Item Quantity:** 1  
**Equipment Compliance:** Yes  
**Surface Area Compliance:** Yes

The item has missing component(s) - Replace missing components

The paintwork on this item has been damaged or worn exposing the metal underneath which is rusting / corroding - Treat affected areas and repaint

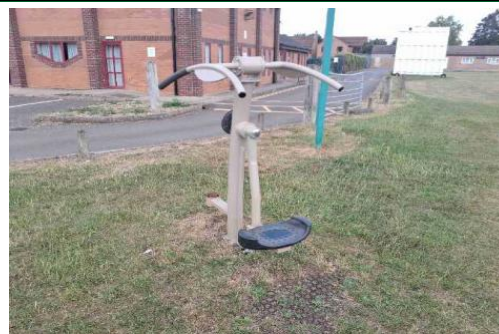
**Item:** Skier  
**Manufacturer:** Proludic  
**Surface Type:** Grass Matrix Tiles  
**Item Quantity:** 1  
**Equipment Compliance:** No  
**Surface Area Compliance:** Yes

The swinging movement of the item exceeds the maximum 55 degrees from the vertical required by BS EN 16630 - Monitor - No action given the risk assessment

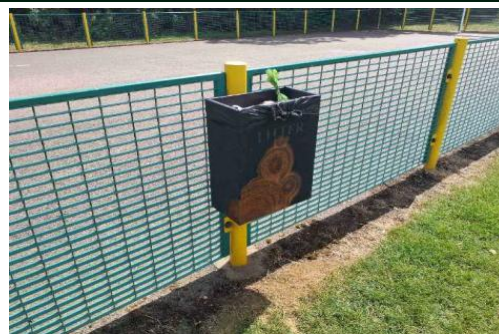
**Item:** Litter Bin  
**Manufacturer:** Not Identified  
**Surface Type:** N/A  
**Item Quantity:** 1  
**Equipment Compliance:** N/A  
**Surface Area Compliance:** N/A

There is some evidence of fire damage to the item - Monitor for any further deterioration and repair as required

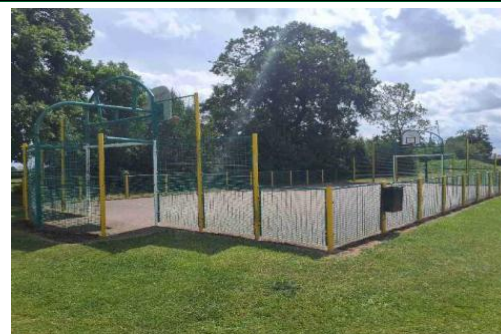
**Item:** Multi Use Games Area (MUGA)  
**Manufacturer:** Safe & Sound  
**Surface Type:** Bitmac  
**Item Quantity:** 1  
**Equipment Compliance:** No  
**Surface Area Compliance:** N/A

A clearly visible facility sign should be provided in a prominent position with the wording as detailed BS EN 15312 - the equipment is not intended for children less than 3 years old - the warning - Do not climb on the framework or nets - the warning - Do not hang on the ring (if provided) - the warning - Do not wear rings or other jewellery - name and telephone number of the administrator - number to call in case of accident - Provide signage to BS EN 15312

There are trip hazards at the edges of the surface - Remove trip hazard

There is/are finger entrapments in the fencing and the item fails to meet the requirements of BS EN 15312 Clause 4.4.2.2 Entrapment of fingers - Monitor - No action given the risk assessment

Bolt cap cover/s missing or damaged - Replace

There is algae, silt or moss growth on the surface resulting in slippery conditions - Clean and treat appropriately

There is / are post or end caps missing / damaged on the item - Replace missing / damaged post or end caps

The bitumen surface is worn or damaged - Repair the bitumen to provide a uniform surface

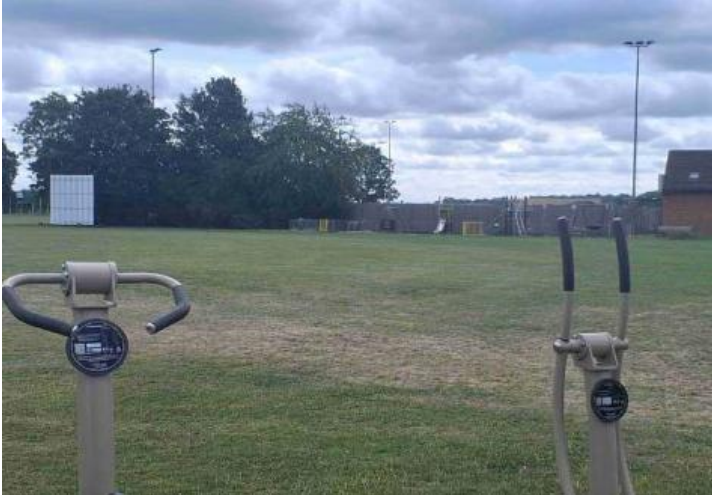
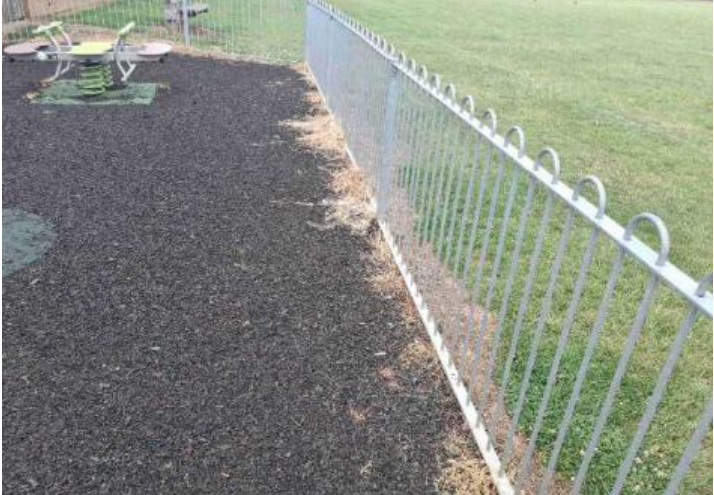
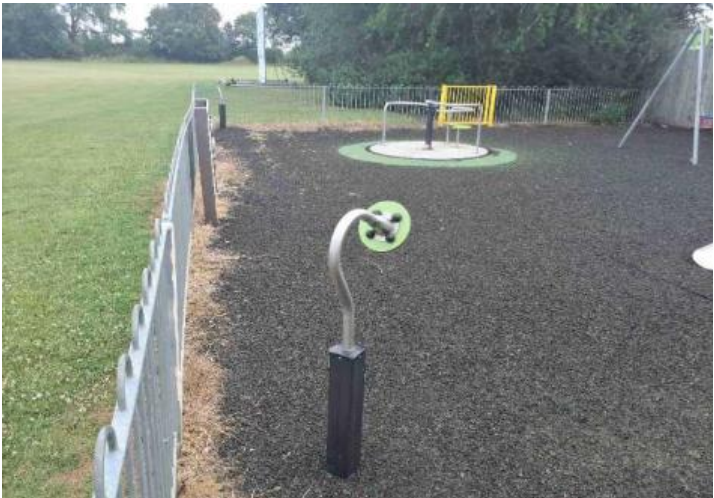
| <div> 6 - Low Risk (Finding 2) </div> | | | |
|---|---|---|---|
| Item: | Ancillary Items - Site General | Risk Level: | L - Low Risk |

| <div> 6 - Low Risk (Finding 2) </div> | | | |
|---|---|---|---|
| <b>Finding:</b> There is weed / vegetation growth within the surface | | <b>Action:</b> Remove weed / vegetation growth | |

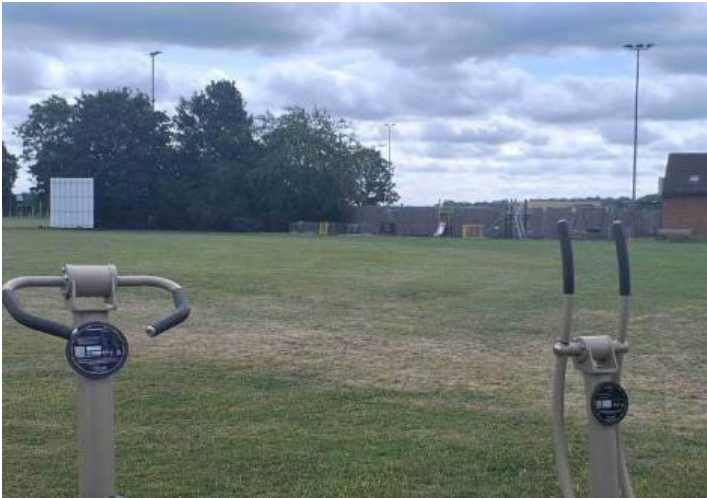
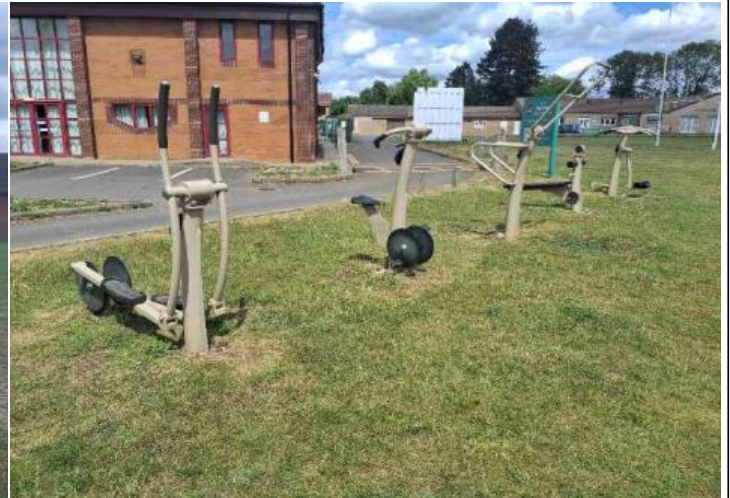
**Item:** Ancillary Items - Site General  
**Manufacturer:** Owner/Operator

**Finding:** The fitness equipment grass mats are silted up, the soil is compacted and the area will become very slippery when the soil is wet.

**Action:** Reinstate as required

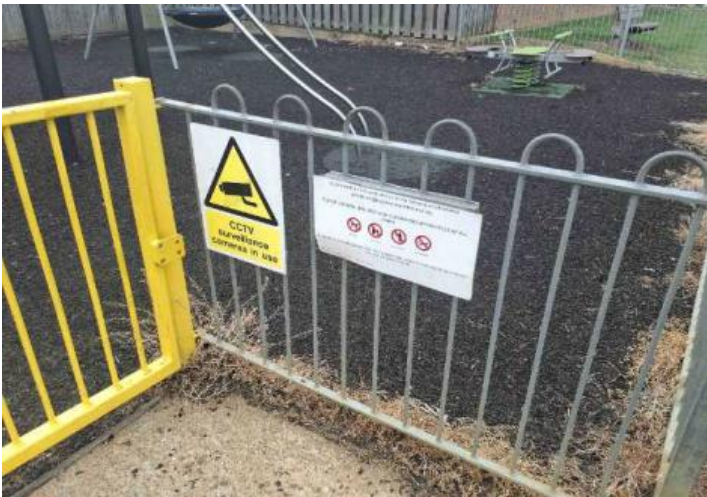
**Item:** Ancillary Items - Sign  
**Manufacturer:** Not Identified

**Finding:** The item has been damaged

**Action:** Monitor for any further deterioration and replace as required

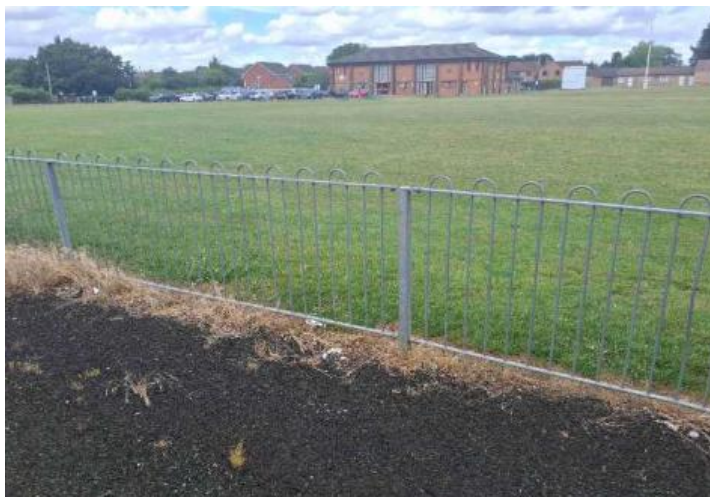
**Item:** Fences - Fence - Bow Top  
**Manufacturer:** Not Identified

**Finding:** There is some damage to the fence sections

**Action:** Monitor for any further deterioration and repair as required

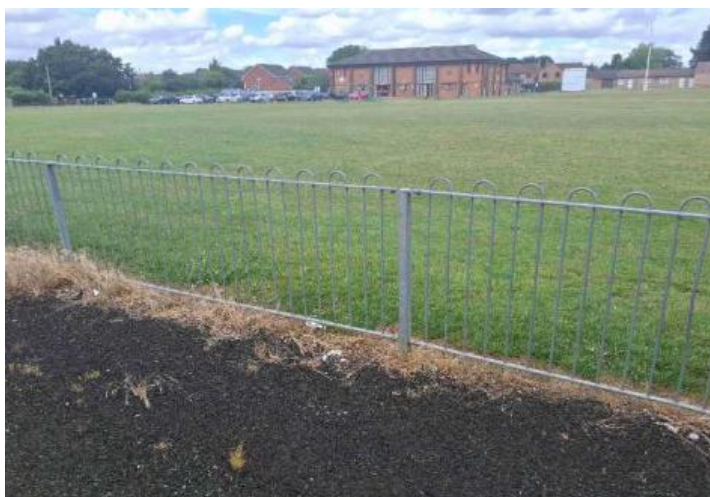
**Item:** Fences - Fence - Bow Top  
**Manufacturer:** Not Identified

**Finding:** There are a number of loose posts around the fence

**Action:** Monitor for any further deterioration and reset as required

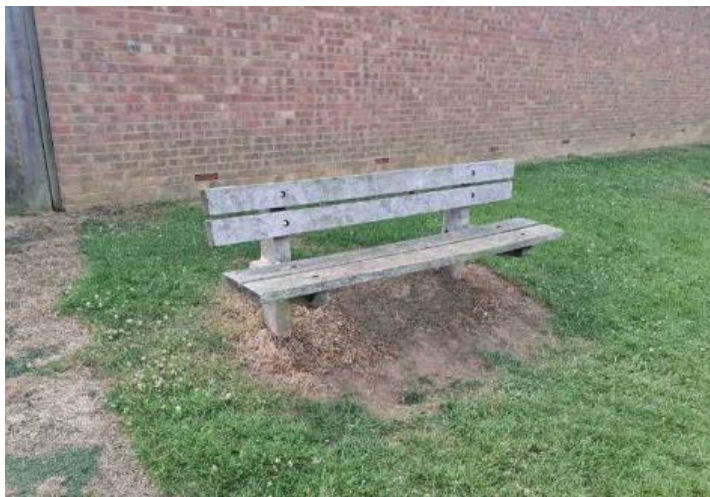
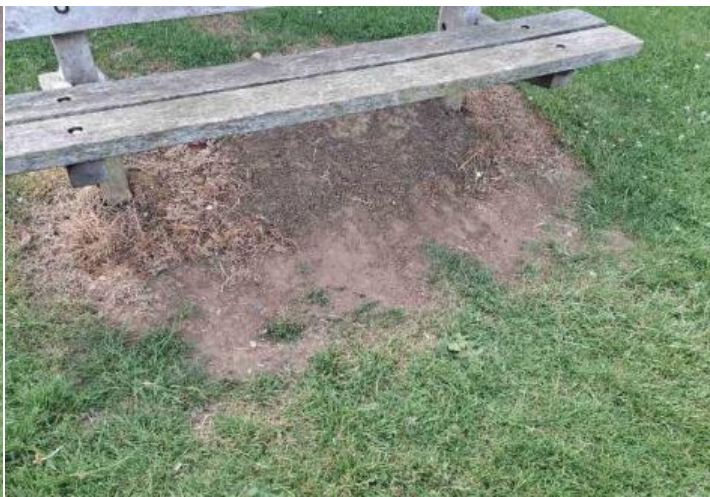
**Item:** Ancillary Items - Bench  
**Manufacturer:** Not Identified

**Finding:** The area around the item has eroded and may become slippery

**Action:** Reinststate eroded area

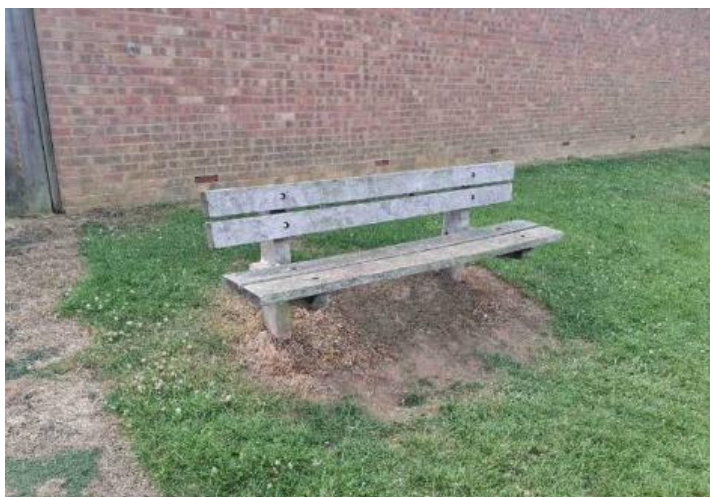
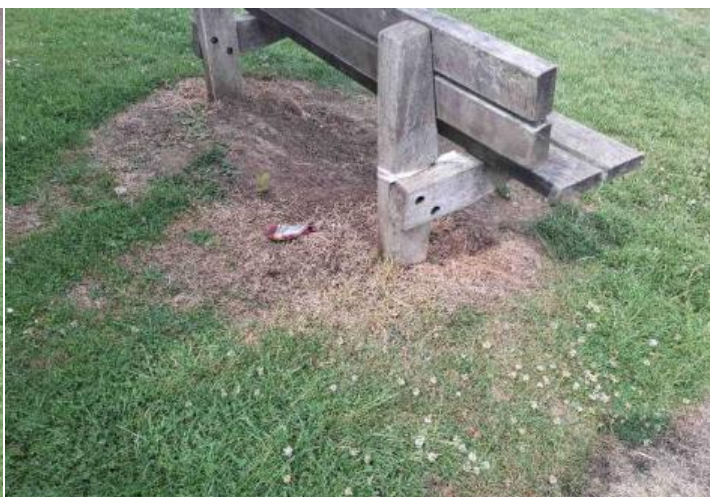
**Item:** Ancillary Items - Bench  
**Manufacturer:** Not Identified

**Finding:** There is some strimmer / machinery damage apparent on the posts, this can penetrate the preservative applied to the timber and accelerate the rotting process

**Action:** Monitor for any deterioration (rot) and replace as required

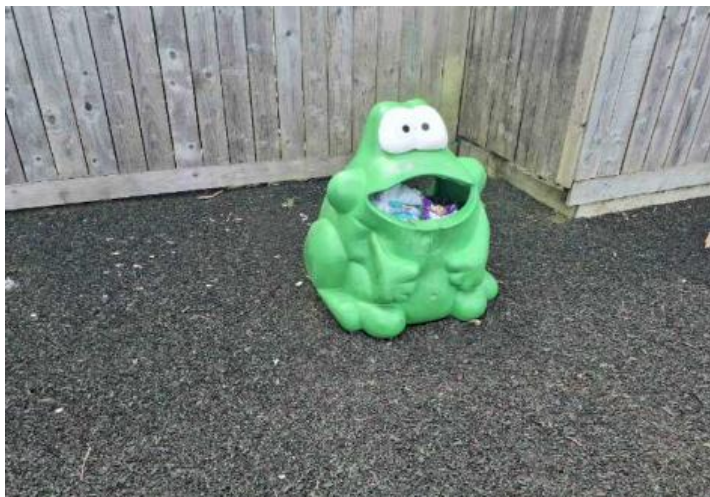
**Item:** Ancillary Items - Litter Bin  
**Manufacturer:** Not Identified

**Finding:** The lid or door of the litter bin is missing

**Action:** Replace and ensure the lid or door is kept locked

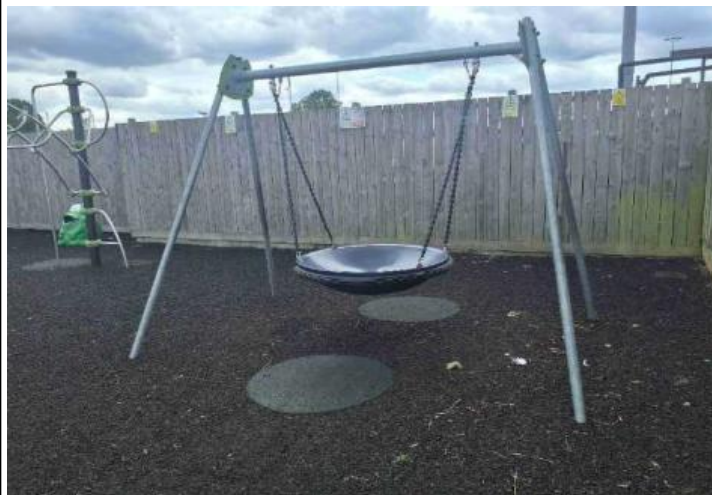
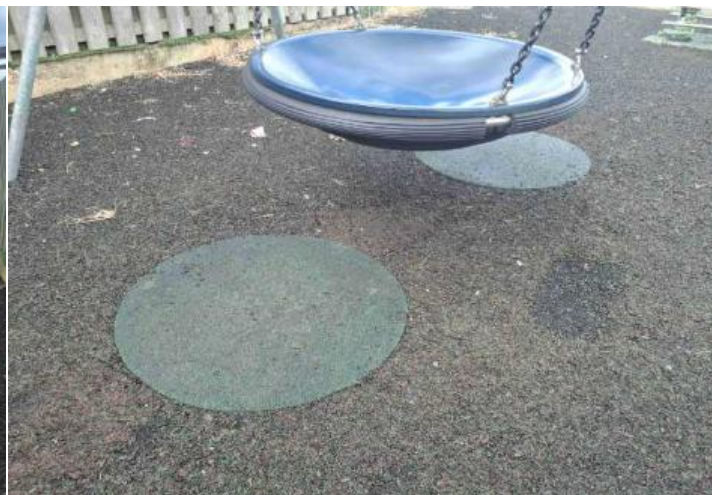
**Item:** Swings - Basket Swing - Type 1  
**Manufacturer:** Proludic

**Finding:** The safety surface around the area is beginning to wear  
**Action:** Monitor for any further deterioration and repair as required

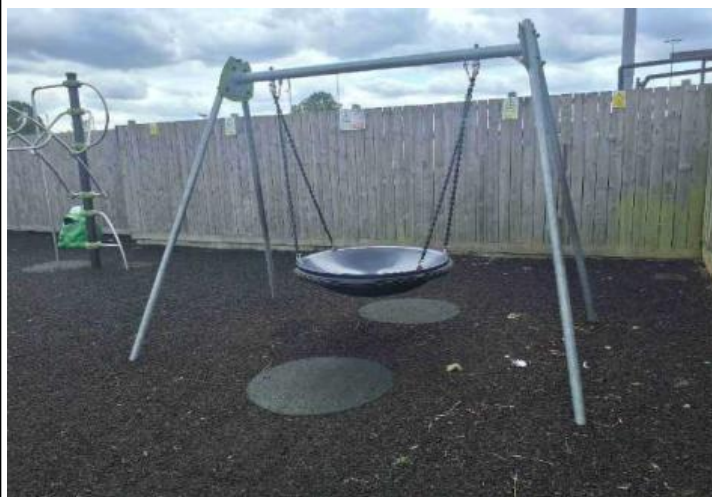
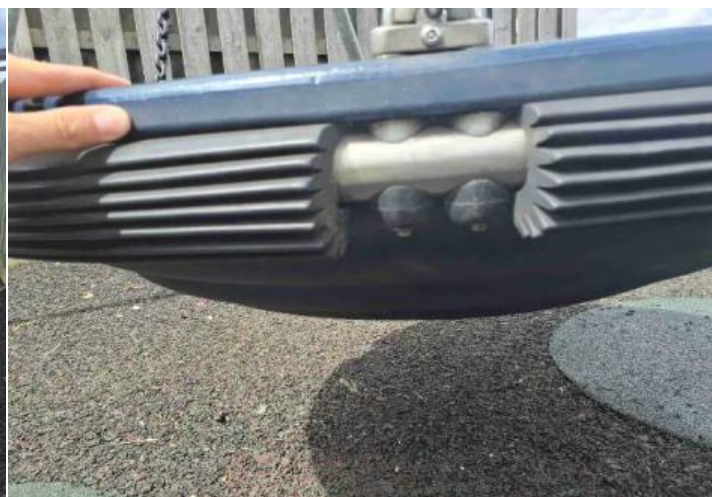
**Item:** Swings - Basket Swing - Type 1  
**Manufacturer:** Proludic

**Finding:** There are caps missing from the underside of the seats  
**Action:** Replace missing caps under the seats

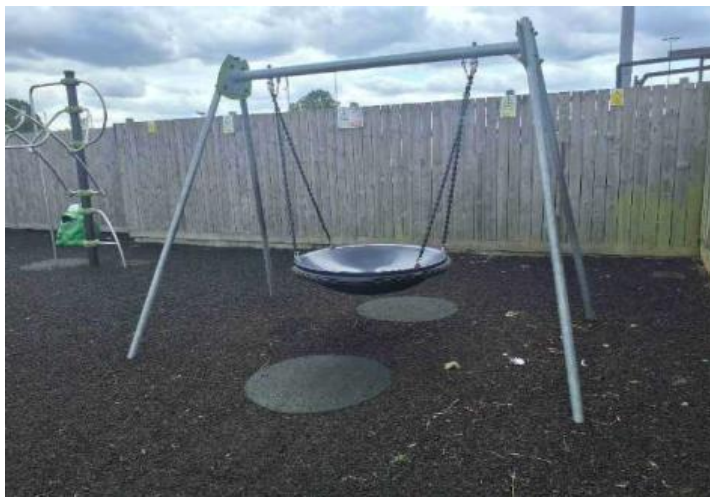
**Item:** Swings - Basket Swing - Type 1  
**Manufacturer:** Proludic

**Finding:** The bushes are showing signs of wear

**Action:** Monitor for any further deterioration and replace as required

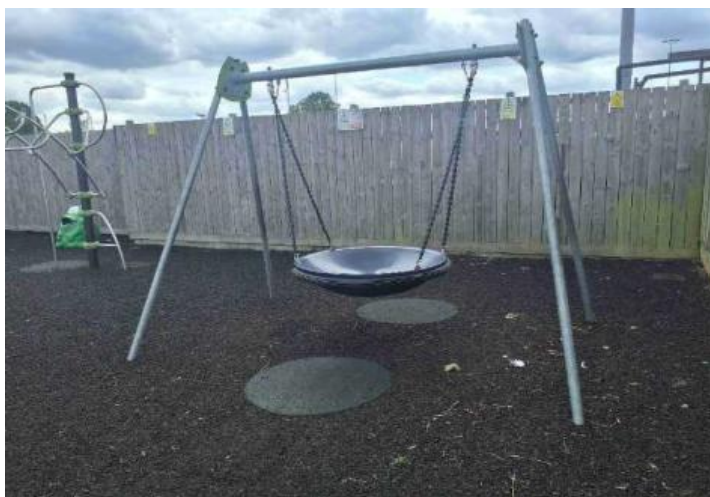
**Item:** Swings - Basket Swing - Type 1  
**Manufacturer:** Proludic

**Finding:** The seat has minor damage or wear

**Action:** Monitor for any further deterioration and replace as required

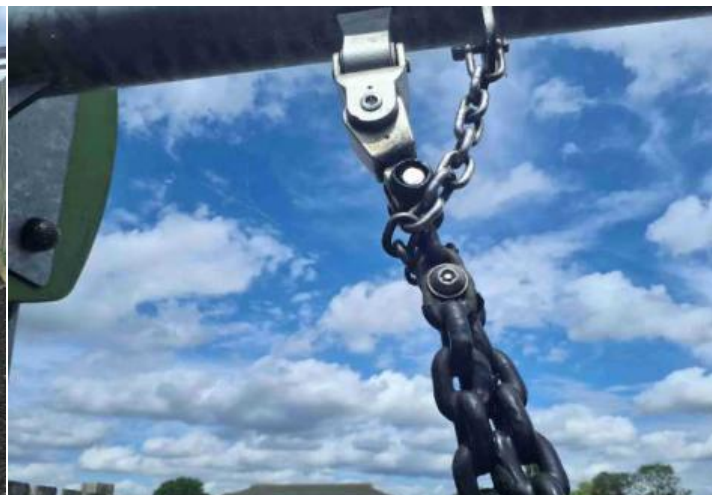
**Item:** Swings - Basket Swing - Type 1  
**Manufacturer:** Proludic

**Finding:** Bolt cap cover/s missing or damaged

**Action:** Replace

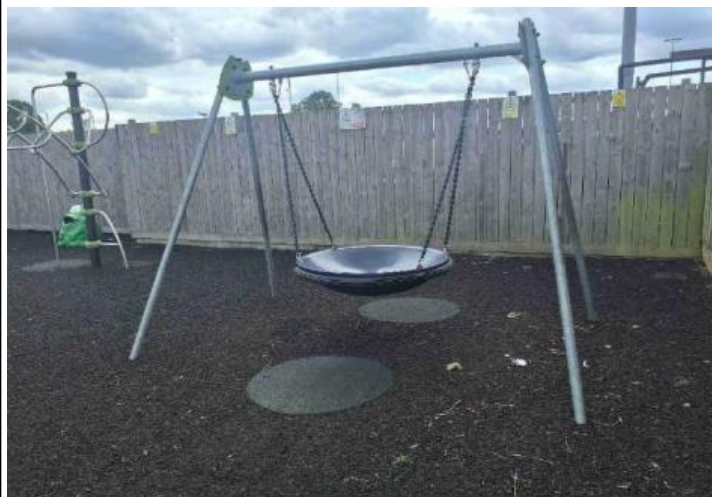
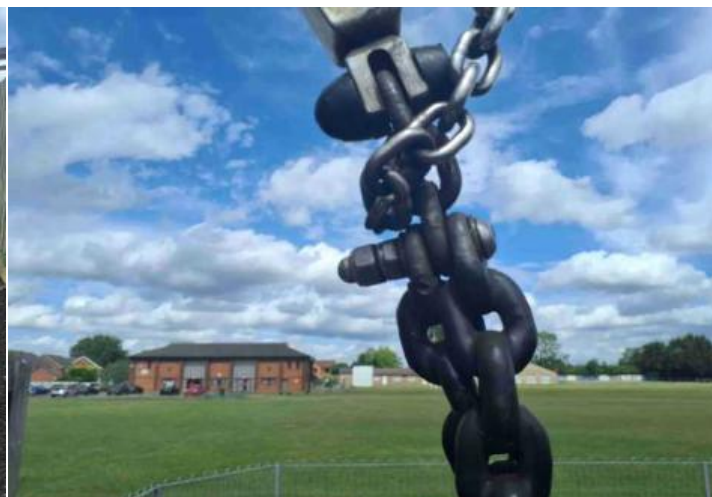
**Item:** Swings - Basket Swing - Type 1  
**Manufacturer:** Proludic

**Finding:** There is some notable evidence of chain wear

**Action:** Monitor for any further deterioration and replace when 40% worn

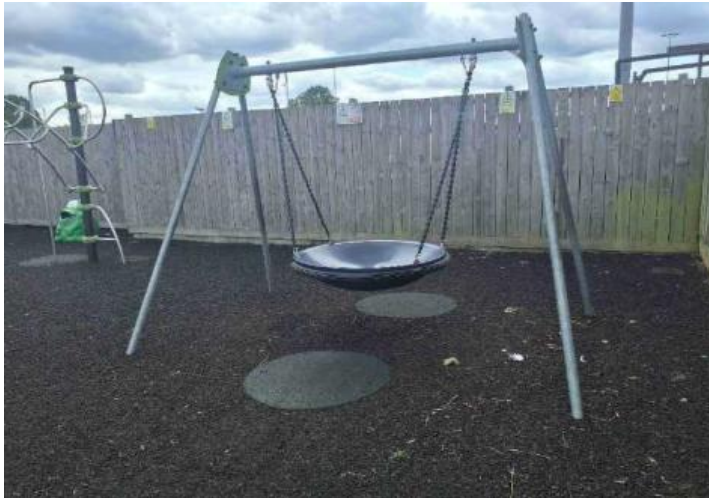
**Item:** Swings - Basket Swing - Type 1  
**Manufacturer:** Proludic

**Finding:** There is some wear to the shackles

**Action:** Monitor for any further deterioration and replace when 40% worn

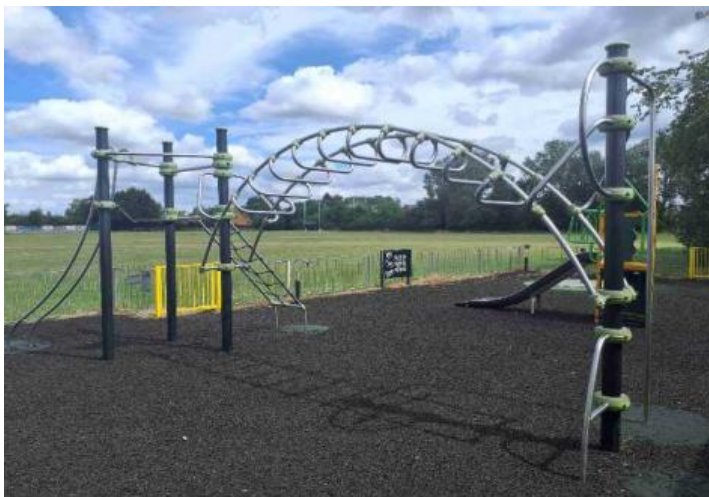
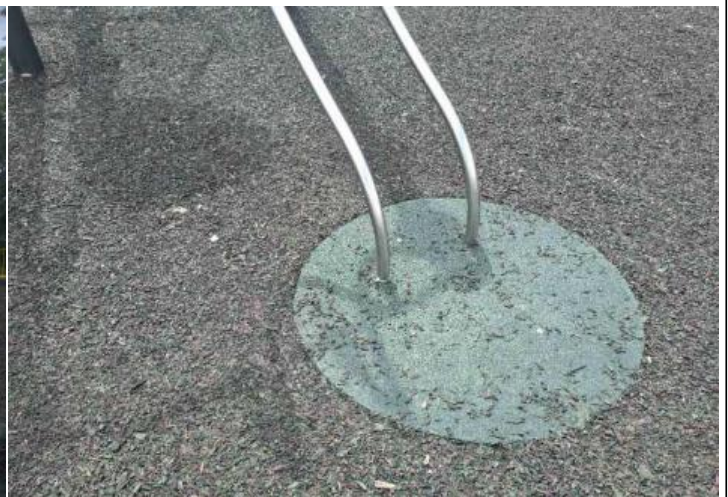
**Item:** Activity Equipment - Climbing Frame  
**Manufacturer:** Proludic

**Finding:** Cable ties are present and there are sharp projecting ends

**Action:** Remove

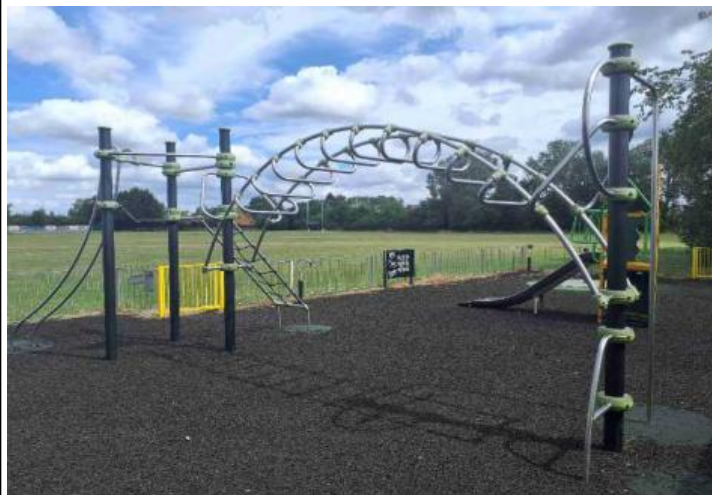
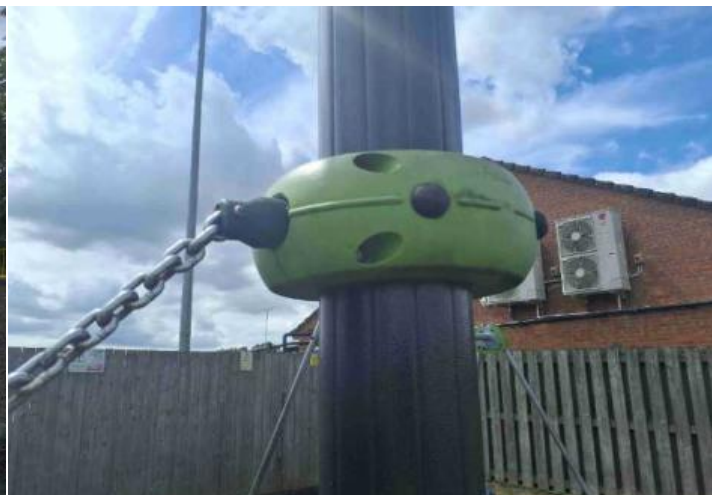
**Item:** Activity Equipment - Climbing Frame  
**Manufacturer:** Proludic

**Finding:** Insert/s missing or damaged

**Action:** Replace

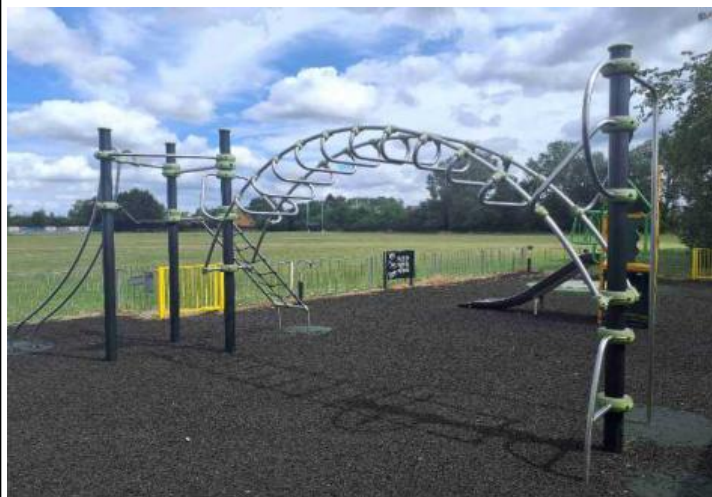
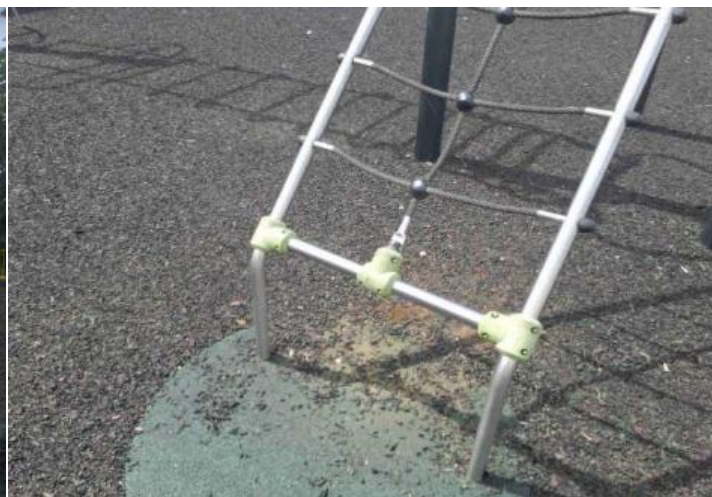
**Item:** Activity Equipment - Climbing Frame  
**Manufacturer:** Proludic

**Finding:** A number of fixing(s) have worked loose

**Action:** Secure all loose fixings

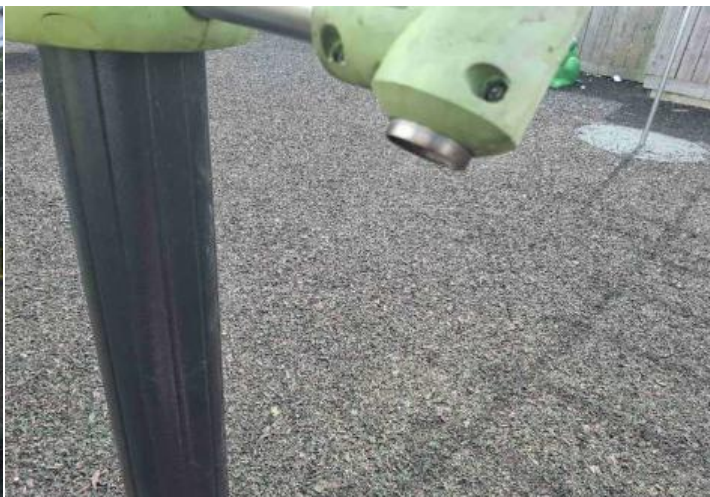
**Item:** Activity Equipment - Climbing Frame  
**Manufacturer:** Proludic

**Finding:** There is / are post or end caps missing / damaged on the item  
**Action:** Replace missing / damaged post or end caps

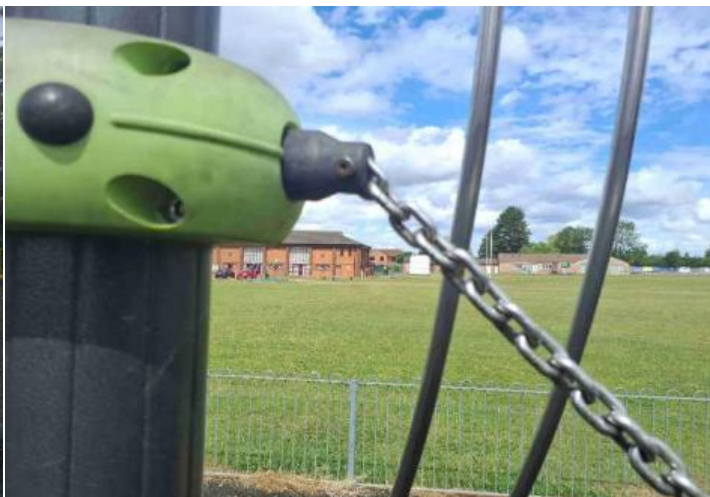
**Item:** Activity Equipment - Climbing Frame  
**Manufacturer:** Proludic

**Finding:** There is some notable evidence of chain wear  
**Action:** Monitor for any further deterioration and replace when 40% worn

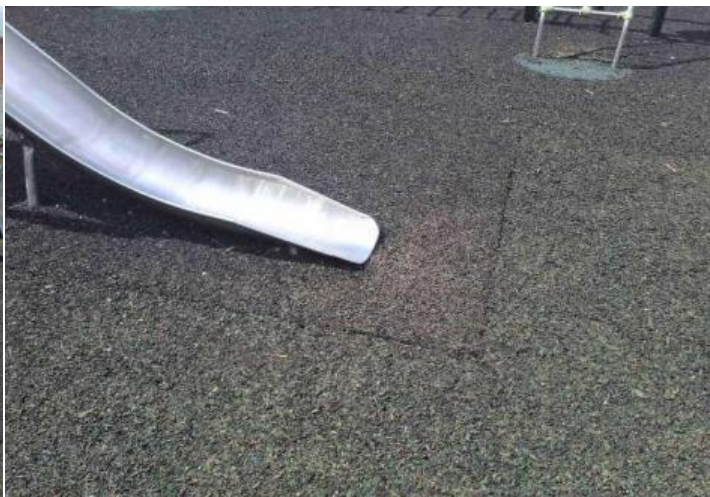
**Item:** Activity Equipment - Multi Play (Junior)  
**Manufacturer:** Wicksteed Playgrounds

**Finding:** There are gaps opening between the surfacing and the edging surround or between the joints in the surfacing  
**Action:** Monitor for any further deterioration and repair as required

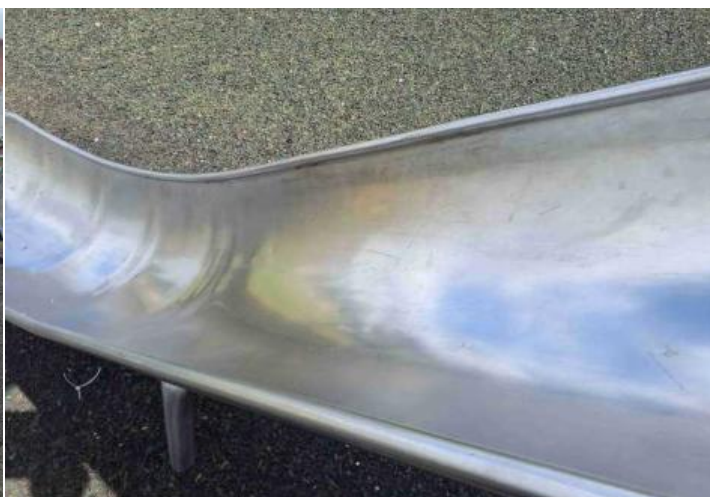
**Item:** Activity Equipment - Multi Play (Junior)  
**Manufacturer:** Wicksteed Playgrounds

**Finding:** There are a number of dents in the slide surface  
**Action:** Monitor for any further deterioration and repair as required

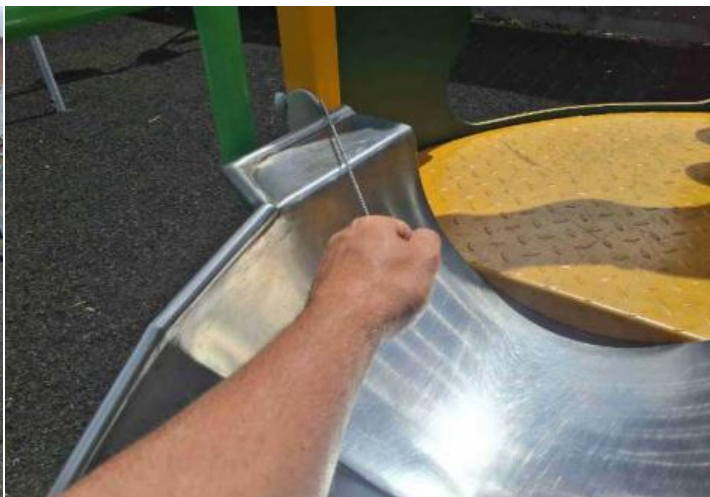
**Item:** Activity Equipment - Multi Play (Junior)  
**Manufacturer:** Wicksteed Playgrounds

**Finding:** There is / are toggle entrapment/s present in contravention of the recommendations set out in BS EN 1176 Part 1

**Action:** Monitor - No action given the risk assessment

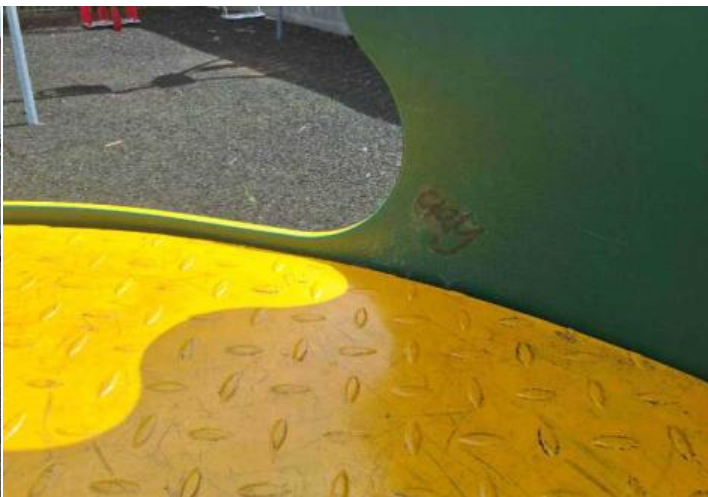
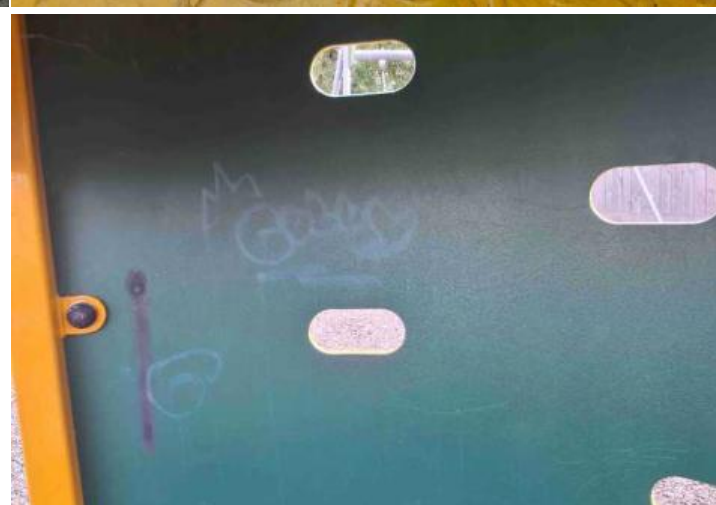
**Item:** Activity Equipment - Multi Play (Junior)  
**Manufacturer:** Wicksteed Playgrounds

**Finding:** There is offensive graffiti present

**Action:** Remove as soon as practicable

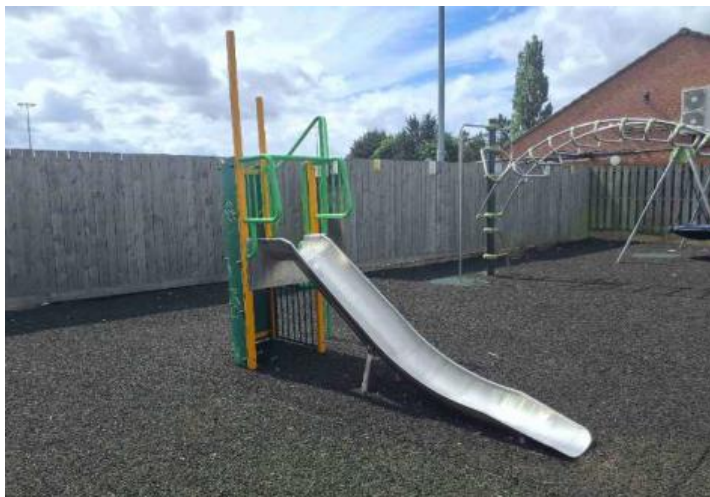
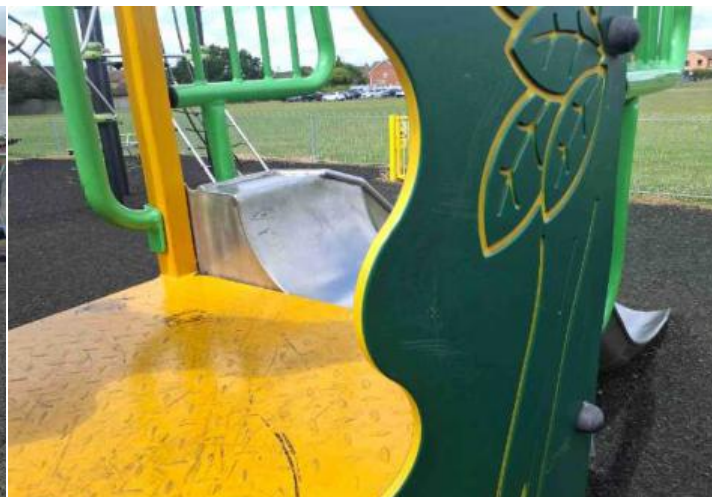
**Item:** Activity Equipment - Multi Play (Junior)  
**Manufacturer:** Wicksteed Playgrounds

**Finding:** The item has been damaged

**Action:** Monitor for any further deterioration and replace as required

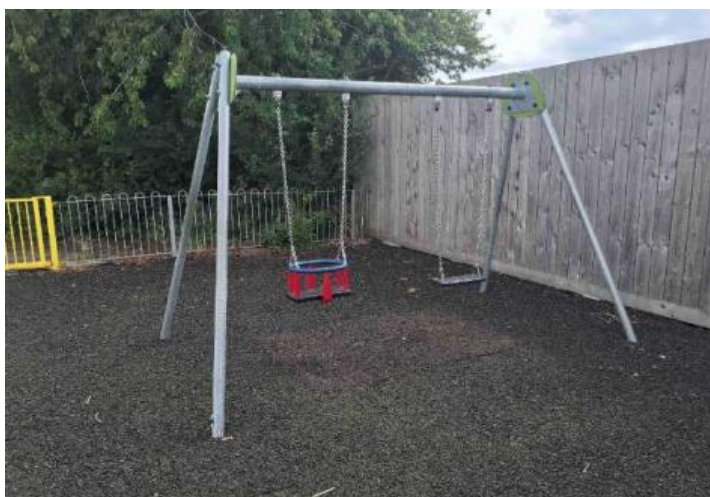
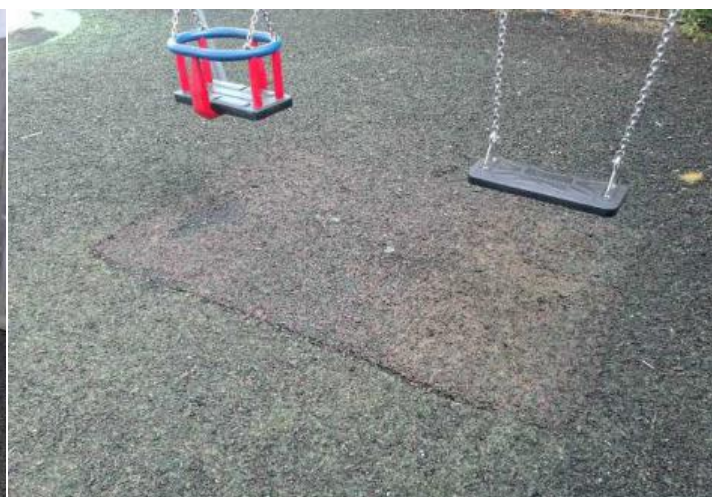
**Item:** Swings - 1 Bay Mixed Seat, 1 Cradle, 1 Flat  
**Manufacturer:** Proludic

**Finding:** The safety surface around the area is beginning to wear

**Action:** Monitor for any further deterioration and repair as required
