the **play inspection** company

## Annual Inspection

Bugbrooke Parish Council

Bugbrooke Community Centre

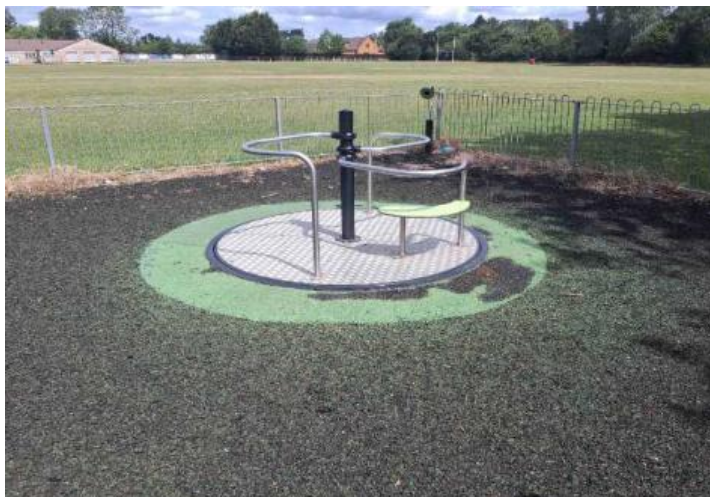
**Item:** Rotor Play - Inclusive Roundabout  
**Manufacturer:** Proludic

**Finding:** Bolt cap cover/s missing or damaged

**Action:** Replace

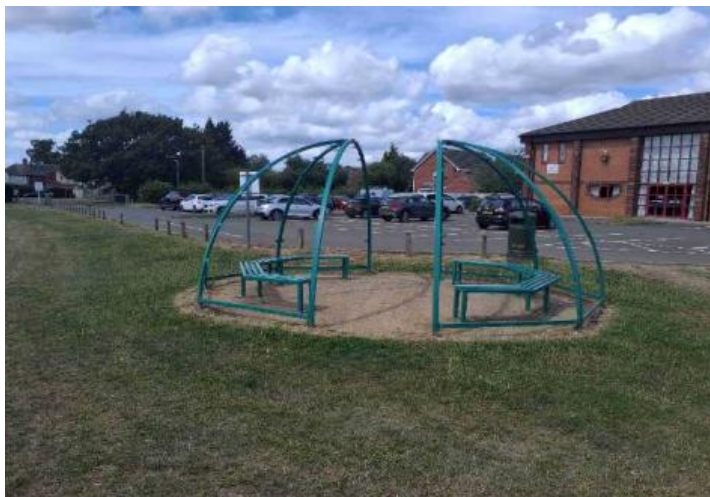
**Item:** Ancillary Items - Shelter  
**Manufacturer:** Not Identified

**Finding:** There is algae, silt or moss growth on the surface resulting in slippery conditions

**Action:** Clean and treat appropriately

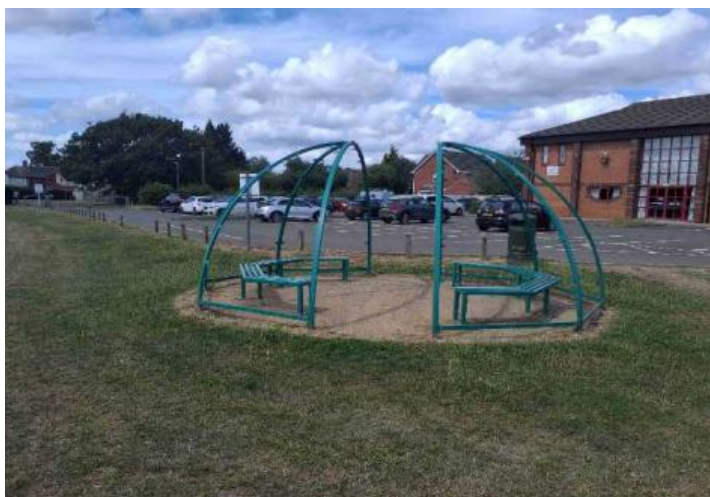
**Item:** Ancillary Items - Shelter  
**Manufacturer:** Not Identified

**Finding:** The item has missing panels exposing projecting brackets

**Action:** Replace missing components

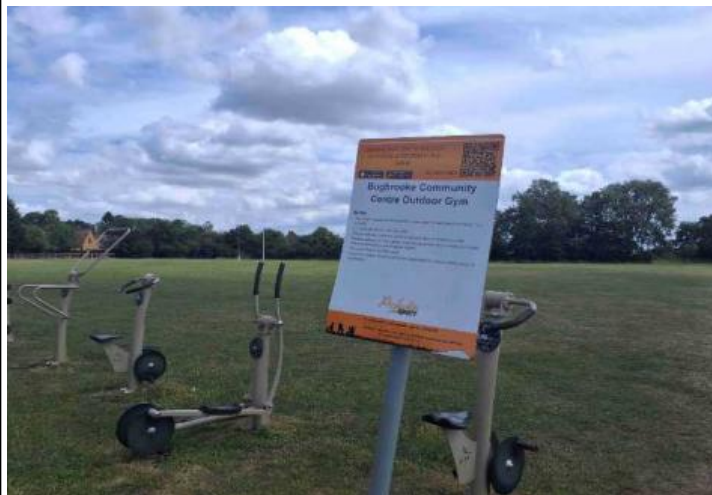
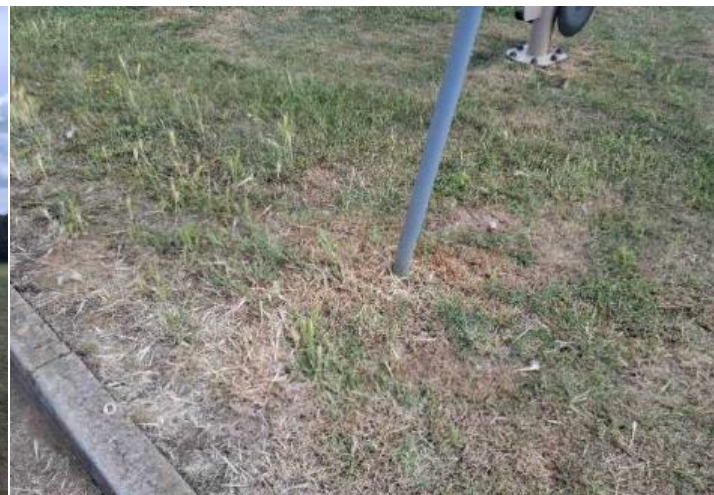
**Item:** Ancillary Items - Sign  
**Manufacturer:** Proludic

**Finding:** The item is slightly loose in its foundations

**Action:** Monitor for any further deterioration and repair as required

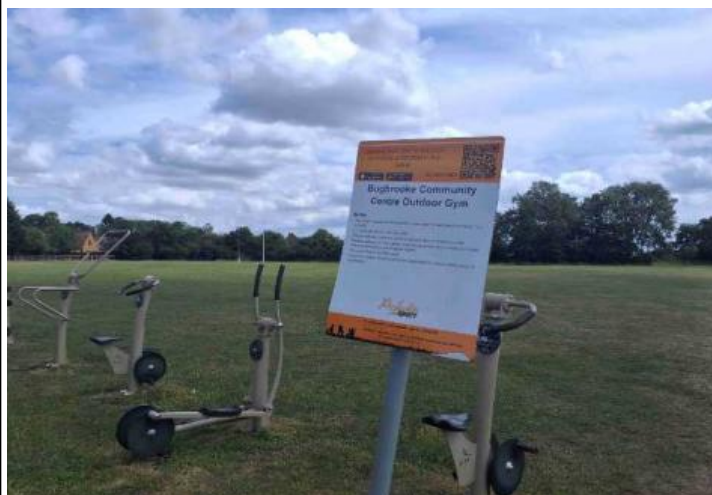
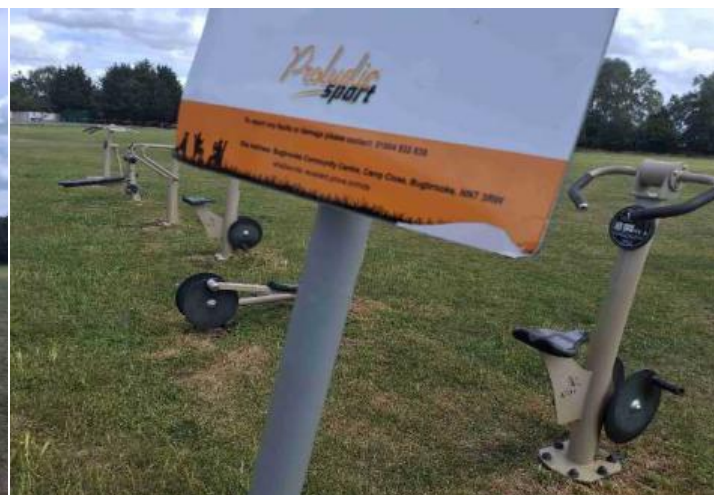
**Item:** Ancillary Items - Sign  
**Manufacturer:** Proludic

**Finding:** The item has been damaged

**Action:** Monitor for any further deterioration and replace as required

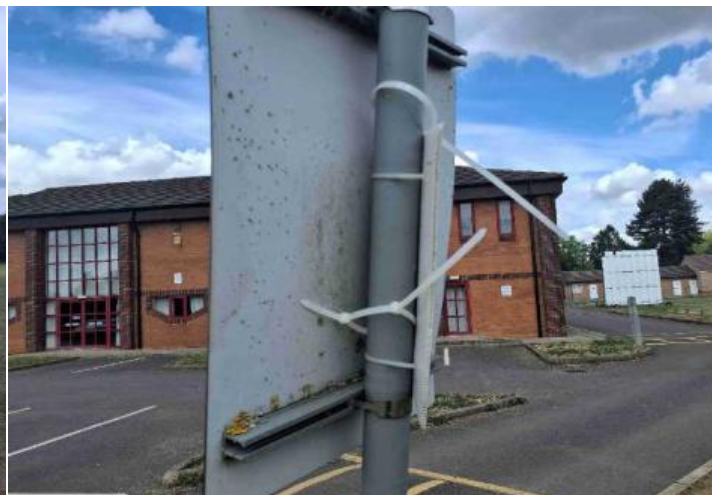
**Item:** Ancillary Items - Sign  
**Manufacturer:** Proludic

**Finding:** Cable ties are present and there are sharp projecting ends

**Action:** Replace with a more appropriate fixing method

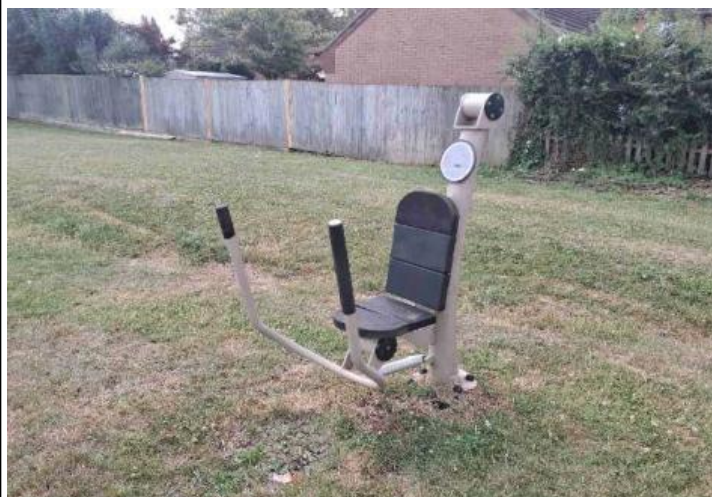
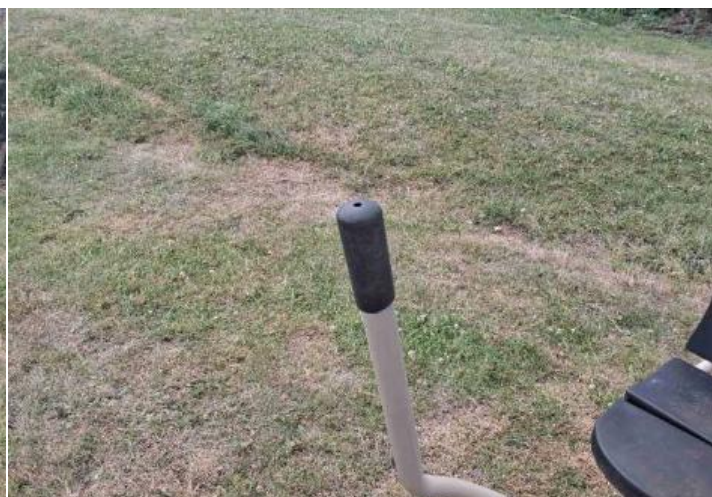
**Item:** Outdoor Fitness Equipment - Chest Press  
**Manufacturer:** Proludic

**Finding:** There is / are post or end caps missing / damaged on the item

**Action:** Replace missing / damaged post or end caps

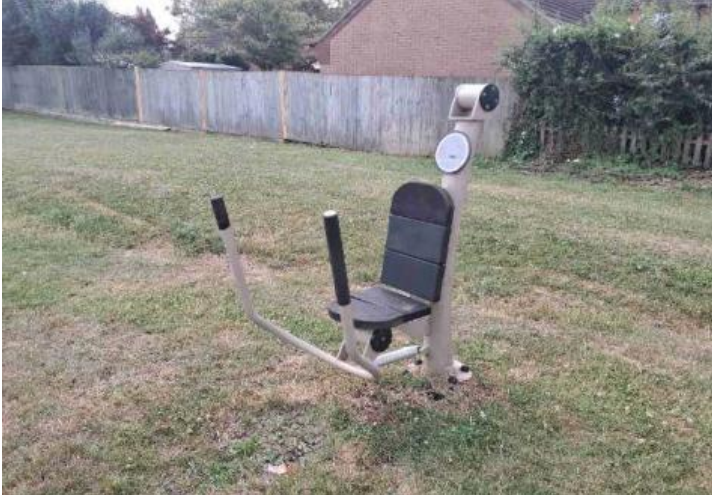
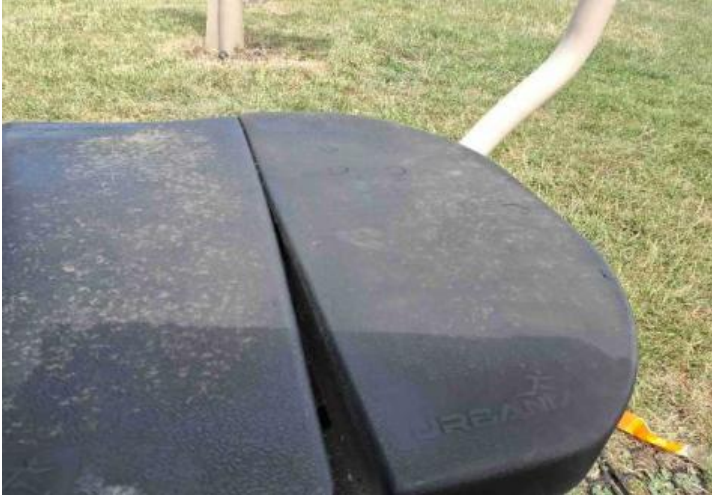
| <div> <div></div> <div>6 - Low Risk (Finding 3)</div> </div> | | | |
|---|---|---|---|
| Item: | Outdoor Fitness Equipment - Chest Press | Risk Level: | L - Low Risk |

| <div> <div></div> <div>6 - Low Risk (Finding 3)</div> </div> | | | |
|---|---|---|---|
| <b>Finding:</b> The item has been damaged | | <b>Action:</b> Monitor for any further deterioration and replace as required | |

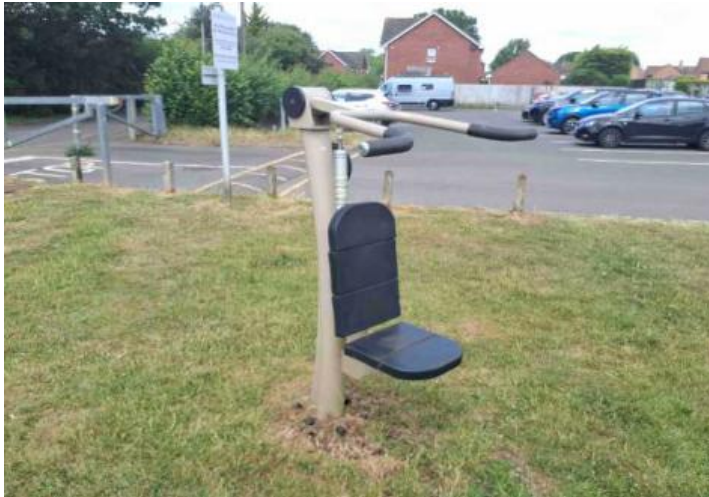
**Item:** Outdoor Fitness Equipment - Lateral Pull Down  
**Manufacturer:** Proludic

**Finding:** There is surface corrosion / rust present on the item

**Action:** Consider treating the item

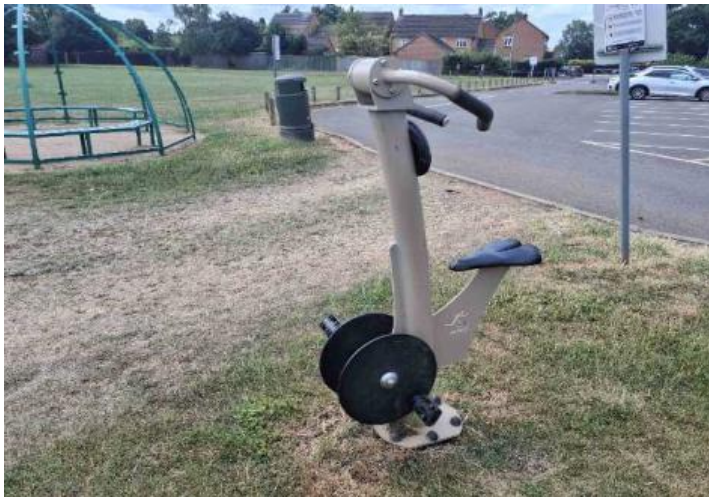
**Item:** Outdoor Fitness Equipment - Cycle  
**Manufacturer:** Proludic

**Finding:** There is / are post or end caps missing / damaged on the item

**Action:** Replace missing / damaged post or end caps

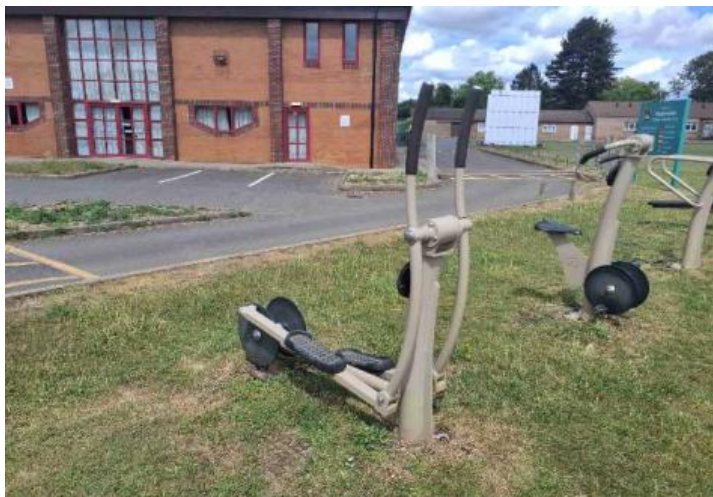
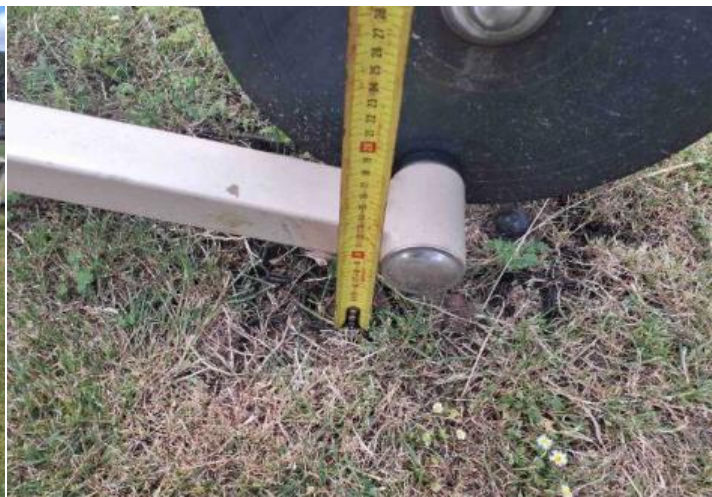
**Item:** Outdoor Fitness Equipment - Cross Trainer  
**Manufacturer:** Proludic  
**Risk Level:** L - Low Risk  
**Surface:** Grass Matrix Tiles

**Finding:** The distance between the underside of the item and the ground is less than the 110mm required by BS EN 16630

**Action:** Monitor - No action given the risk assessment

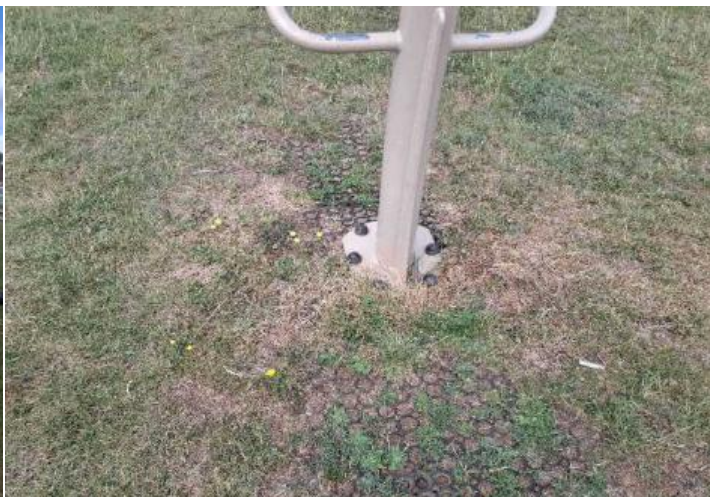
**Item:** Outdoor Fitness Equipment - Dip Station  
**Manufacturer:** Proludic

**Finding:** The item is slightly loose in its foundations

**Action:** Monitor for any further deterioration and repair as required

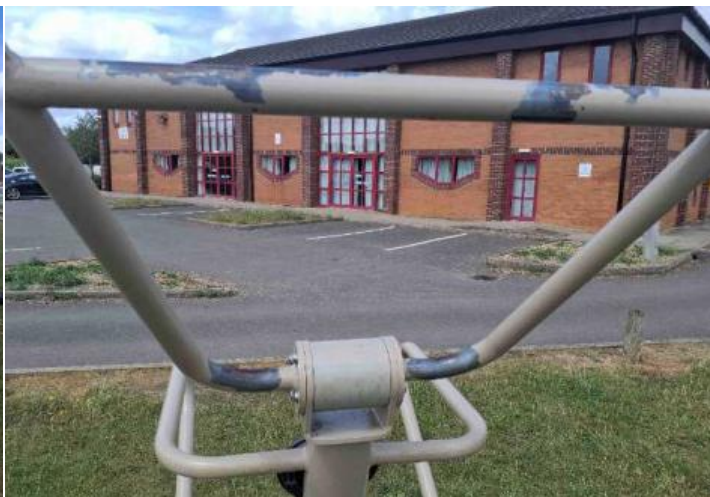
**Item:** Outdoor Fitness Equipment - Dip Station  
**Manufacturer:** Proludic

**Finding:** There is surface corrosion / rust present on the item

**Action:** Consider treating the item

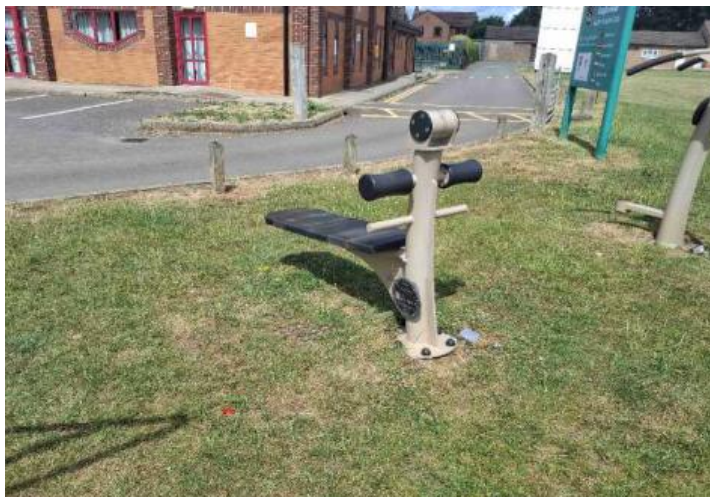
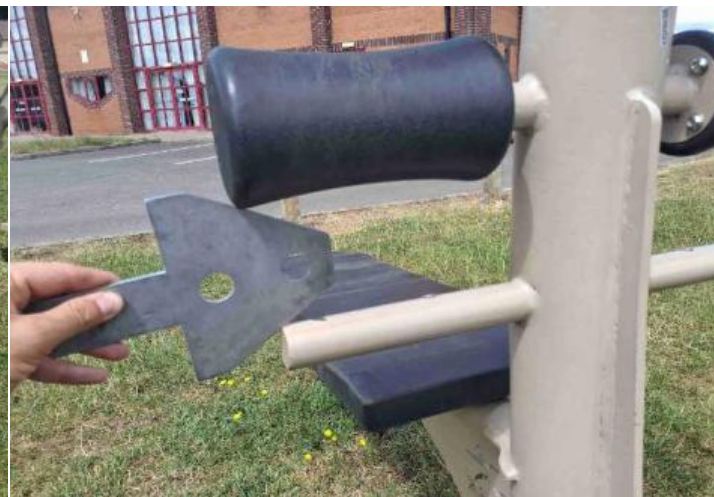
**Item:** Outdoor Fitness Equipment - Ab Station  
**Manufacturer:** Proludic

**Finding:** There is a head and neck entrapment in the framework in contravention of the requirements of BS EN 16630:2015 clause 4.3.6.1

**Action:** Monitor - No action given the risk assessment

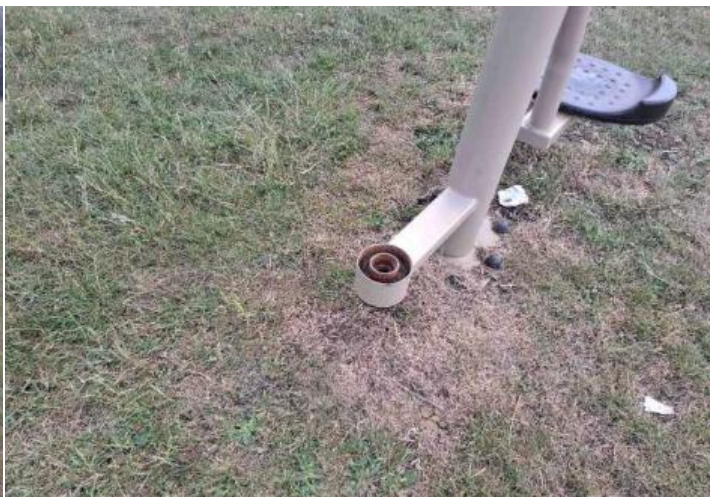
**Item:** Outdoor Fitness Equipment - Hip Twister  
**Manufacturer:** Proludic

**Finding:** The item has missing component(s)

**Action:** Replace missing components

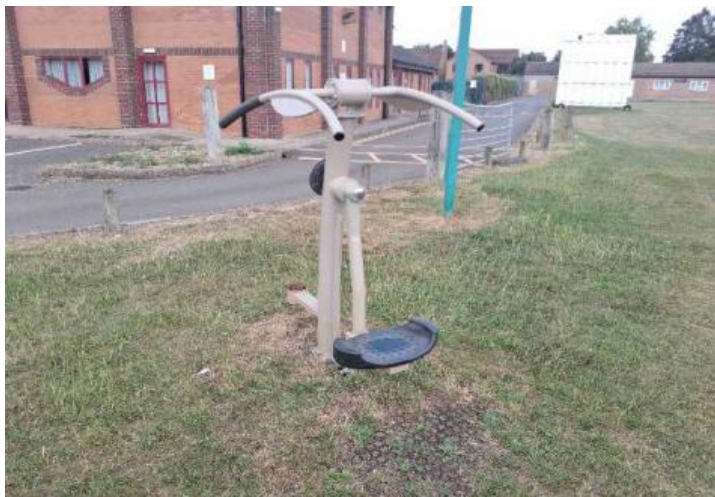
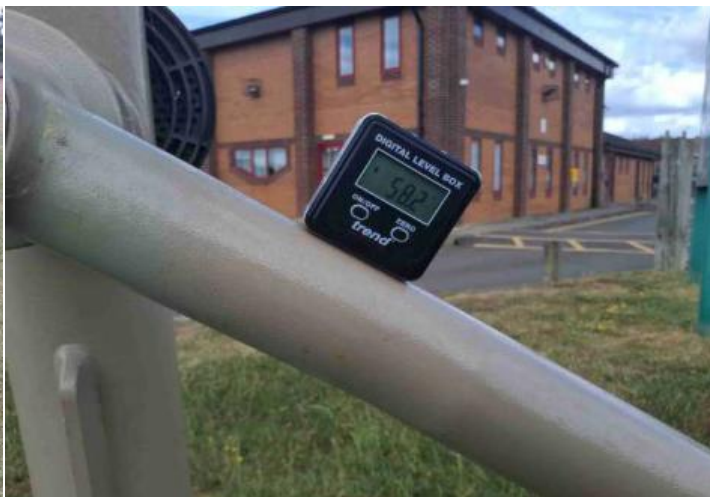
**Item:** Outdoor Fitness Equipment - Skier  
**Manufacturer:** Proludic

**Finding:** The swinging movement of the item exceeds the maximum 55 degrees from the vertical required by BS EN 16630

**Action:** Monitor - No action given the risk assessment

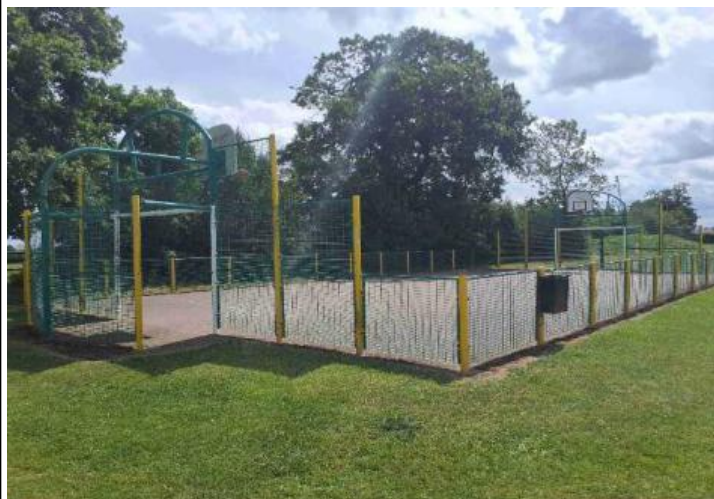
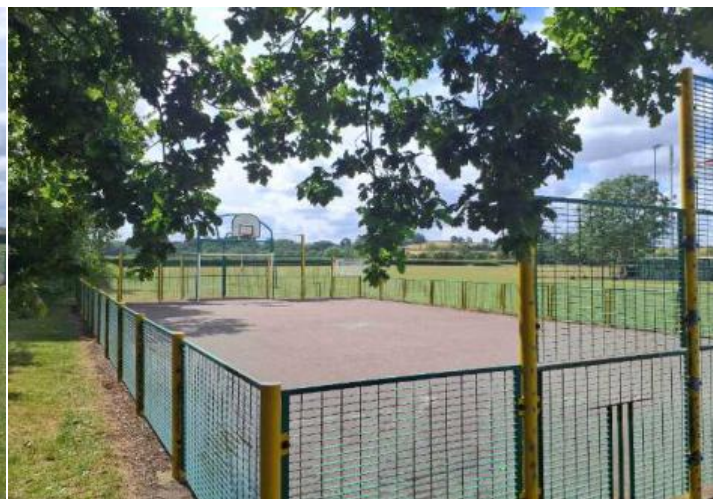
**Finding:** The adjacent foliage is overhanging

**Action:** Cut back and maintain

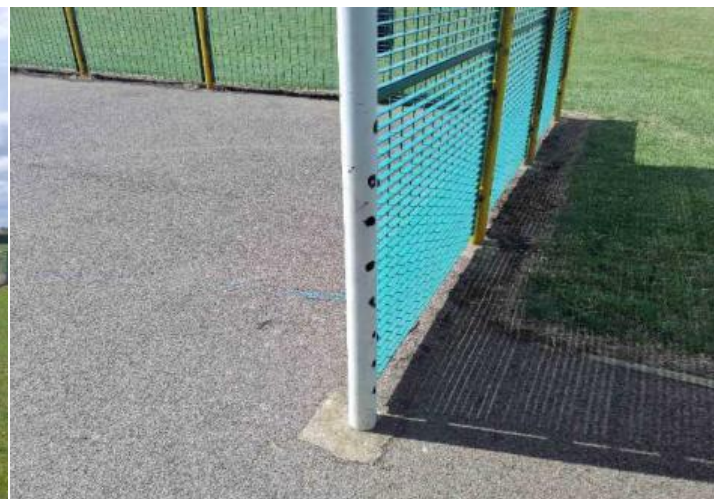
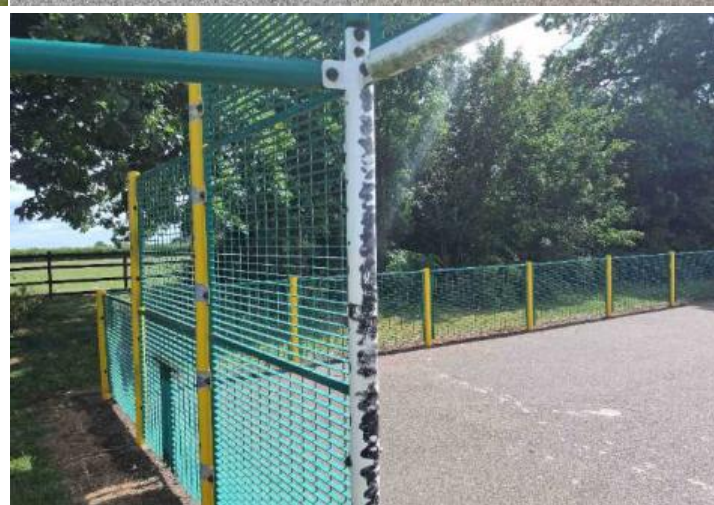
**Finding:** There is some graffiti present

**Action:** Remove the graffiti

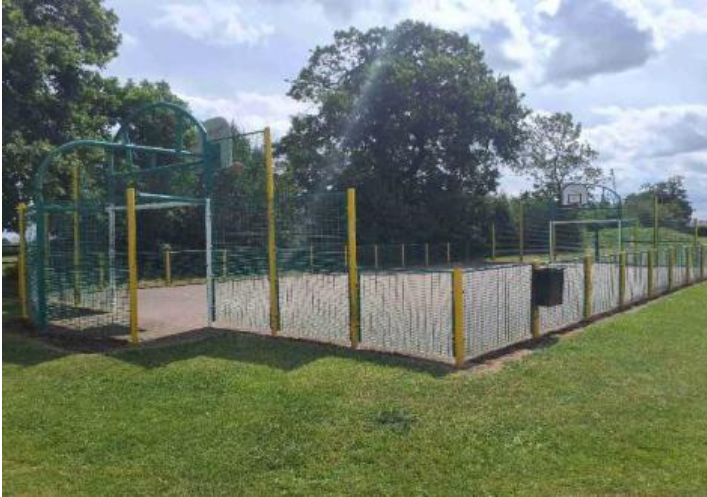
**Item:** Multi Use Games Area - Multi Use Games Area (MUGA)  
**Manufacturer:** Safe & Sound

**Finding:** Bolt cap cover/s missing or damaged

**Action:** Replace
